Introducing Automated Obstacle Detection to British Level Crossings

Abstract

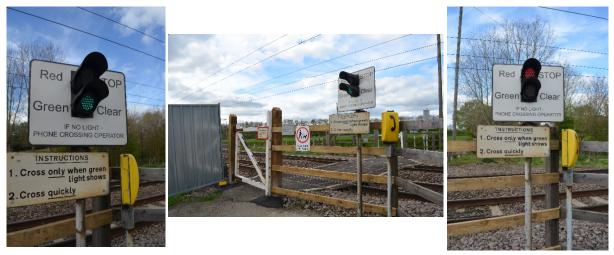
Figure 3. Eaves Lane level crossing (FP-MWL). From left, miniature warning lights showing it is safe to cross, image of level crossing, miniature warning light showing that a train is approaching and it is unsafe to cross.

This variation of the typical footpath crossing has similar features. However, the inclusion of red and green lights inform the pedestrian whether or not it is safe to cross. The light remains green until a train approaches the crossing, at which time the light will turn to red and will stay so until the train has passed. The red light could still be showing after a train has gone through which would indicate that another train is approaching and it is still unsafe to pass.

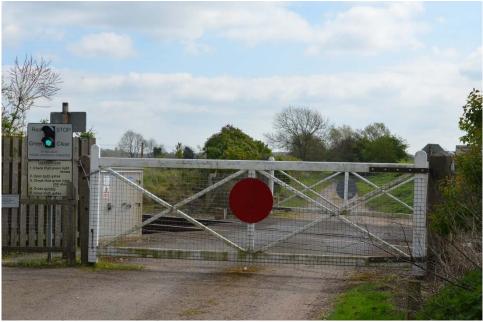
Figure 4. Westbrook Lane level crossing (UWC-MWL)

This level crossing has gates or barriers which extend across the whole road or path and the user must operate the crossing themselves before crossing. Similarly to a footpath crossing with miniature warning lights, there are red and green lights indicating to the user when it is safe to cross. There are also signs in place to tell the user how to safely pass the crossing.

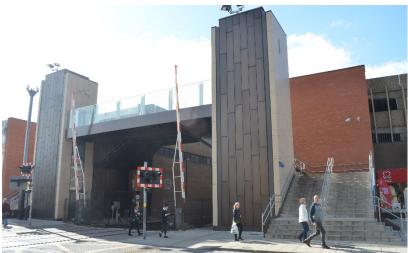
Figure 7. The footbridge over Lincoln High Street level crossing

One case of reducing risk is the level crossing on Lincoln High Street. Every day, the level crossing is used by approximately 35,000 people and around 140 trains pass through it (Network Rail, 2017). It was originally targeted due to it having the highest case of misuse in the region (Pidluznyj, 2016). Network Rail proposed to put a footbridge (with lifts) over the crossing, in an attempt reduce the misuse caused by pedestrians who would run across the level crossing as the barriers lower. Having the bridge there would allow pedestrians to cross the railway safely while the barriers are down, rather than waiting for a train to pass. The plans for it were accelerated after a woman attempted to run across as the barriers were closing, resulting in her tripping and being badly injured. The footbridge reportedly cost £12 million and opened on the 24th June 2016 (Pidluznyj, 2016).

Since opening, the bridge experienced problems within the first few months. There were reportedly issues with the paving stones coming loose and the lift malfunctioning causing pedestrians to be trapped inside (Barker, 2016). This required a lot of maintenance to get it to a standard which was safe for the public to use, thus increasing costs.

Witnessing first hand, even now when the footbridge is fully functional and safe to use, some pedestrians still choose to run across when the audible warning sounds to reach the other side, before the barriers close. The bridge is primarily used by pedestrians who reach the level crossing as the barriers have just come down. There are also approximately half of the pedestrians who want to pass, who still wait by the barriers rather than using the bridge, see Appendix D. As a way to reduce people trying to run across the crossing, this method doesn't appear effective.

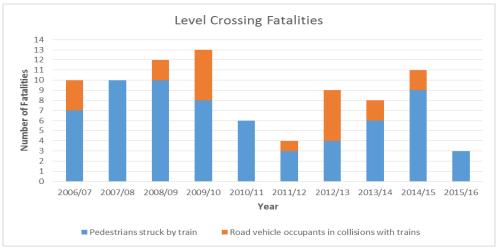
Figure 8. The number of fatalities that have occurred at level crossings over the past 10 years (excluding suicide) (Rail Safety and Standards Board, 2016)

Over the past ten years there has been a gradual decline in the number of fatalities that have occurred at level crossings, although there is variation from year to year. The most recent year recorded saw the lowest number of fatalities ever in Britain with only 3. These fatalities occurred at a user worked crossing, footpath crossing and manually controlled barrier with CCTV (Rail Safety and Standards

Board, 2016). For all these fatalities in Figure 8, none of them were passengers on a train and all were pedestrians or vehicle users involved in a collision with a train.

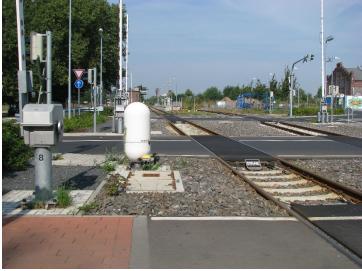
Figure 13. A Radar detector in place at one a German level crossing (ACBahn, 2013)

Germany first trialled obstacle detection on 70 different level crossings and used radar detectors. Since introducing it, there have been no known instances of objects going undetected, but there were some cases of false positives occurring. The main reason for the German railways to introduce obstacle detection wasn't primarily to improve safety but rather the economic benefits (Rail Safety & Standards Board, 2006). The level crossings upgraded are the equivalent of manual barrier or gated crossings in Britain. Germany also thought that there was an economic preference to replace automatic half barrier crossings with grade separation schemes such as bridges and underpasses where possible.

The overall cost of upgrading each level crossing was approximately €100,000, half of this cost was for the installation and interfacing with existing equipment and the other half was for the cost of equipment, this gave a financial payback of about 2 years (Rail Safety & Standards Board, 2006). The radars were calibrated to detect vehicles, cyclists and "adult-sized" pedestrians but not smaller children and animals. This is because there have been no accidents that have involved small children and ignoring smaller objects means that fewer false positives will occur.

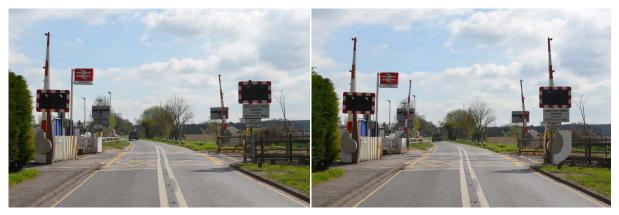
Figure 17. Left: The current setup at Collingham level crossing (AHB). Right: Edited image showing barriers on both sides of the road for the introduction of obstacle detection

In order for obstacle detection to be fully effective at level crossings, full barriers that cover the entrance and exit separately must be used instead of a half barrier. One of the main features of an AHB crossing are the short strike-in times, which are a minimum of 27 seconds. If an object was stuck on the crossing the approaching train wouldn't be able to stop in time to avoid a collision if the train was travelling at full speed. The way around this would be to increase the strike-in distance, thus increasing the waiting time for vehicles and pedestrians at the crossing. This would, however, lead to an increase in the misuse of automatic half barrier crossings as more vehicles and pedestrians would "zigzag" over the crossing to avoid waiting; similarly to what happened in the Netherlands' trial.

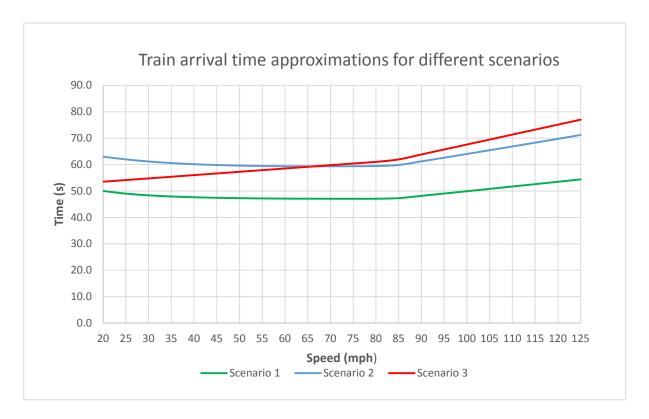
Appendix E. Graph of train approximated arrival times

For Scenario 3, the time taken to stop is a distance of 50m back from the level crossing. For Scenario 1 and 2, it is the time taken for the train to reach the level crossing. At lower speeds this distance of 50m is quite significant because it is the reason why Scenario 3 has a lower arrival time than Scenario 2.
