Physical Analysis of Worn Surfaces
Formed under Extreme Pressure
Lubrication Conditions

A Thesis submitted for the degree of

Doctor of Philosophy

in the University of Aston in Birmingham

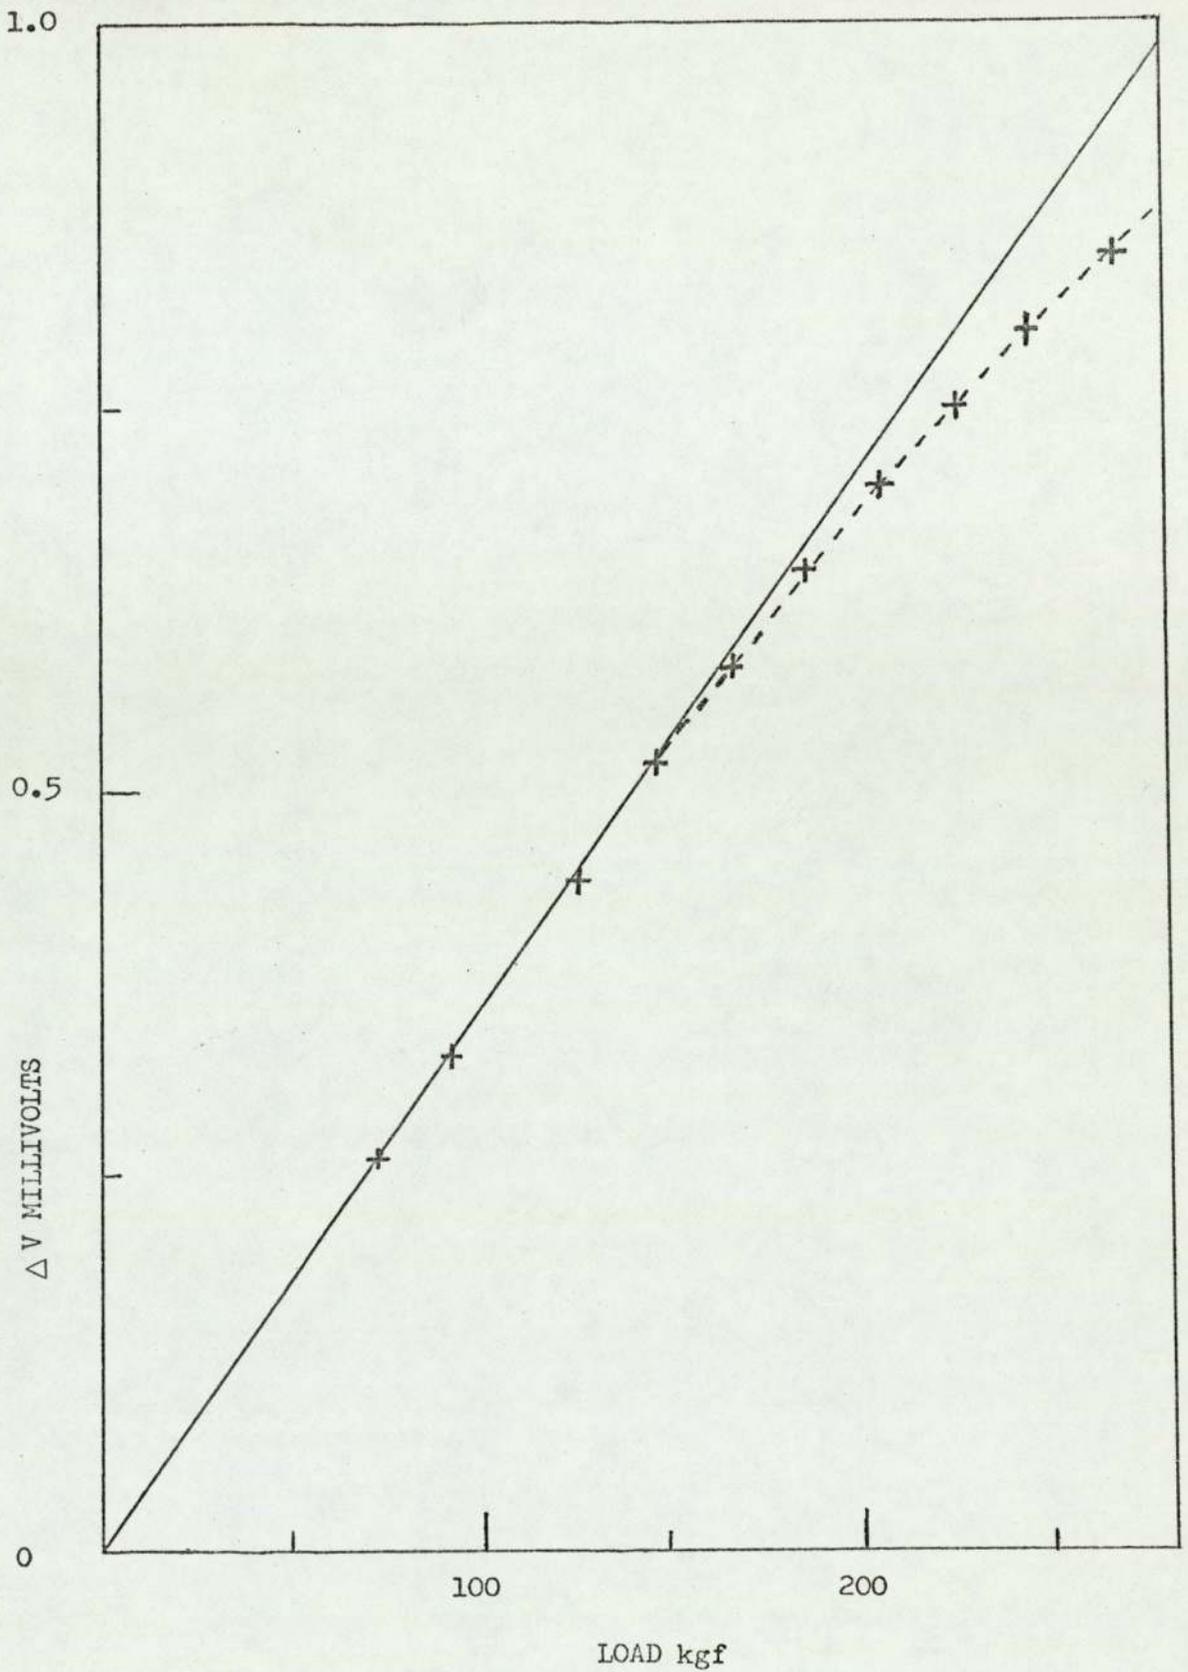
FIG.2.5 LOAD VERSUS ΔV

(b) DASHED LINE (+) NOMINAL 4-BALL LOAD VERSUS ΔV

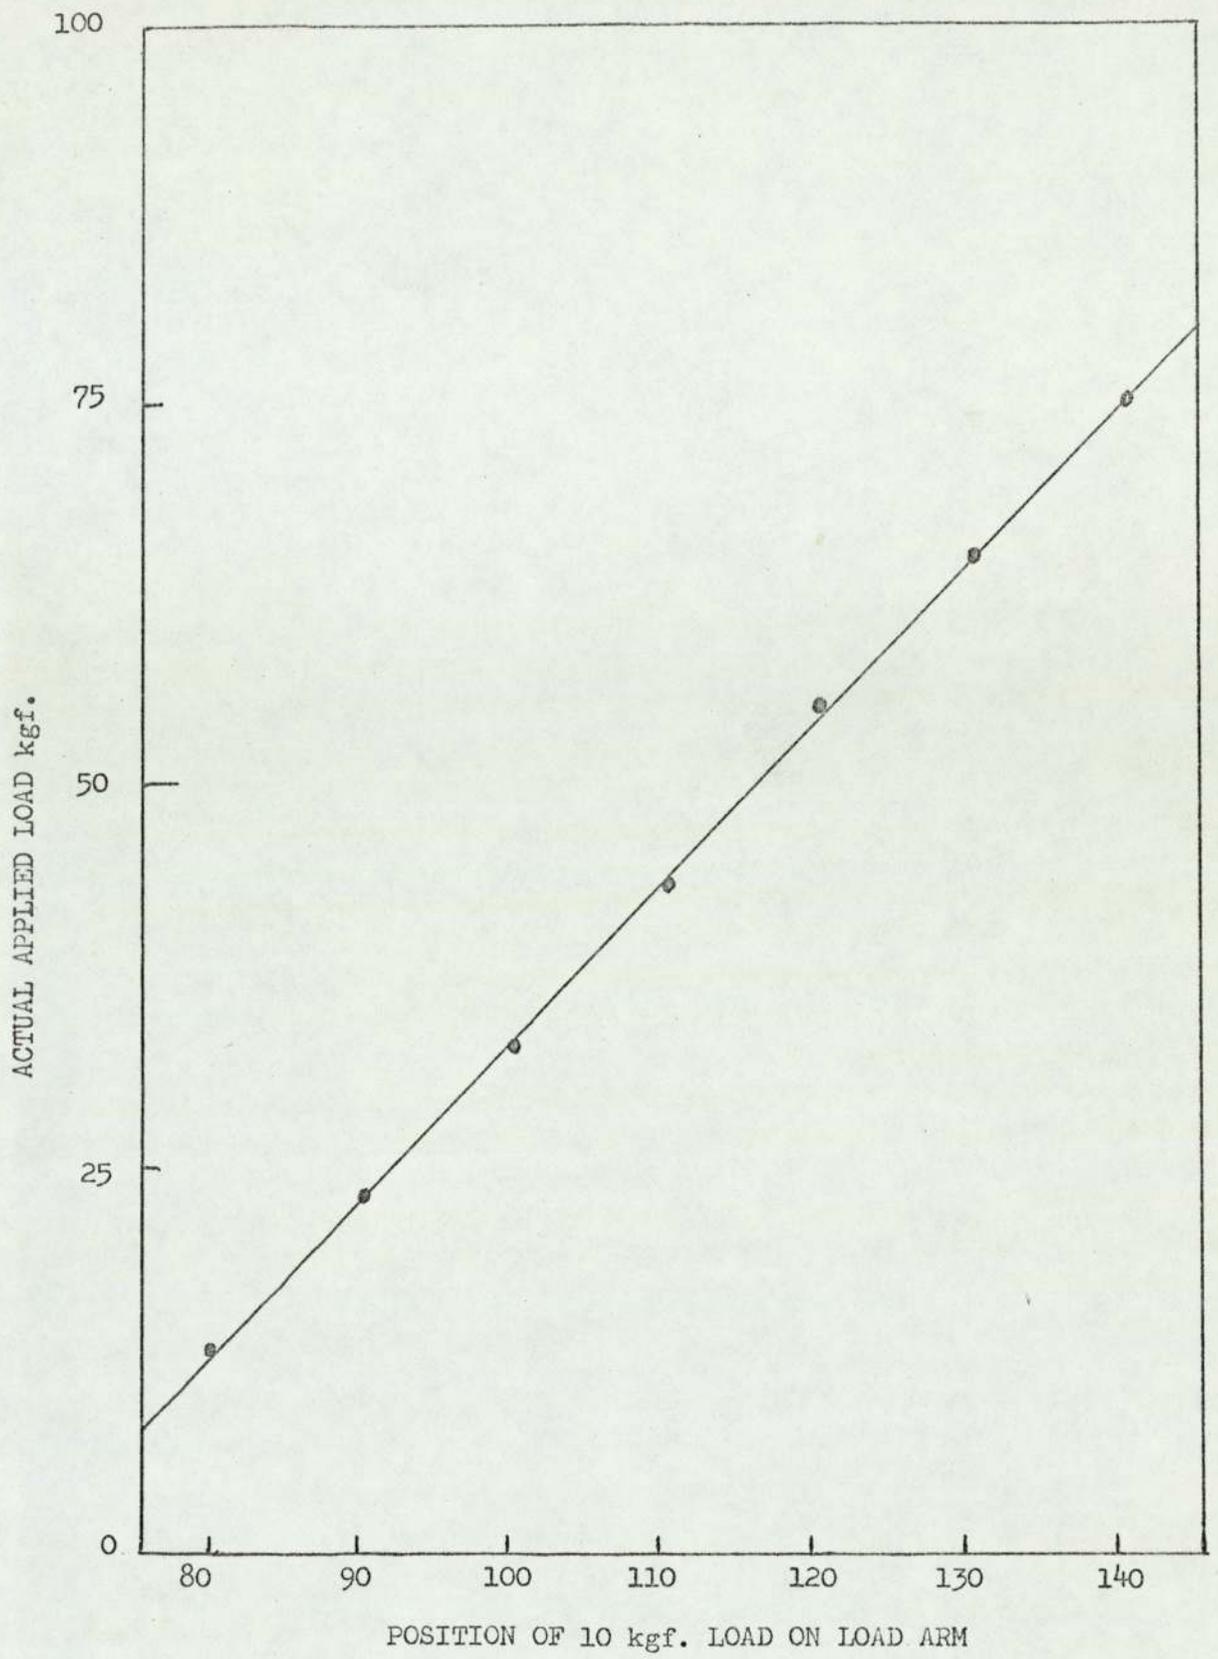
FIG.2.6 ACTUAL APPLIED LOAD WHEN 4 kgf. COUNTERBALANCE IS USED

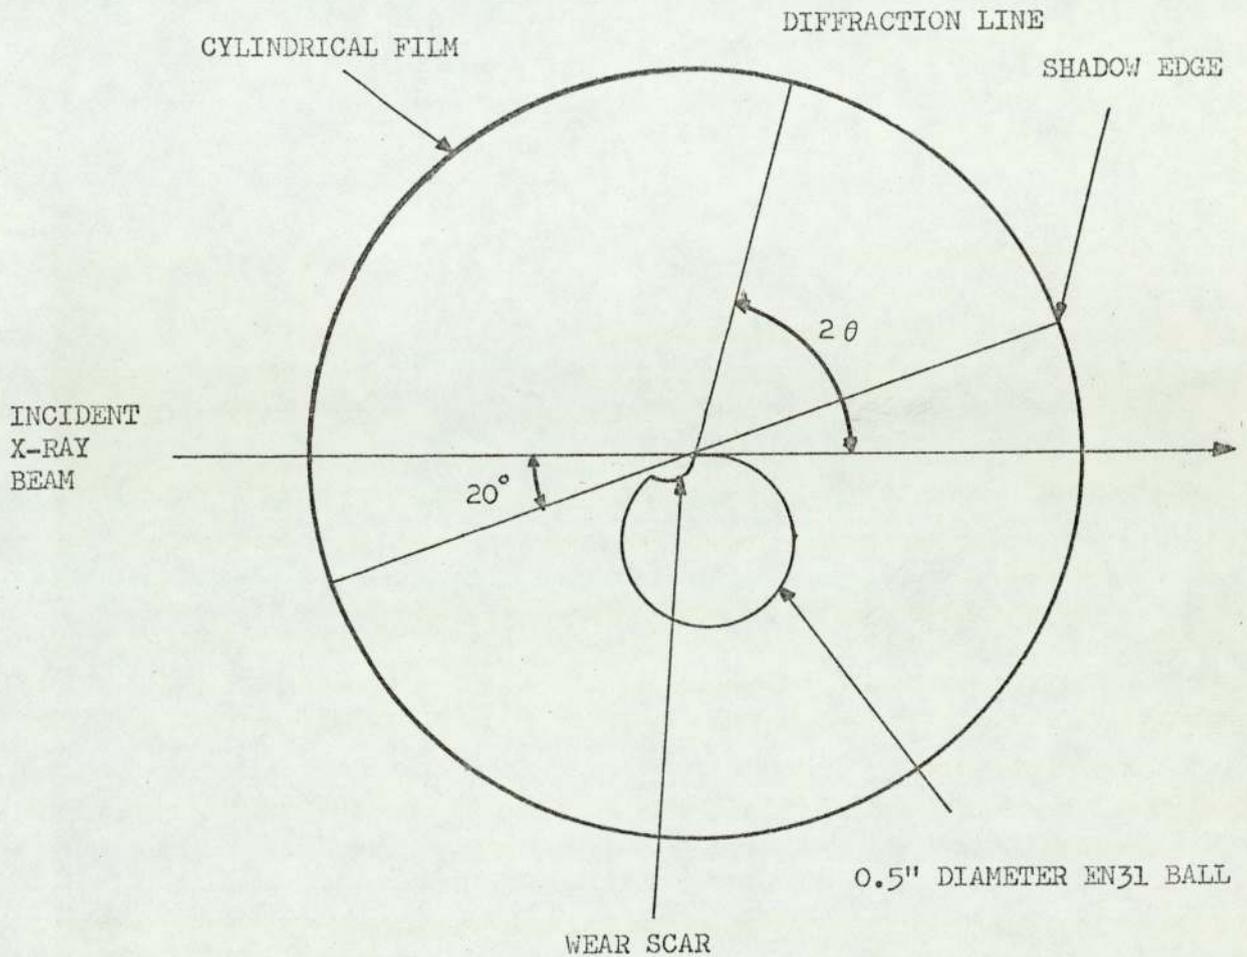
FIG.2.8 Diagram of the irradiation geometry used for obtaining the glancing-angle, edge-irradiated x-ray diffraction patterns (wear scar size exaggerated for the sake of illustration)

A number of standard specimens were used to facilitate indexing of the films obtained from worn specimens. Two flat faces intersecting at 90° were ground on an unworn ball and the resultant edge irradiated. After

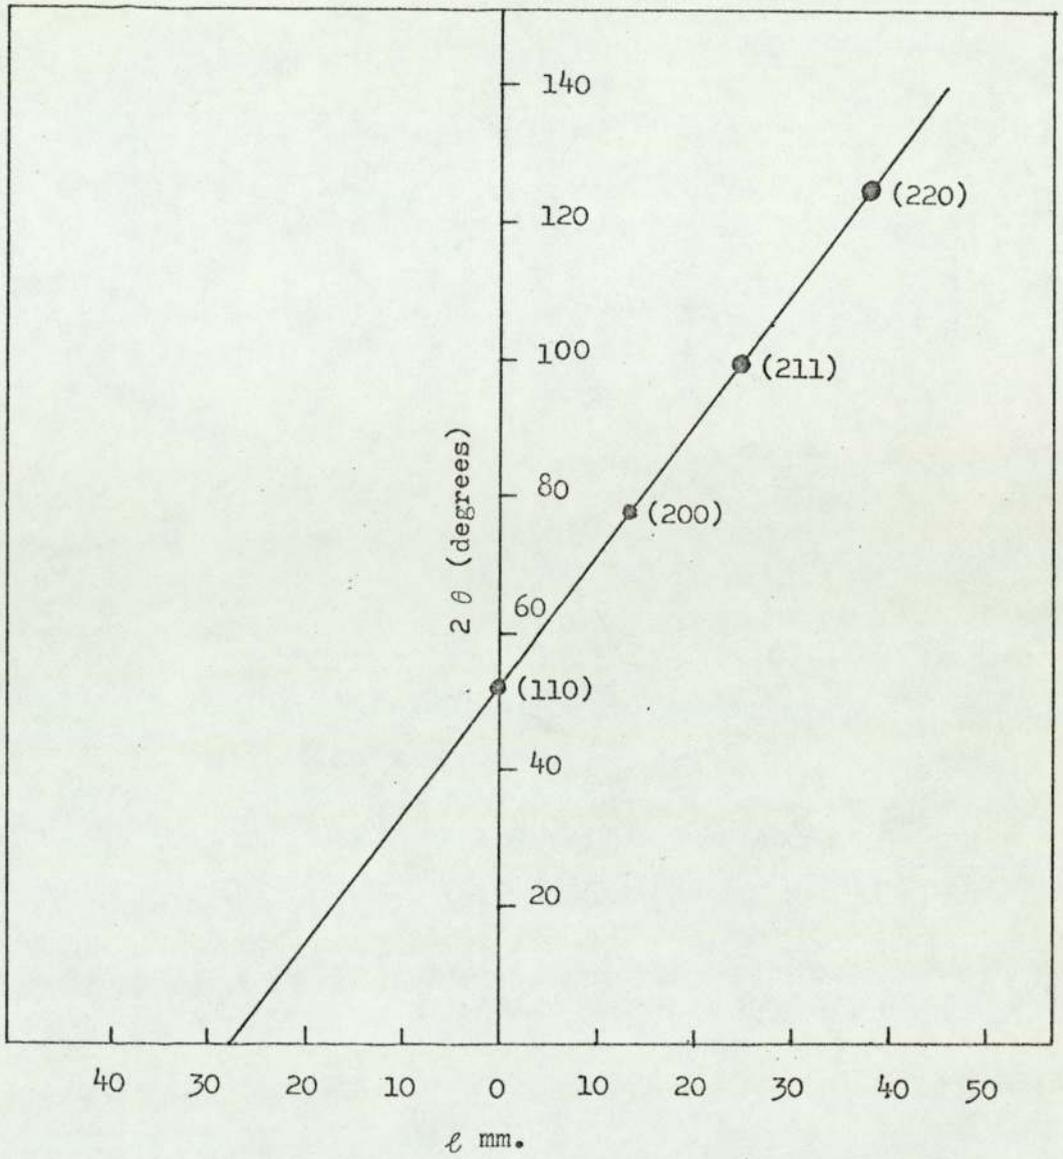
FIG.2.9 GRAPH OF 2θ AGAINST DISTANCE ALONG THE FILM ' l ' mm.

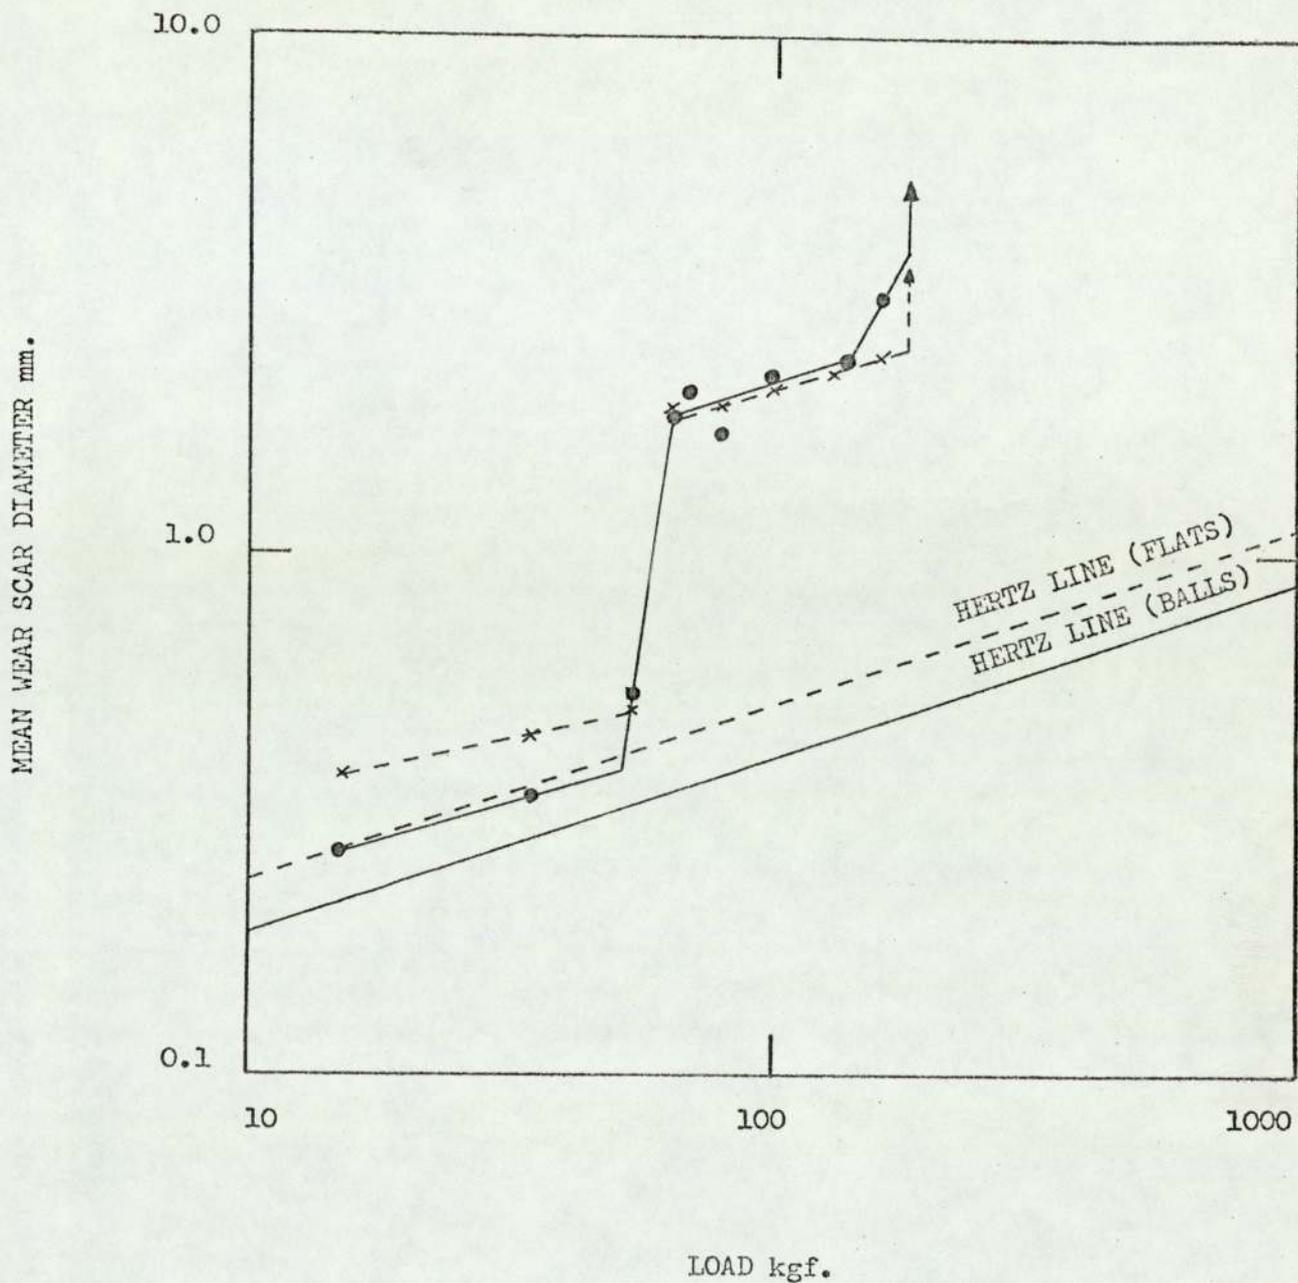
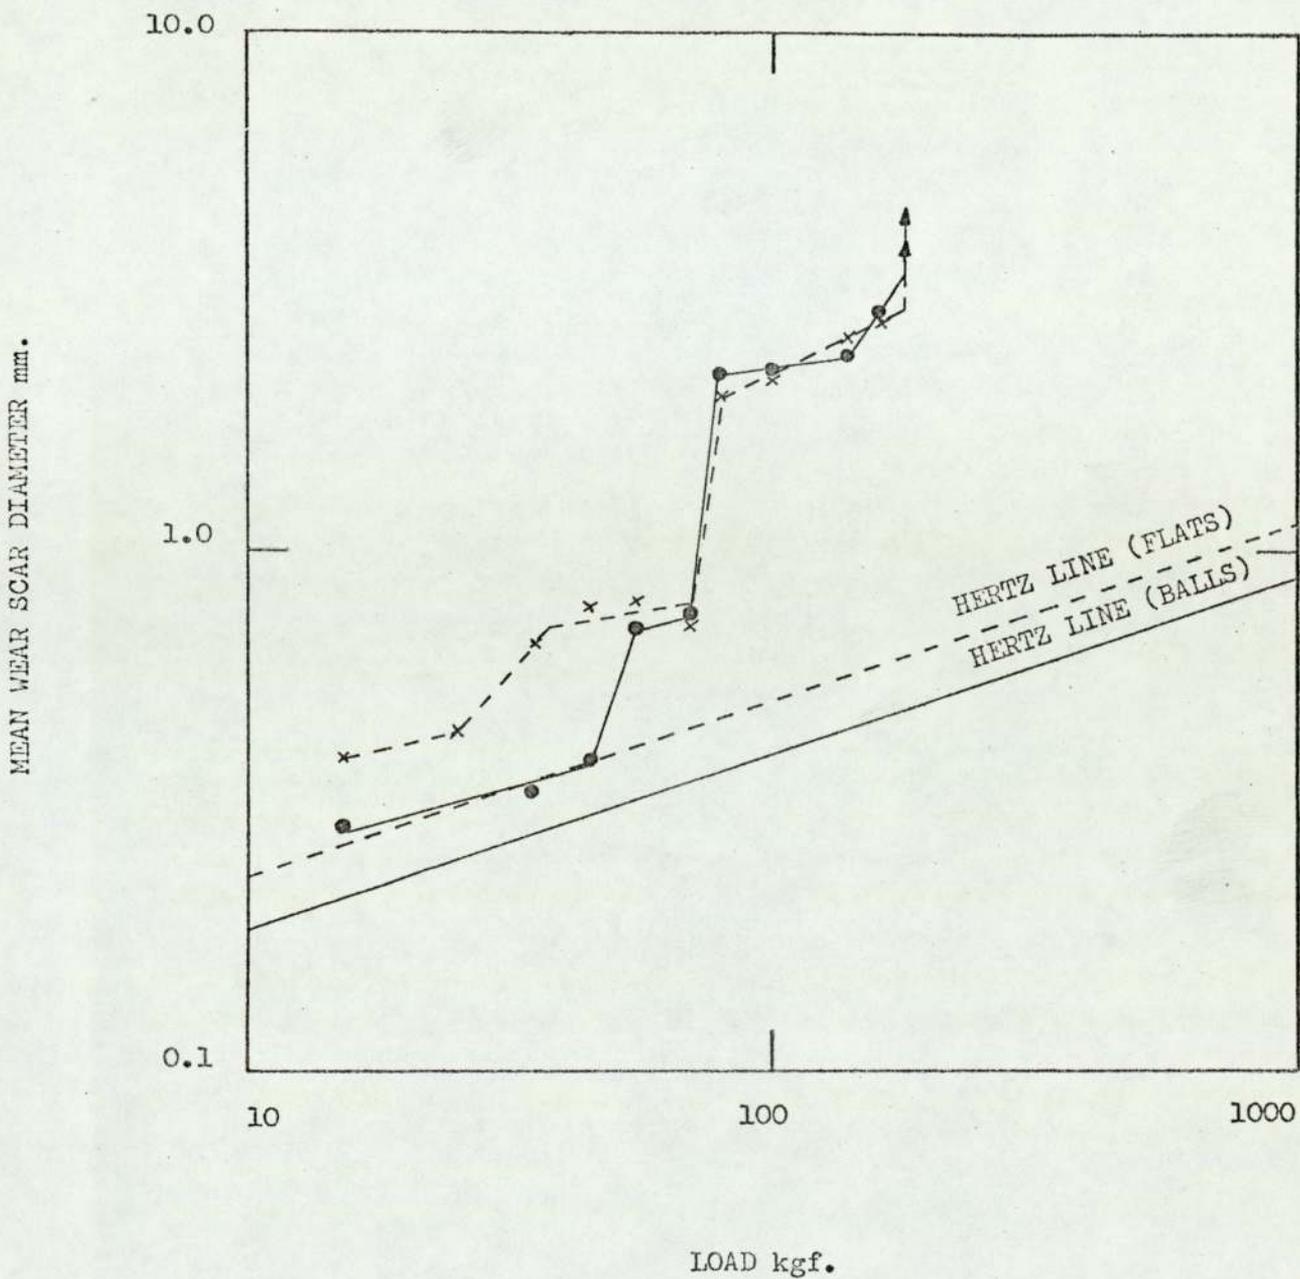
FIG. 3.5 LOAD VERSUS MEAN WEAR SCAR DIAMETER.

FIG. 3.6 LOAD VERSUS MEAN WEAR SCAR DIAMETER.

When 0.886% by weight of Diphenyl Disulphide was used as additive the graphs of load versus wear scar diameter (Figures 3.5 and 3.6) have final seizure loads around 180 Kgf, considerably below those using Dibenzyl Disulphide. Using Risella 29 as base oil initial seizure occurred at 55 and 65 Kgf for ball on ball and ball on flat geometries respectively. Final seizure occurred at 180 Kgf in both cases. When HVI oil was used initial seizure occurred at 55 Kgf for ball on ball and at 35 Kgf for ball on flat.

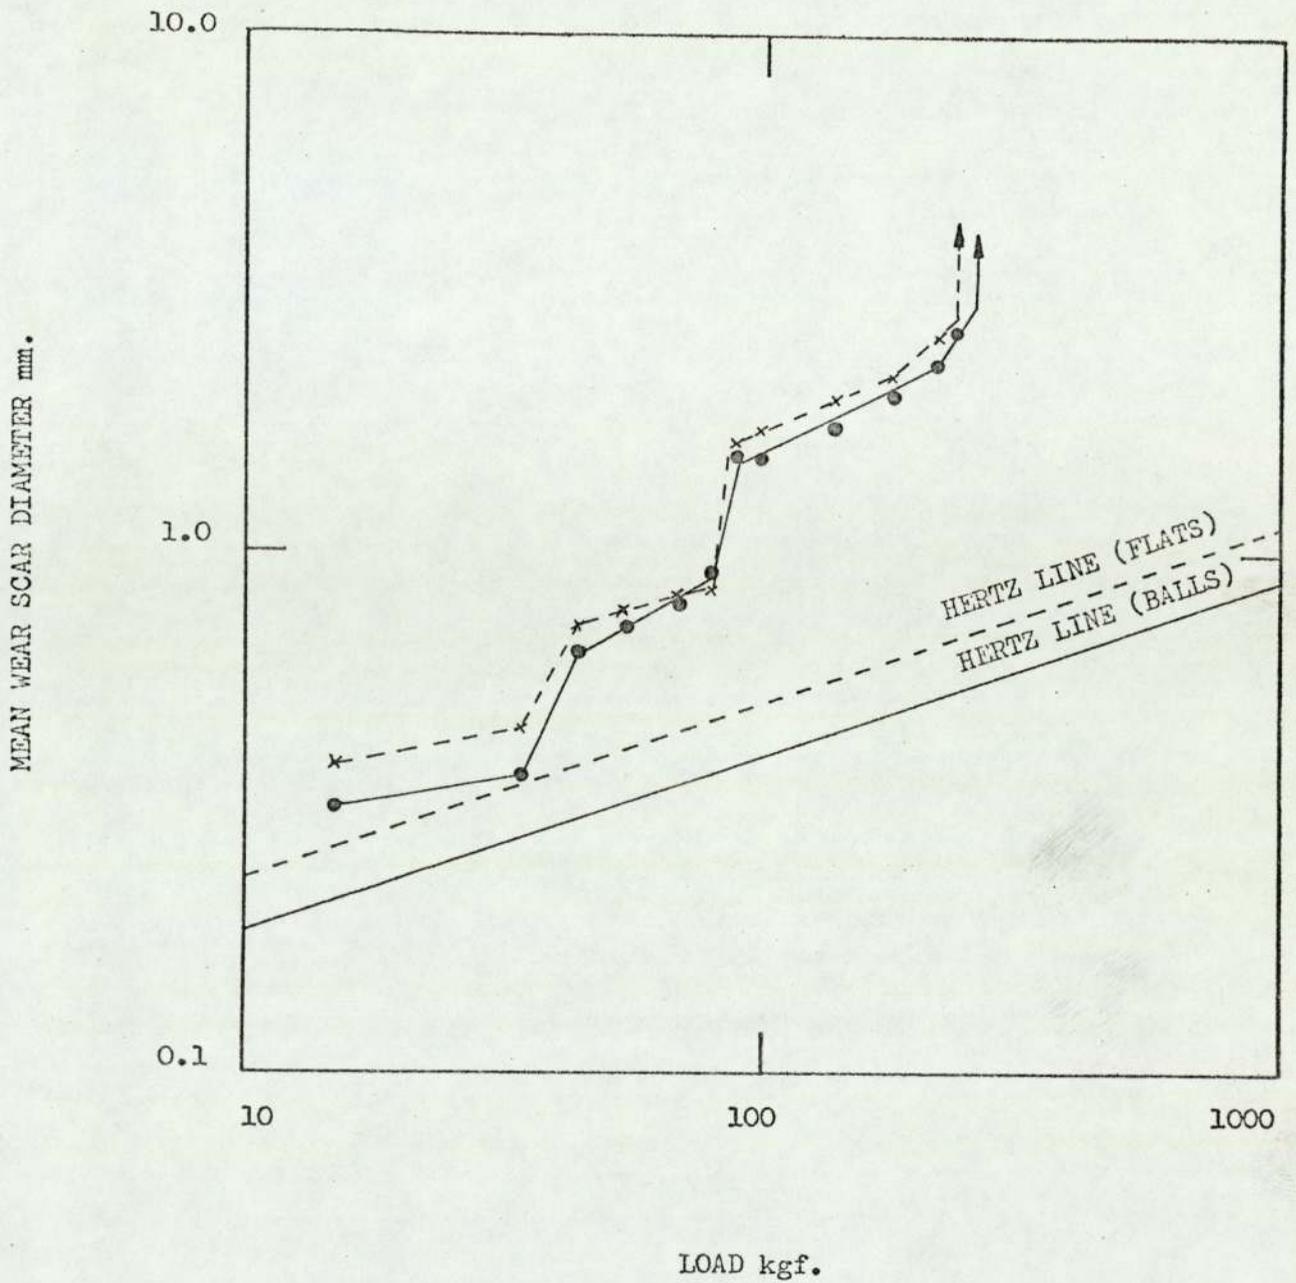
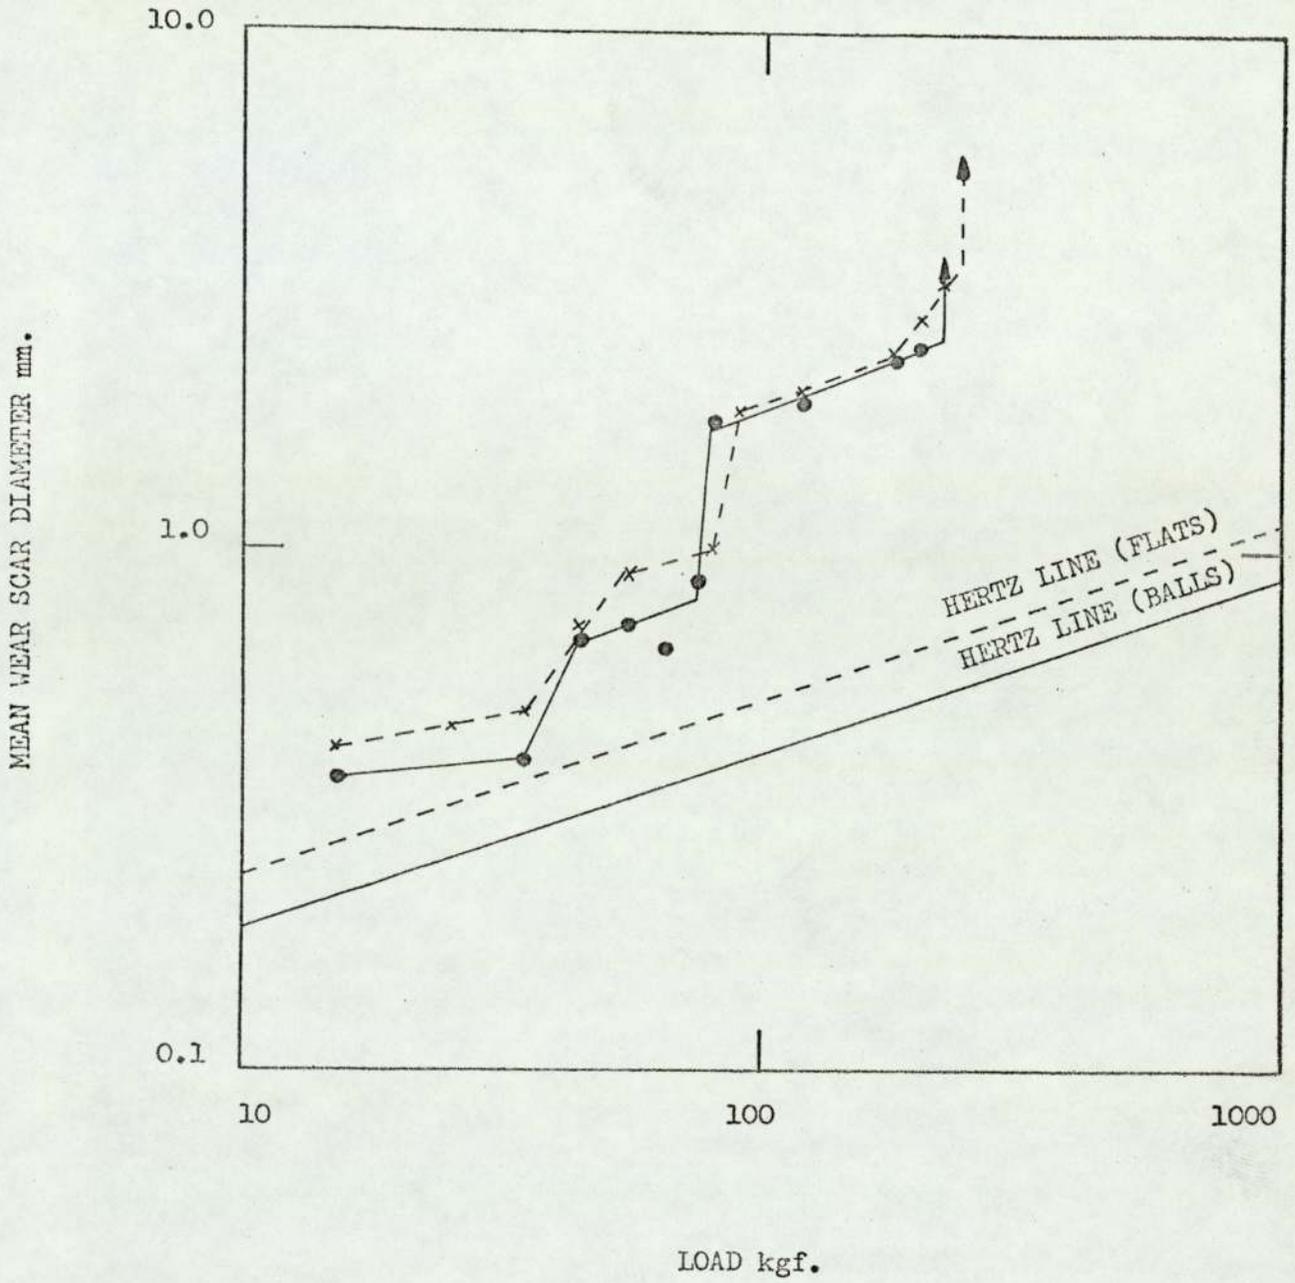
FIG. 3.7 LOAD VERSUS MEAN WEAR SCAR DIAMETER.
 LUBRICANT: RISELLA 29 + 0.723%wt DTBDS

- ——— 4-Ball Geometry
- × - - - 1-Ball-on-3-Flats Geometry

FIG. 3.8 LOAD VERSUS MEAN WEAR SCAR DIAMETER.

The graphs of load versus wear scar diameter (Figures 3.7 and 3.8) using 0.723% by weight of Di-tert-butyl Disulphide as additive are similar to those obtained using Dibenzyl Disulphide. Initial seizure occurred at slightly lower loads (45 Kgf) using DTBDS than using DBDS. This was followed by an intermediate step up to 80 Kgf and then on to the e.p. region where final seizure occurred between 220 and 260 Kgf. The behaviour of DTBDS seemed much more predictable than that of DBDS. In the a.w. region the wear scar diameters at 15 Kgf were quite large indicating that a considerable amount of wear had taken place. As the loads were increased the wear scar diameters approached the Hertzian diameters showing that the wear rate was decreasing with increasing load up to initial seizure. The graphs for the two geometries, ball on ball and ball on flat, are very similar, showing that for this additive, the different surface finishes and

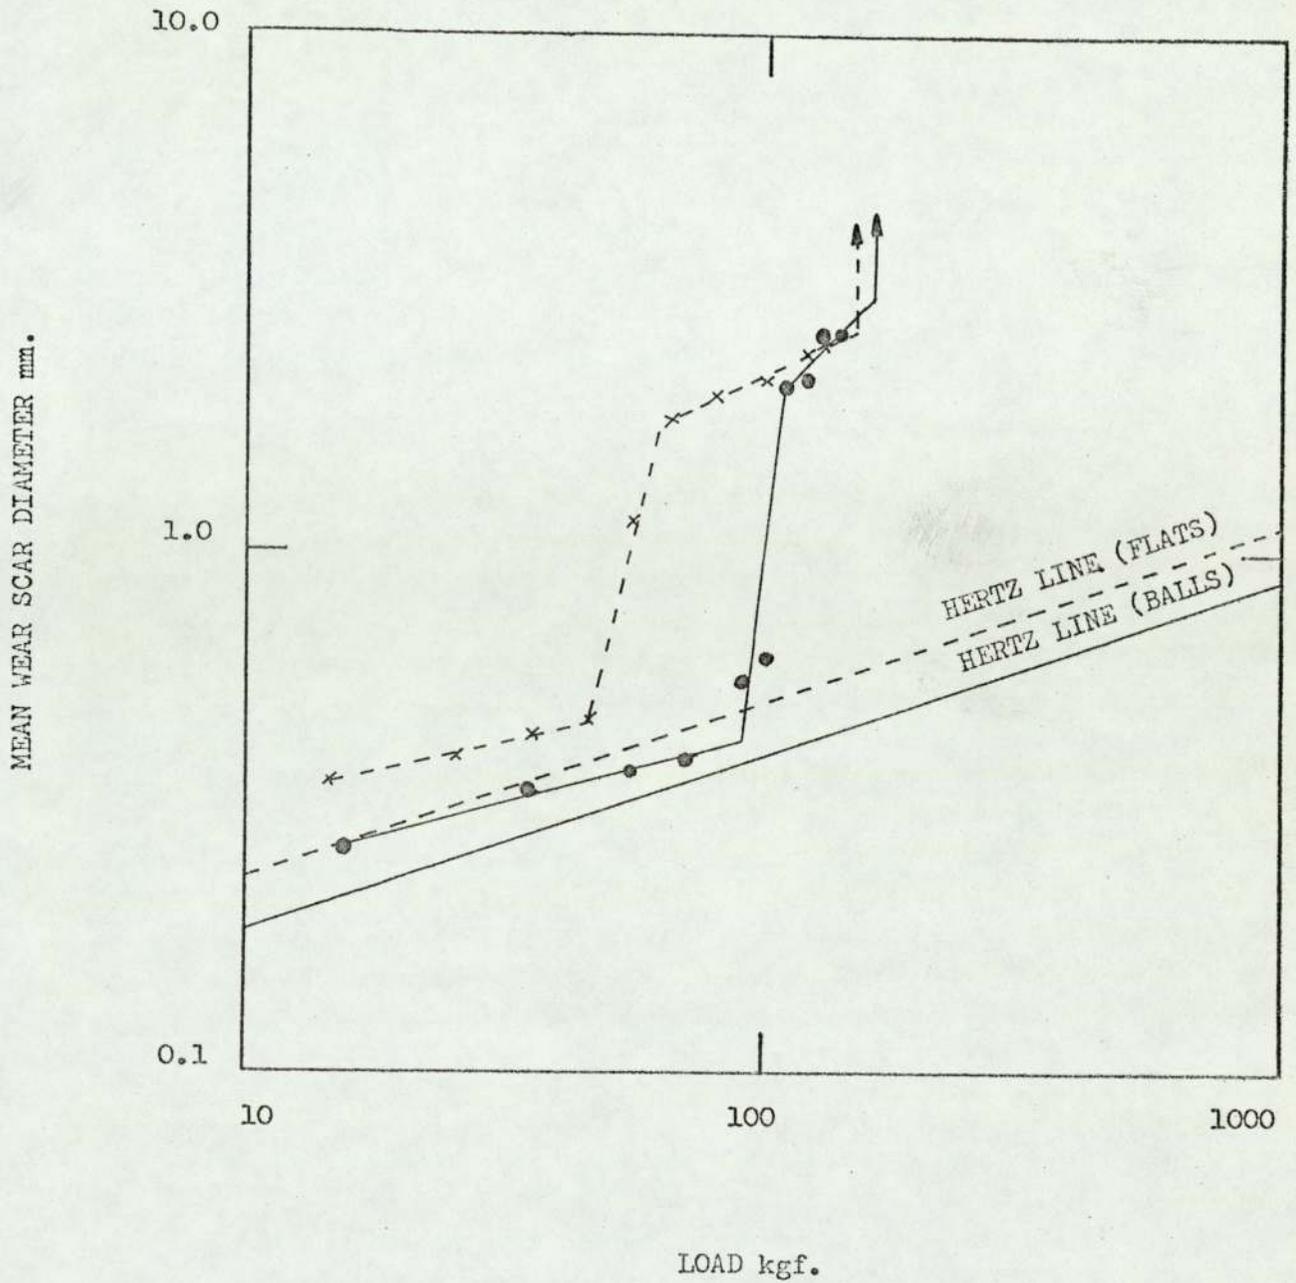
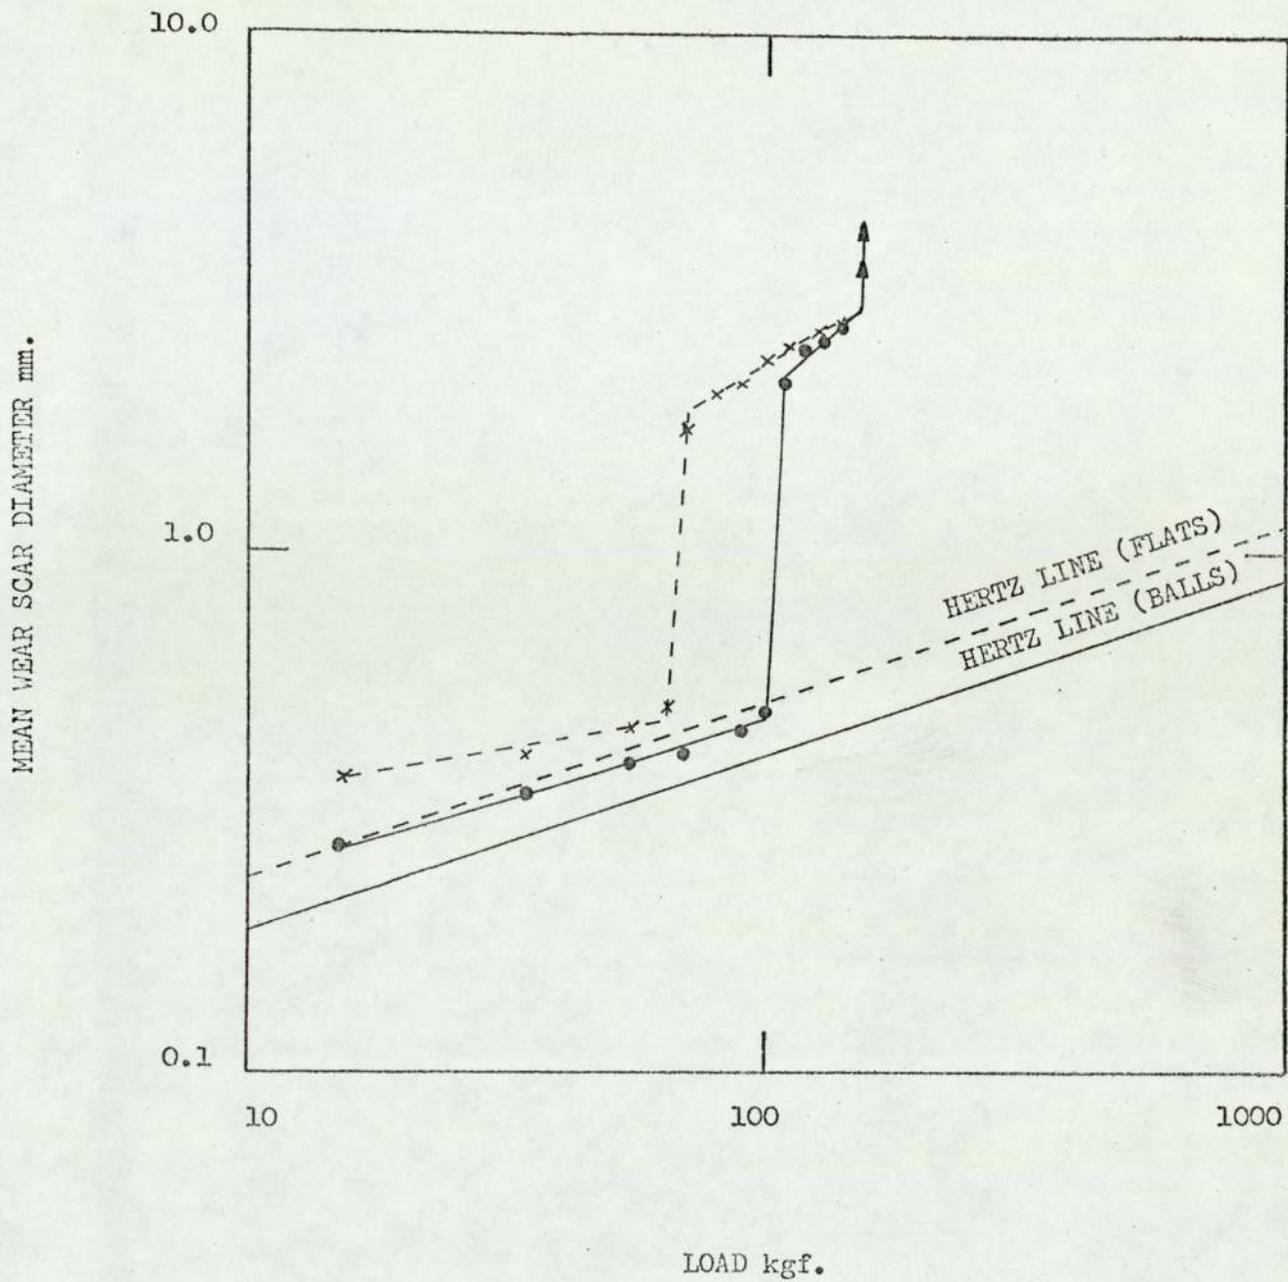
FIG. 3.11 LOAD VERSUS MEAN WEAR SCAR DIAMETER.

FIG. 3.12 LOAD VERSUS MEAN WEAR SCAR DIAMETER.
 LUBRICANT: HVI + 1.0%wt LUBRIZOL 1395

Figures 3.11 and 3.12 show the results of 4-ball machine tests using 1.0% by weight of Lubrizol 1395 as additive. The initial seizure load

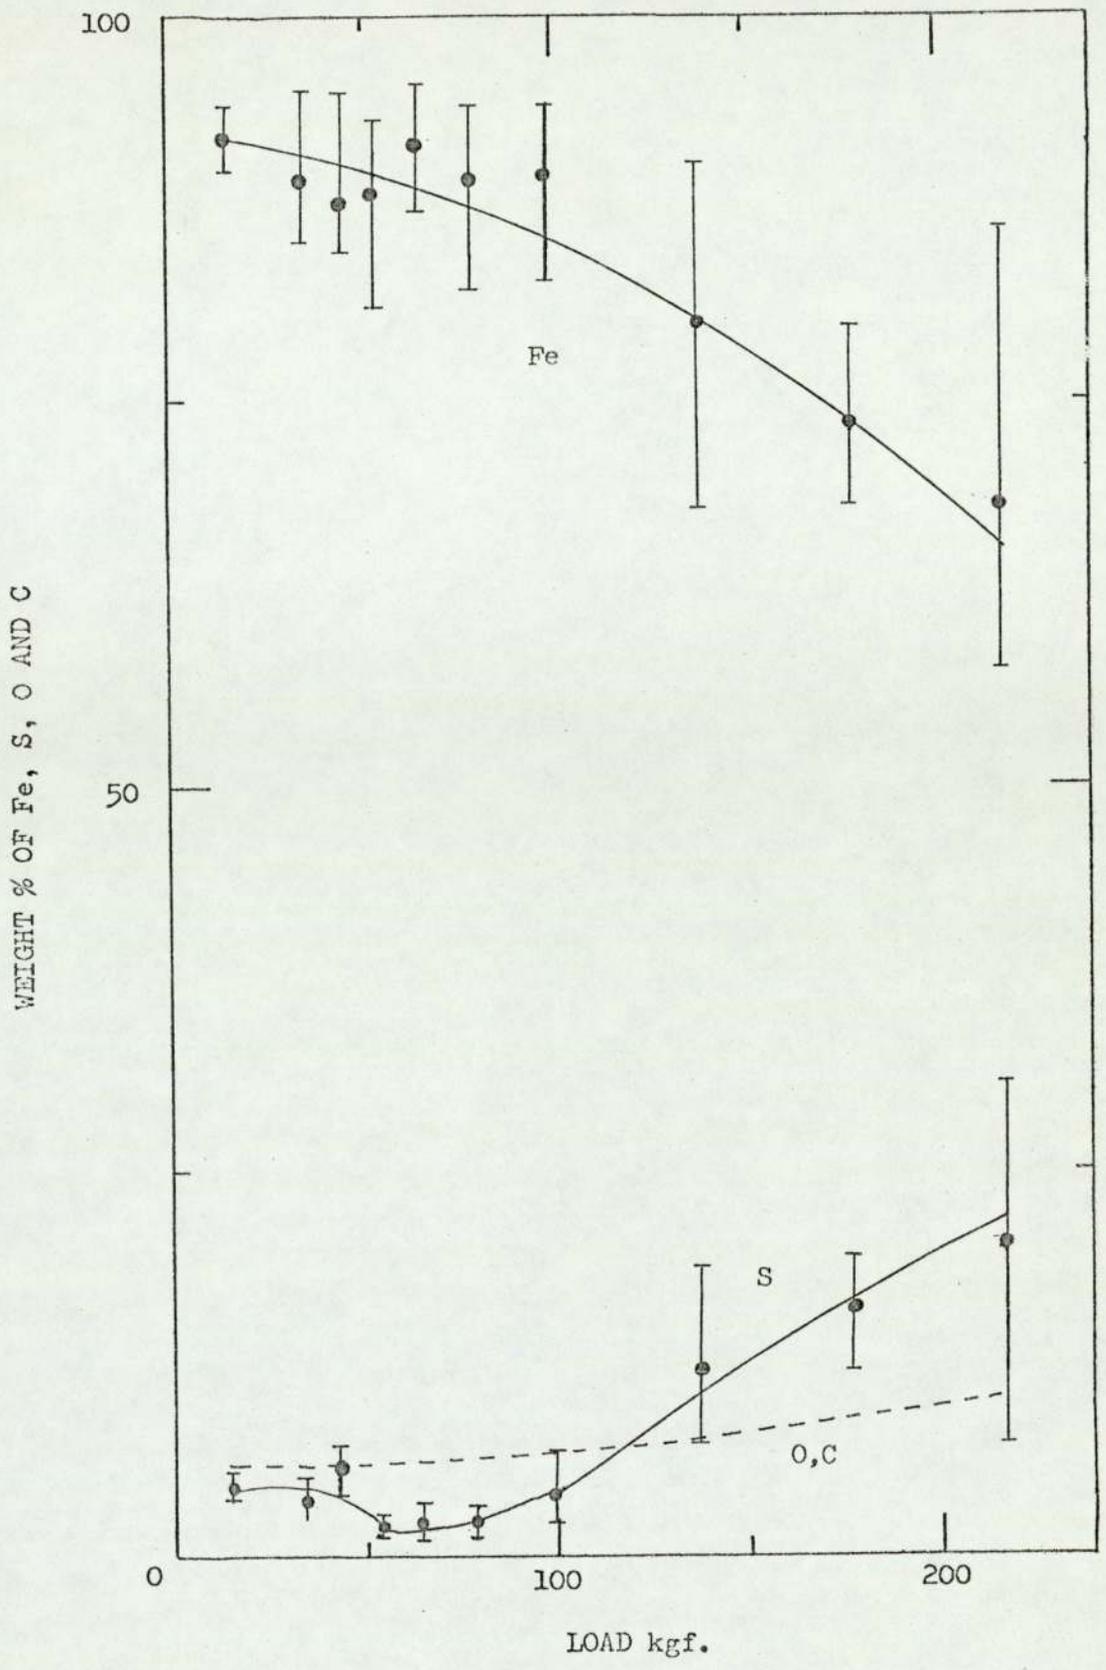
FIG. 5.8 VARIATION OF WEIGHT % OF Fe, S, O and C WITH LOAD.

LUBRICANT: RISELLA 29 + 1% DBDS

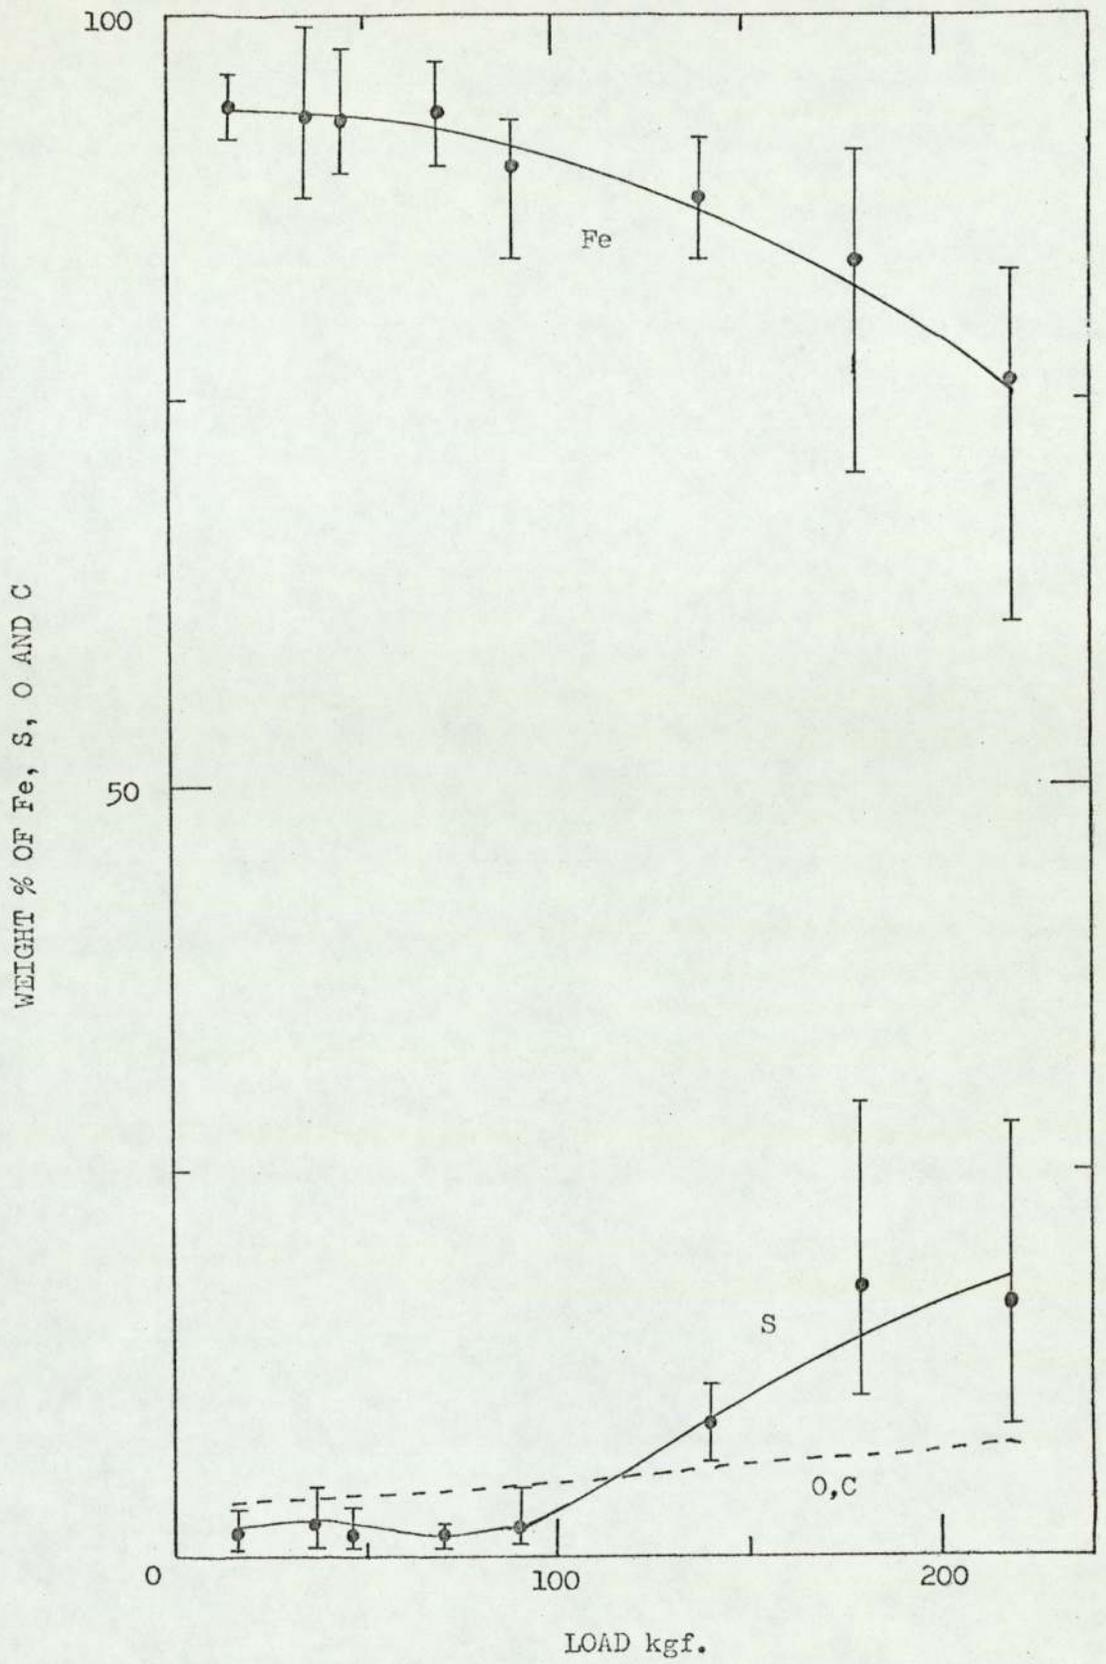
FIG. 5.10 VARIATION OF WEIGHT % OF Fe, S, O and C WITH LOAD.

LUBRICANT: RISELLA 29 + 0.723% DTBDS

When similar analyses were carried out using DTBDS as additive there were differences in the graphs at low loads. In Figure 5.10 the results of area analyses of scars formed at loads of 15, 35, 45, 70, 90, 140, 180 and 220 Kgf with Risella 29 + 0.723% DTBDS as lubricant are presented. The sulphur content of the scars before initial seizure varied between 0.5 and 4% and was lower than with DBDS as additive. The change after initial seizure was less pronounced than in Figure 5.8. However, as the load increased the sulphur content of the scars increased at a similar rate until at a load of 220 Kgf there was between 9 and 30% sulphur and between 61 and 84% iron. The difference (oxygen and carbon) varied between 0 and 14% over the whole load range. When HVI + 0.723% DTBDS was the lubricant, analyses at loads of 15, 35, 45, 80, 120, 180 and 220 Kgf (Figure 5.11) showed that the amount of sulphur in the scars before initial seizure was lower than the results with Risella 29 + 0.723% DTBDS. In the a.w. region between 0.3 and 1.4% sulphur was detected. In the intermediate region, between loads of 45 and 80 Kgf, 0.6 to 2.0% sulphur was found. At higher loads in the e.p.

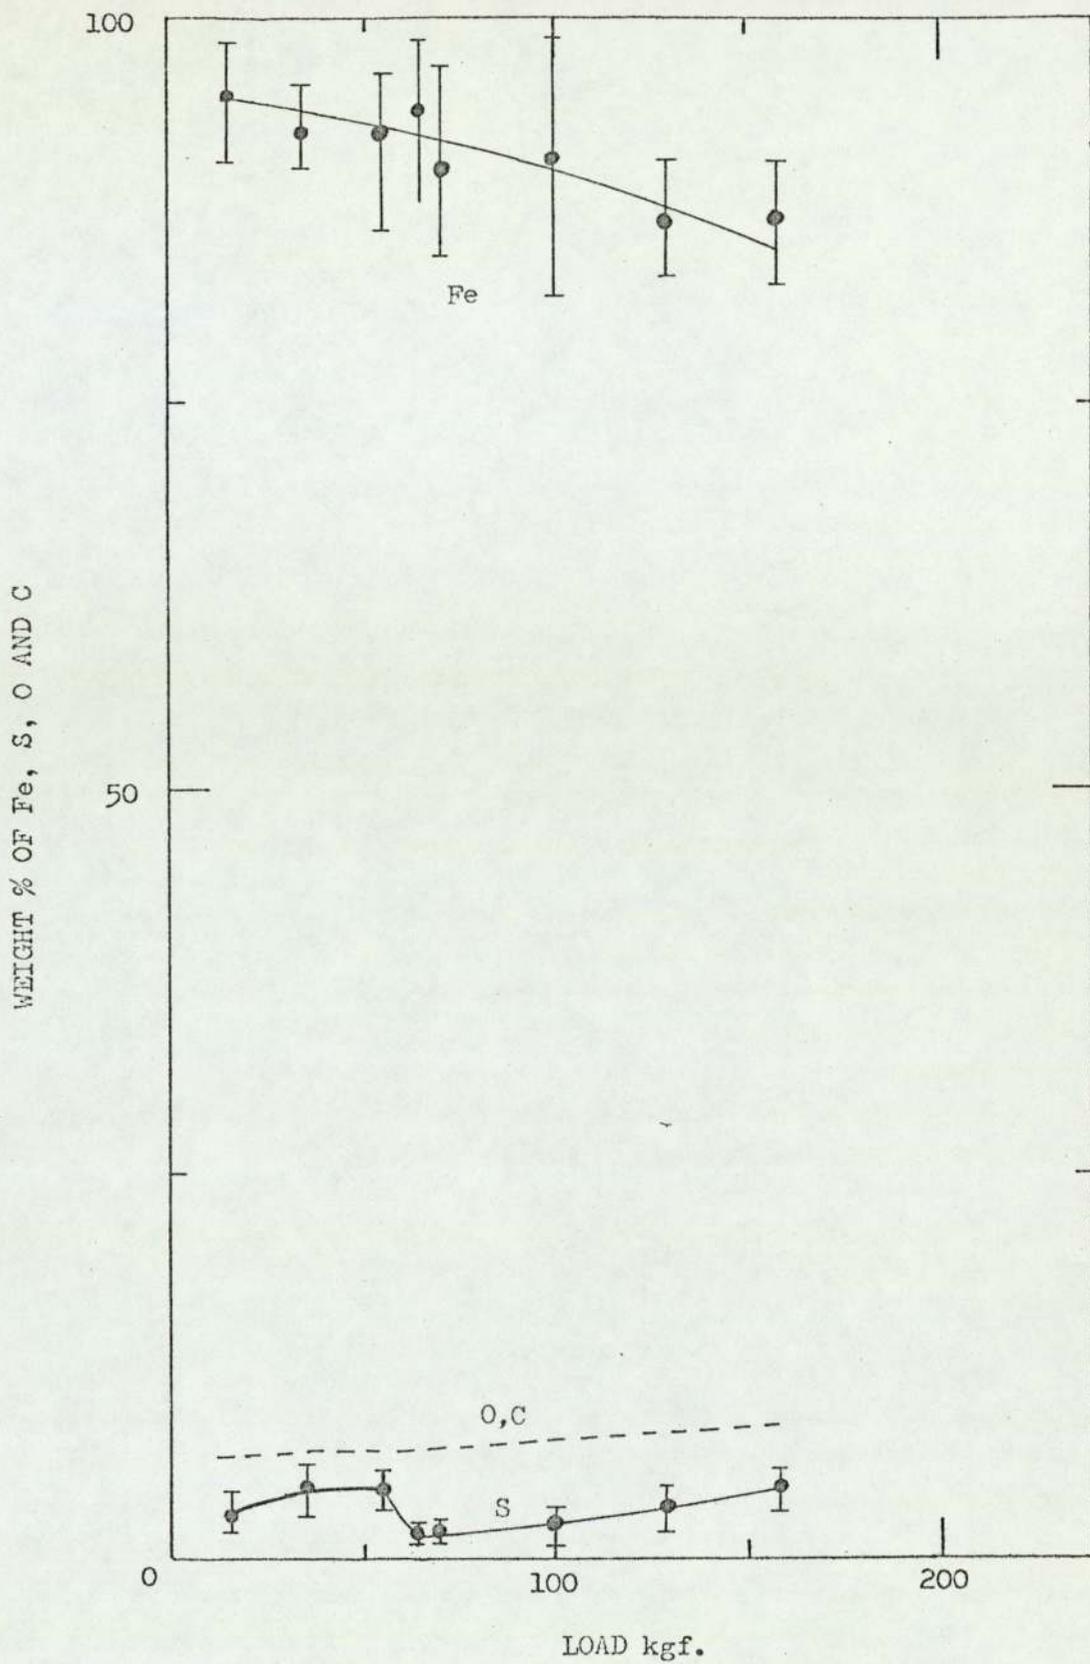
FIG.5.12 VARIATION OF WEIGHT % OF Fe, S, O and C WITH LOAD.

LUBRICANT: RISELLA 29 + 0.886% DPDS
