Physical Analysis of Worn Surfaces
Formed under Extreme Pressure
Lubrication Conditions

A Thesis submitted for the degree of

Doctor of Philosophy

in the University of Aston in Birmingham

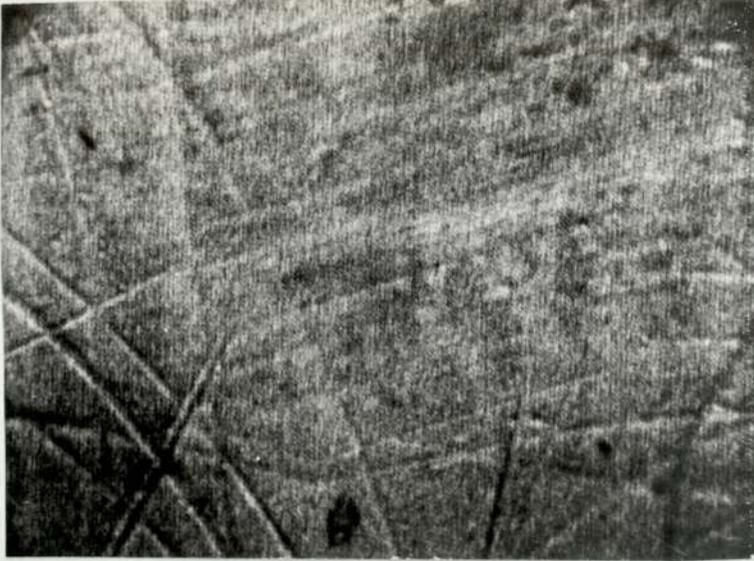
(a) ELECTRON IMAGE

Figures 5.14 (a), (b), (c), (d) and (e) show the electron image and the iron, sulphur, phosphorus and zinc X-ray images respectively of a wear scar formed at a load of 35 Kgf with Risella 29 + 1.112% ZDP as lubricant. The sulphur distribution is very closely associated with the dark areas of the scar, there being little outside these regions. The zinc and phosphorus distributions are very similar in appearance and extend over most of the wear scar. The close association of the zinc and phosphorus distributions suggests that they are bound together in some way, whereas the sulphur appears to have a separate action. Similar results were obtained using HVI + 1.112% ZDP as lubricant where the scars fell on the a.w. line close to the Hertz line (see Figure 3.10). When intermediate wear scar diameters were obtained the surfaces were pitted and the distribution of the elements on the surface was different. Figures 5.15 (a), (b), (c), (d) and (e) show the electron image and the iron, sulphur, phosphorus and zinc X-ray images respectively of part of a wear scar formed at a load of 55 Kgf with HVI + 1.112% ZDP as lubricant. Most of the high concentrations of sulphur,

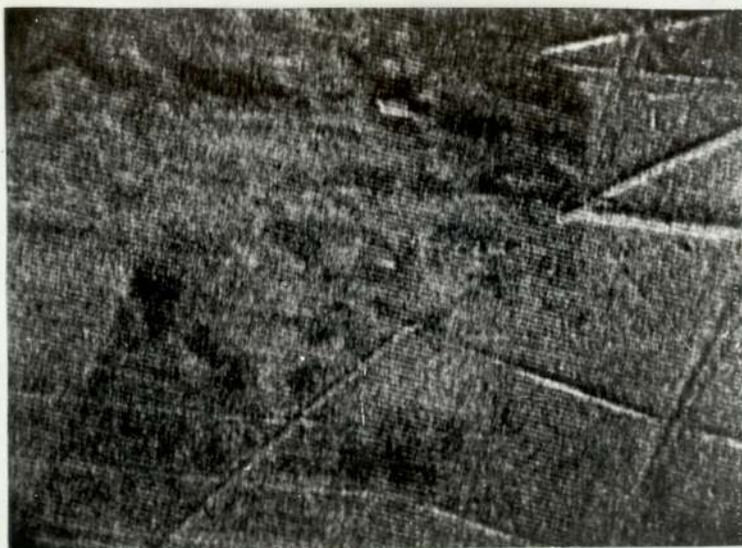
(a) ELECTRON IMAGE

When Lubrizol 1395 was used the same sort of distribution was observed. Figures 5.18 (a), (b), (c), (d) and (e) show the electron image and the iron, sulphur, phosphorus and zinc X-ray images respectively of part of a wear scar formed at a load of 130 Kgf with Risella 29 + 1.0%

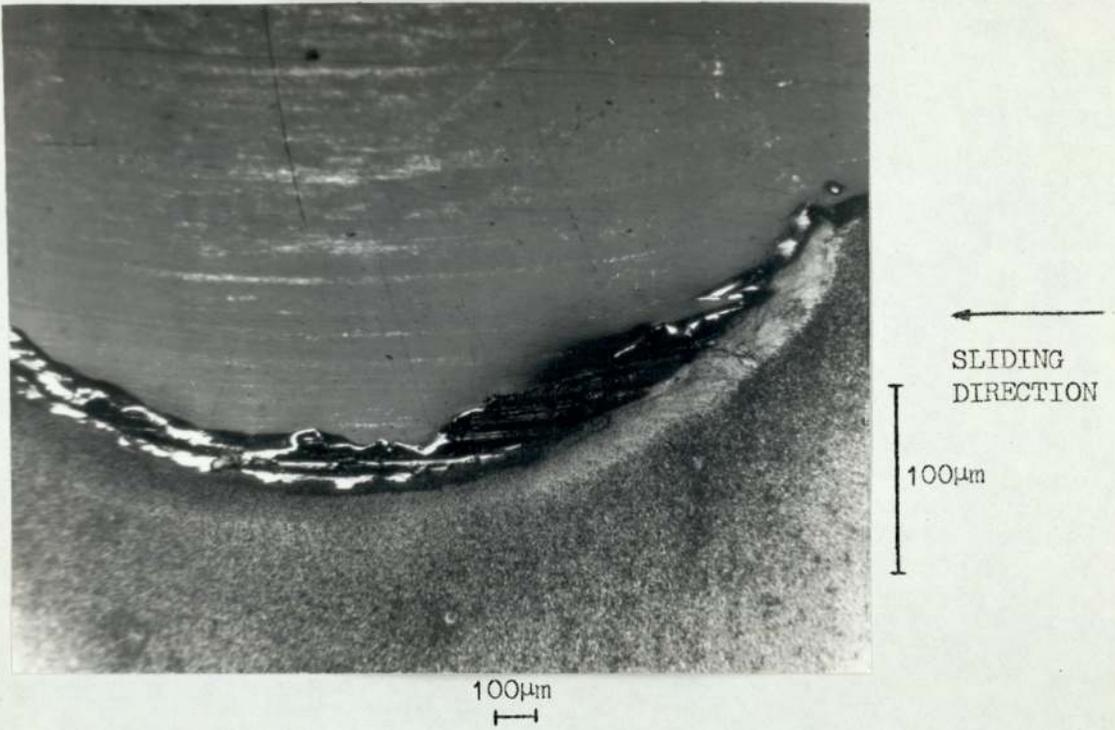
FIG. 7.1 TAPER SECTION

Figure 7.1 shows a taper section through a scar formed on a roller at a load of 180 Kgf with HVI + DBDS as lubricant. The wear scar has been covered with clear plastic prior to grinding and polishing so that the surface of the wear scar is visible. A light coloured layer has been formed under the scar, which is thick at the leading edge of the scar and disappears towards the trailing edge. Above this layer a thin, darker film has been formed in the centre of the scar and below the light layer a darker area of tempered martensite has been formed. Below this area of tempered martensite the lighter ordinary martensite can be seen. Figure 7.2 shows a series of photographs of the structures formed below the front half of the wear scar

illustrated in Figure 7.1, with micro-indentations visible at various points. The indentations above the cracks near the leading edge indicated a hardness of 640 V.P.N., the one below the crack 610 V.P.N. and the three indentations on the left of Figure 7.2 gave hardness values of 460, 480 and 460 V.P.N. The region under the leading edge of the scar is the hardest area and would be expected to have had a high temperature. The hardness of the darker layer near the surface was the same as the light coloured layer. The hardness of the tempered martensite increased from 490 V.P.N. near the light layer to 860 V.P.N. when the ordinary martensite was reached at a depth of about 100 μ m. The hardness of the sulphide film was not obtained as the film cracked even under lighter loads than 100 gms. The hardness of the layers under the scar increased with increasing depth. This was observed for scars formed with both DBDS and DPDS additives in the e.p. region and gives weight to the results presented in Table 7.1. In Figure 7.2 flow lines can be observed in the light surface layer. These flow lines follow the direction of sliding.

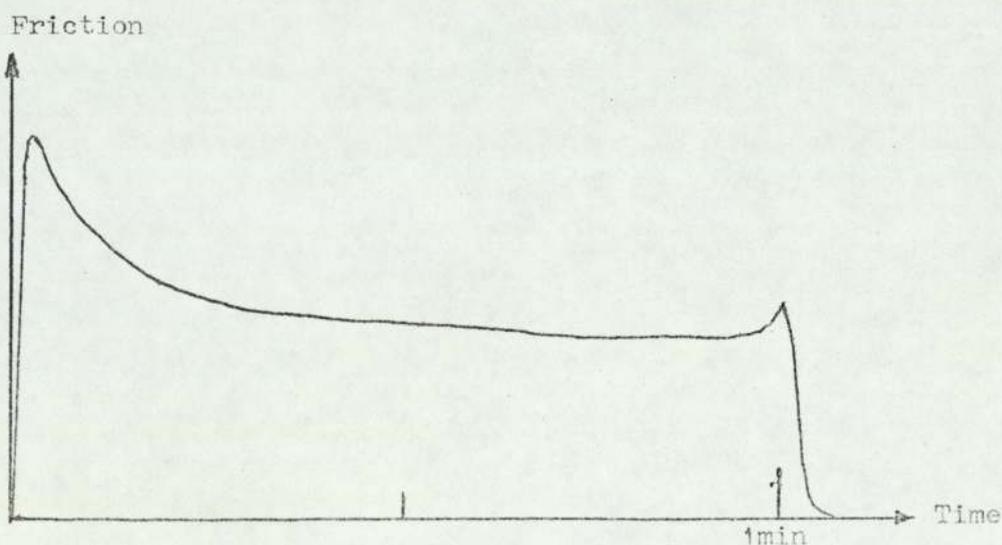
Fig. A.5

Figure A.5 shows a typical friction versus time plot.

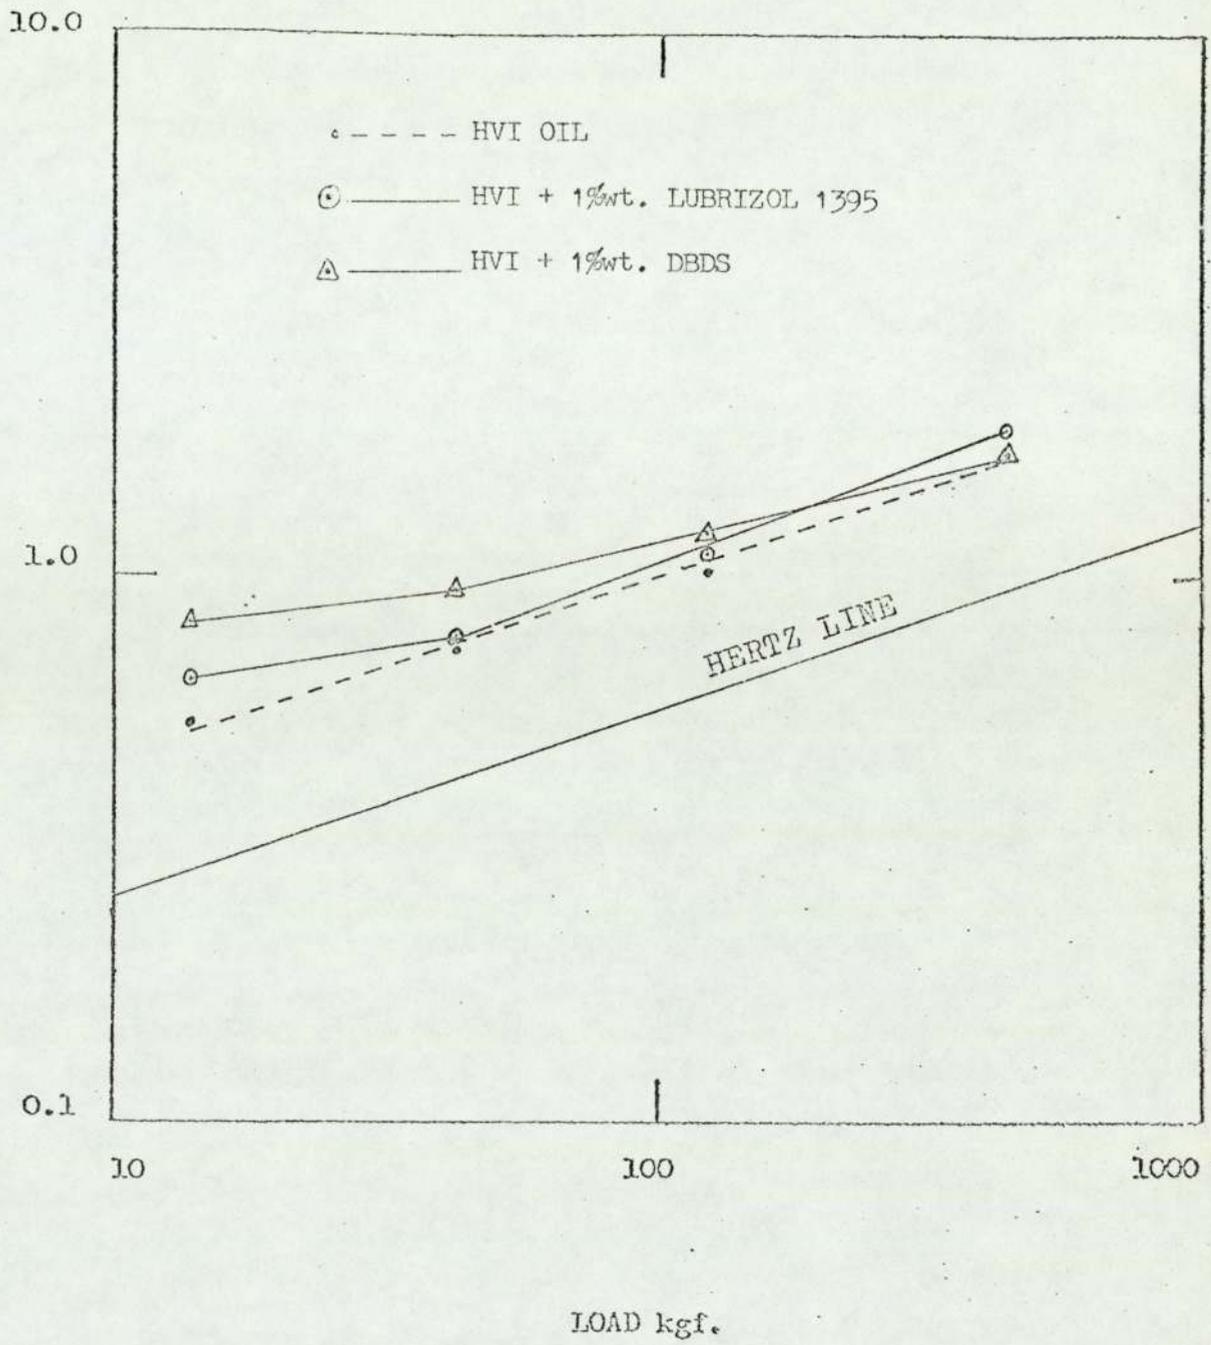
FIG. A.3

Load Versus Mean Wear Scar Diameter -
Phosphor Bronze Rollers

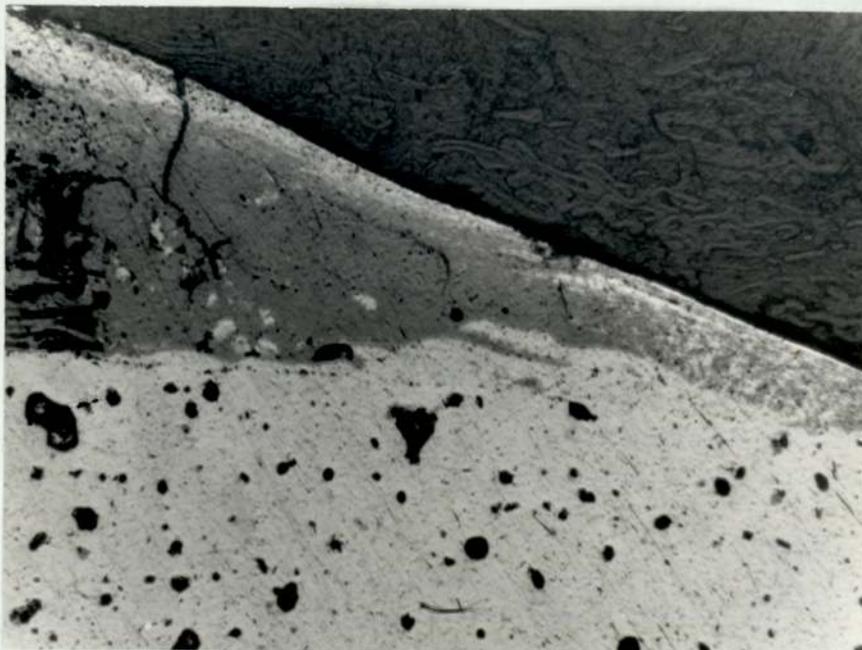
Etched cross-section
of worn surface of
lead bronze roller
cut along the direction
of sliding (trailing
edge).

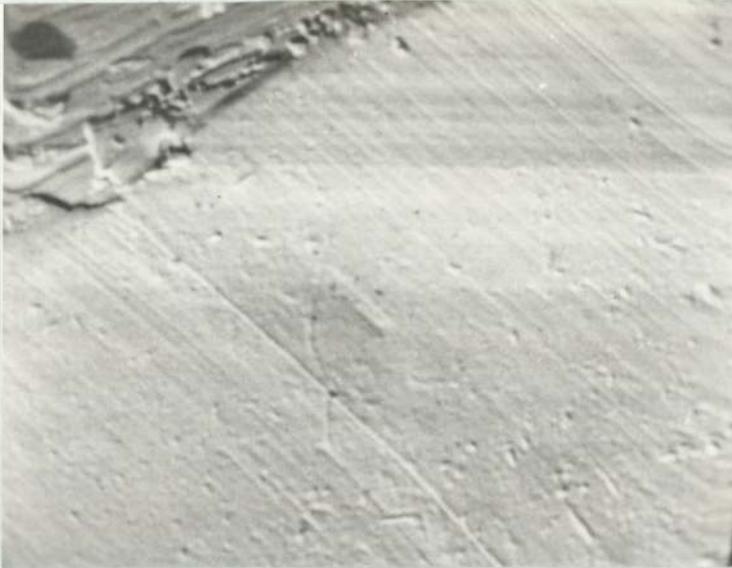
(a) Electron image of phosphor bronze roller (trailing edge of scar).

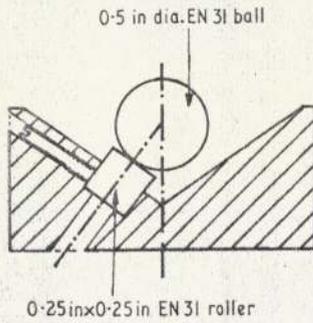
Fig. 94.1. The specially designed '1-ball-on-3-flats' modification of the normal four-ball machine

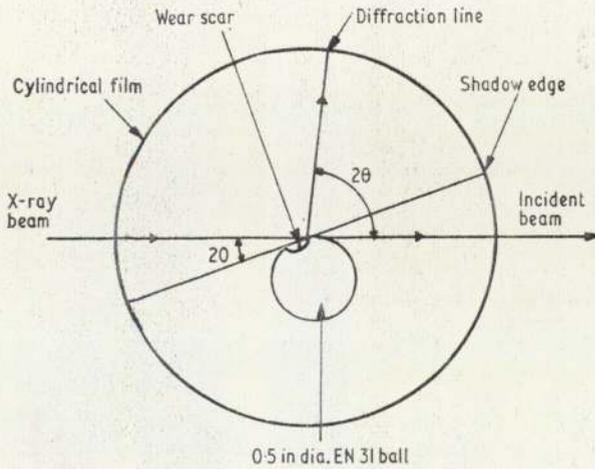
Fig. 94.2. Diagram of the irradiation geometry used for obtaining the glancing-angle, edge-irradiated X-ray diffraction patterns (wear scar size exaggerated for the sake of illustration)

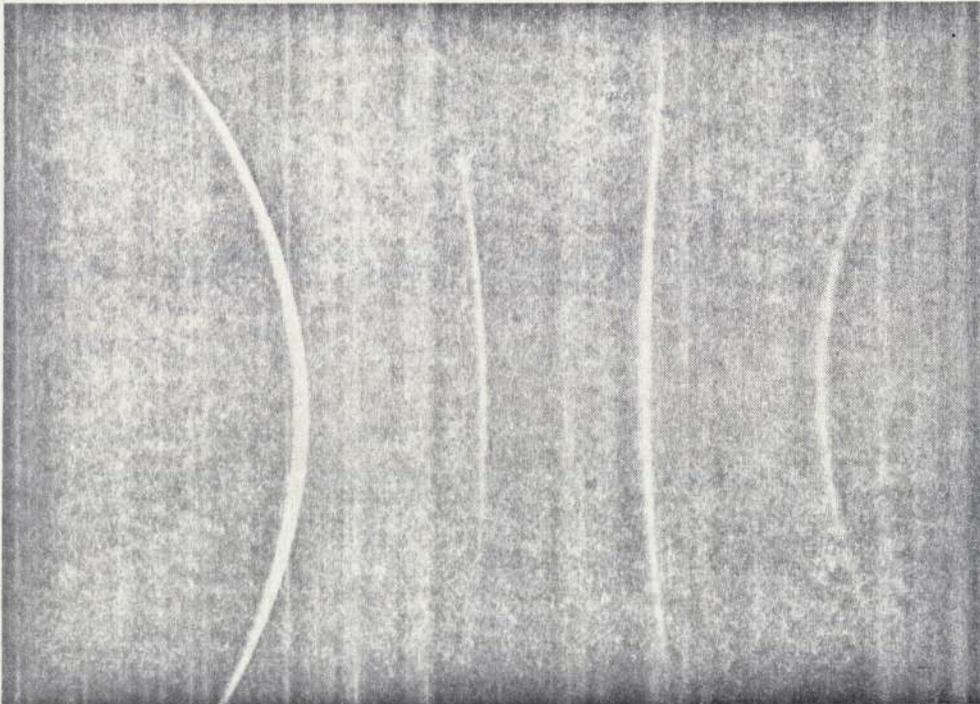
Fig. 94.3. Glancing-angle, edge-irradiated X-ray diffraction pattern from a surface worn under extreme pressure conditions with dibenzyl disulphide (d.b.d.s.) as the additive

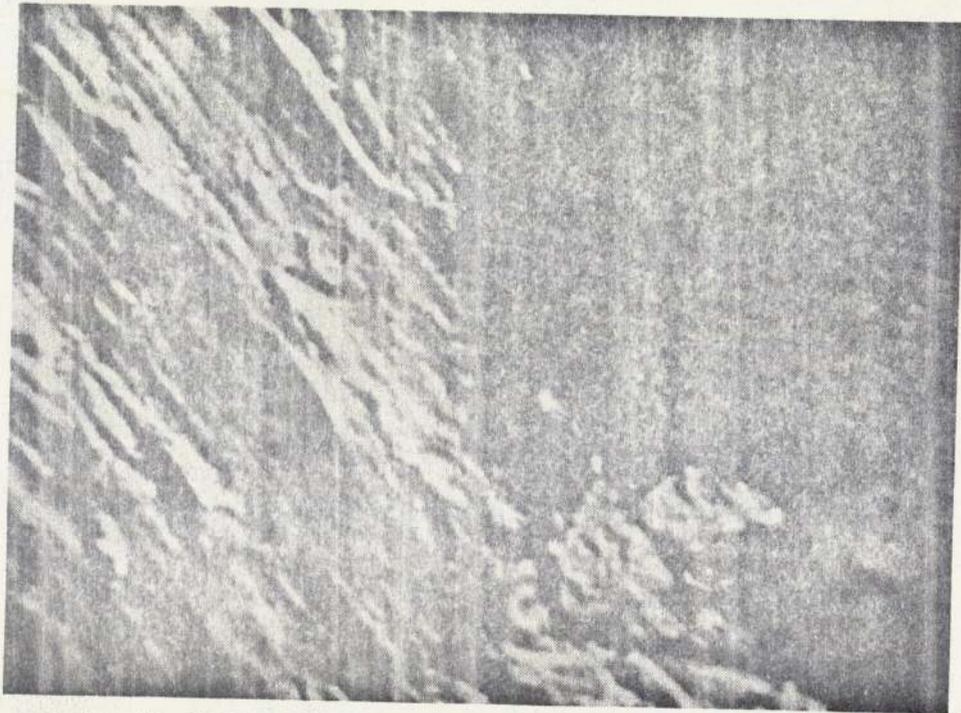
Fig. 94.7. 'Electron picture' of the region shown in Fig. 94.6

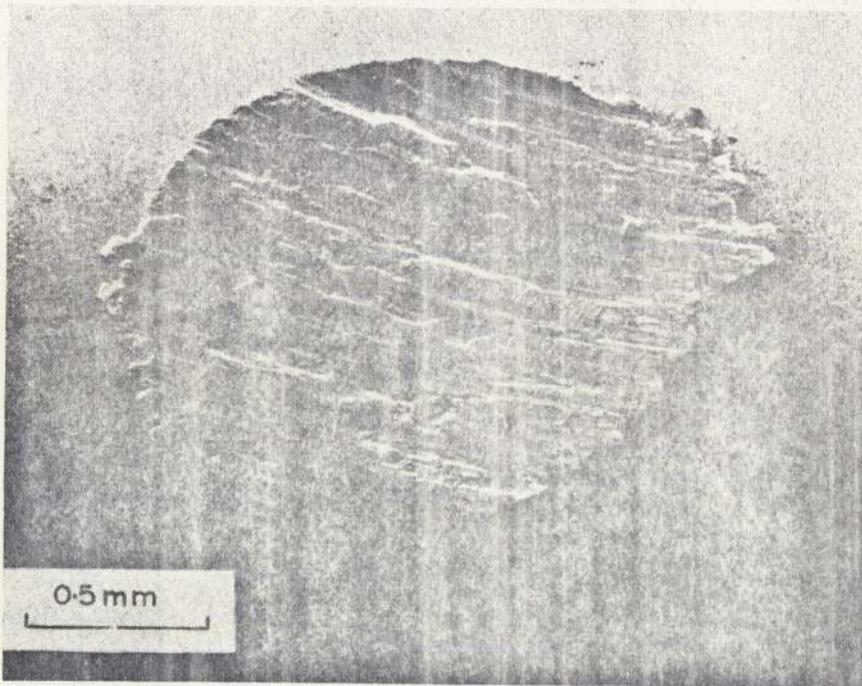
Fig. 94.8. Scanning electron micrograph of the wear scar on a ball worn with tricresyl phosphate (t.c.p.) as additive

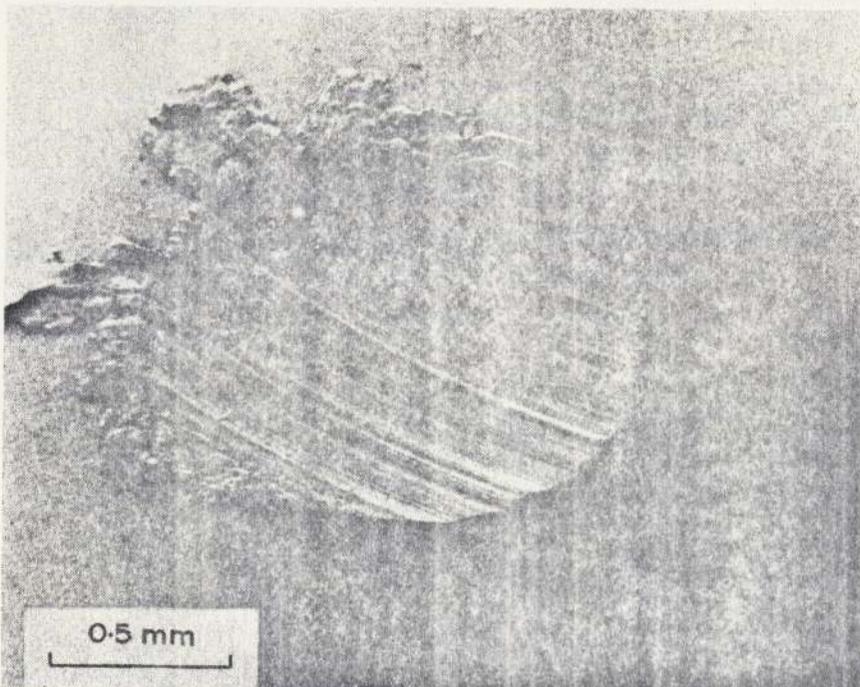
Fig. 94.9. Scanning electron micrograph of the wear scar on a ball worn with dibenzyl disulphide (d.b.d.s.) as the additive
