FAILURE MECHANISMS IN SURFACE  
TREATED TOOL STEELS

A thesis submitted for the degree of Doctor of Philosophy  
at the UNIVERSITY OF ASTON in Birmingham.

OCTOBER 1979.

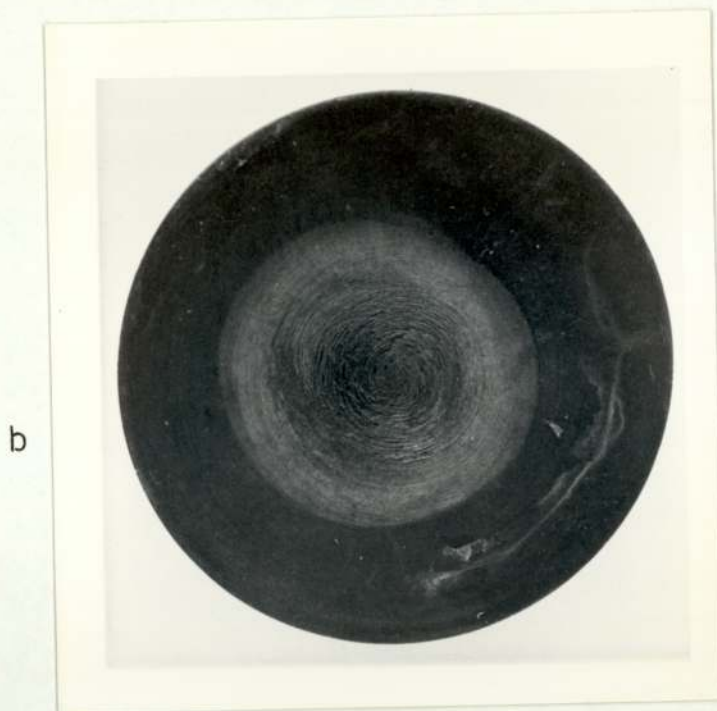
Fig. 13 (a) Variation of wear modes across die surface after forging.  
 (b) Plasma Nitrided die surface showing the wear regions in (a)

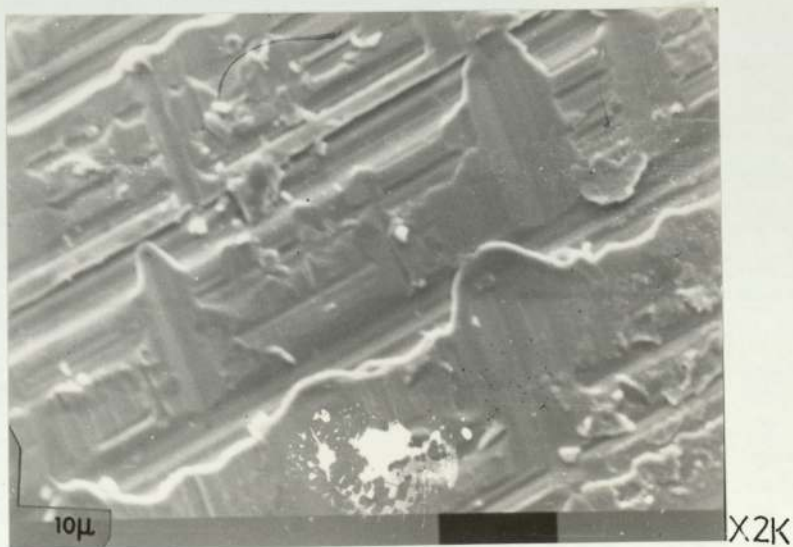
Fig. 14 Ploughing abrasion of a hardened and tempered No.5 die in the as-forged condition after 1 cycle hot forging.

Evidence of a number of abrasive wear mechanisms were observed on the worn surfaces. For example, it can be seen from figs (14 and 15) that ploughing of the surface of hardened and tempered No.5 inserts occurred after the first and second forging cycles. This feature is revealed by the rough edges of the grooves caused by the lateral plastic flow of material. It was thought that this ploughing action may be due to hard scales from hot slugs since no wear particles were present on the die surface after the first forging cycle. However, the transition from ploughing to cutting abrasion shown in fig. 15 indicates that after a large number of forging cycles a high-stress grinding type of abrasion becomes operative. This may either lead to the generation of curled, smooth backed and continuous wear particles or the production of impressions due to plastic deformation (Fig. 18). It should be emphasised, however,

Figs (19, 20, 21, 26, 30, 31, 35, 38, 41, 47) show some of the polygonal cracks and voids which were observed on various dies. It is worth noting that far more voids and cracks were observed on unplated No. 5 die inserts than on plated No.5 dies as well as surface treated and hardened and tempered BHI3. This may be due to the relatively low resistance to deformation of unplated No.5 die. Micrographs of worn die surfaces and sub-surfaces (Figs. 14,16,18,22,23,27, 28,29,33 and 39) show that subsurface deformation occurred during forging. In addition, Figs. (53 and 59) show that subsurface deformation of the inserts occurred before forging due to machining. The amount of deformation which occurred appeared to depend on the number of forging cycles, die material and its surface treatment. For example plough marks were observed on plasma nitrided BHI3 inserts only after 100 forging cycles (Fig.44), where as they were observed after the first cycle on an unplated No.5 die insert (Fig. 14)

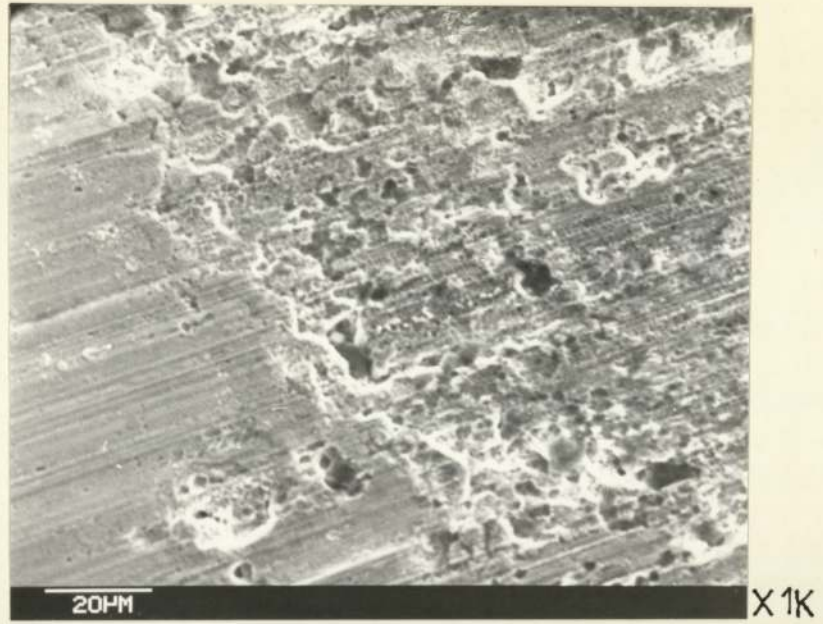
Fig. 16 Erosion of a hardened and tempered No.5 die after 5 cycles hot forging. Surface was descaled.

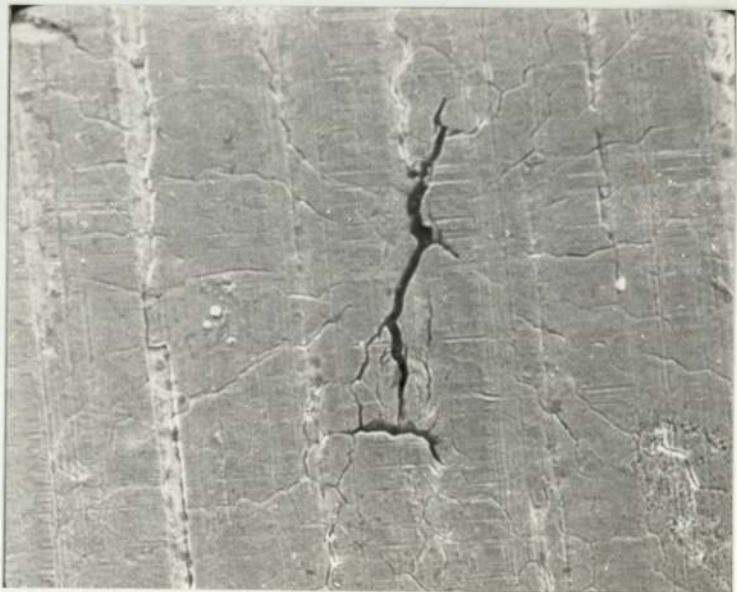
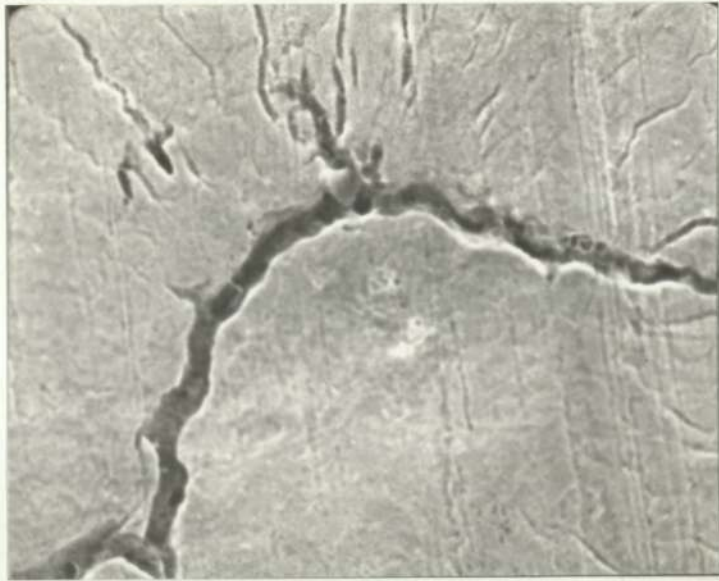
Fig. 19 Worn surface of a hardened and tempered No.5 die after 100 cycles hot forging showing

- (a) undislodged metal island (Mag. x 500)
- (b) several voids and cracks associated with them (Mag. x 1K) surface was descaled

Figs. (21, 24, 26, 26, 50, 51) show some of the inclusions in both die steels, some of which were observed on the worn die surface after descaling. Two types of inclusions were observed, i.e. silicates and sulphides. Fig. 51 shows a typical elongated sulphide inclusion after forging. It can be seen from figs (19,26,43) that these inclusions act as void and cracks initiation sites during forging. Thus it will appear that the characteristic polygonal cracks originate in the steel substrate for both surface treated and, hardened and tempered dies. However, as subsurface deformation continues (with increasing forging cycles) these cracks grow and join neighbouring ones to form metal islands. Figs (19, 20, 23, 35, 38 and 39) show some of the dislodged and undislodged metal islands (flakes or platelets) formed by this process.

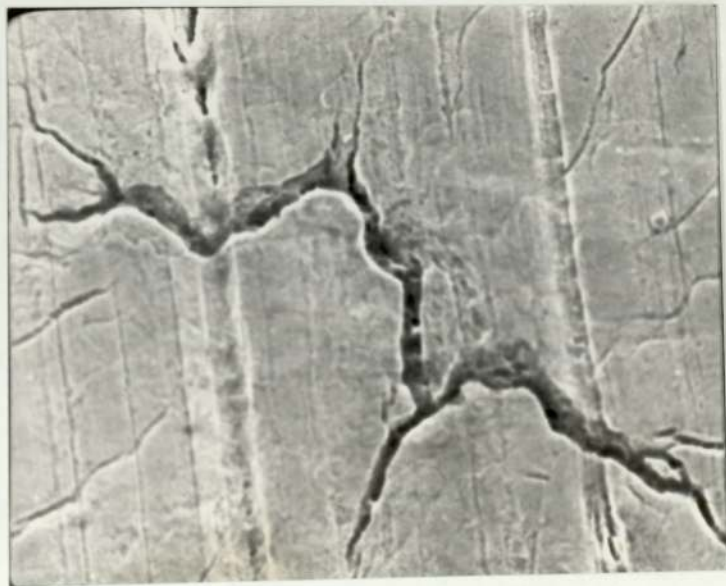
Fig. 20 Worn surface of a hardened and tempered No.5 die after 100 cycles hot forging showing the linking of neighbouring cracks. (Mag. x 1K) surface was descaled.

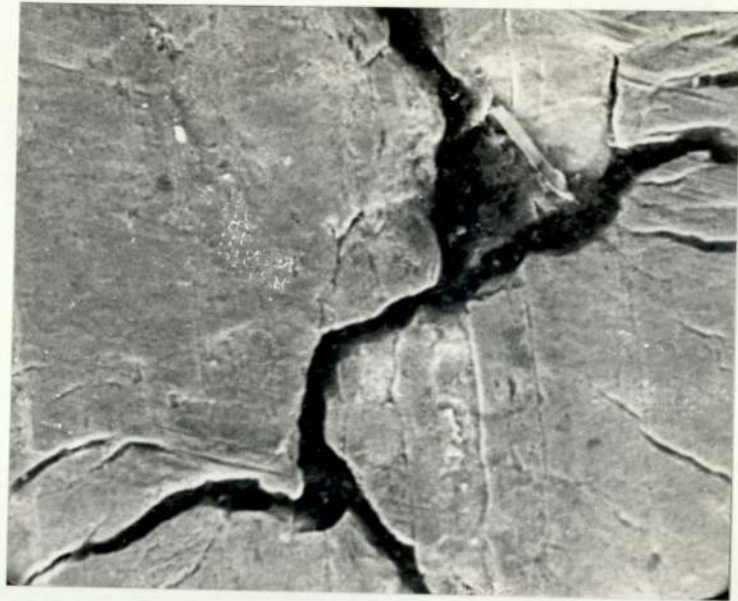
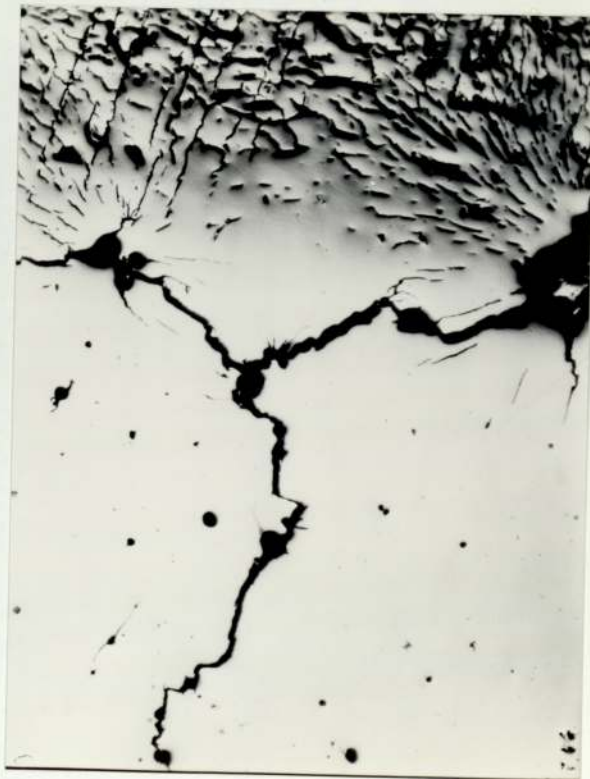
Fig. 21

Similarity between surface and subsurface cracks in a hardened and tempered No.5 die after 1000 cycles hot forging.

- (a) S.E.M. showing an inclusion and cracking of die surface. (Mag. x 2K). Surface was descaled.
- (b) Optical micrograph showing subsurface inclusion and cracking. Magnification including that due to taper  $\times 1K$  (after Aston et al<sup>2</sup>).

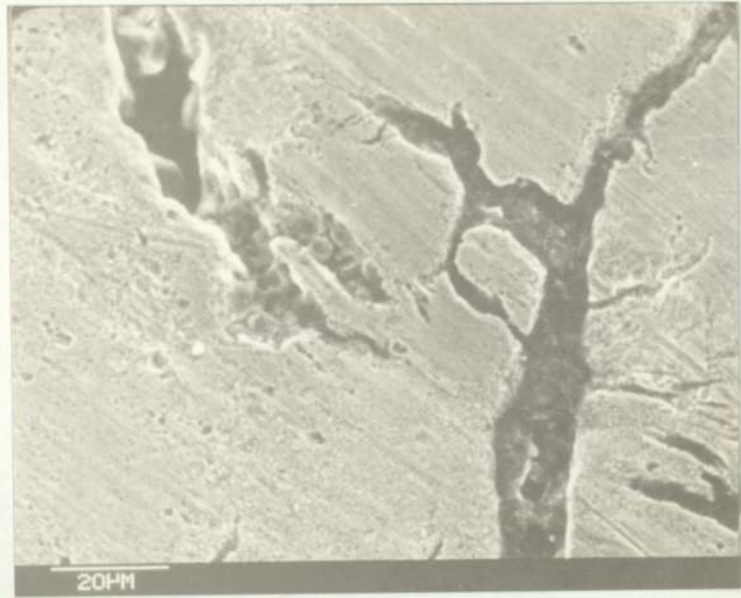
Fig. 24 A view of the surface of a hardened and tempered No.5 die after 1000 cycles hot forging showing an exposed subsurface inclusion.

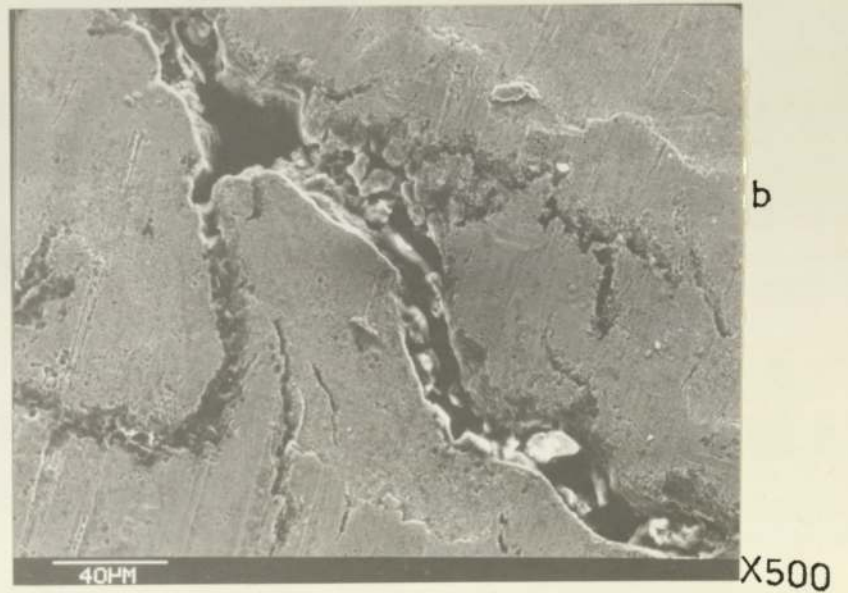
Fig. 26 A deformed region of the surface of a hardened and tempered No.5 die after 1000 cycles hot forging (a) shows the void and crack formed at an inclusion while, (b) is a further view of the region below (a)

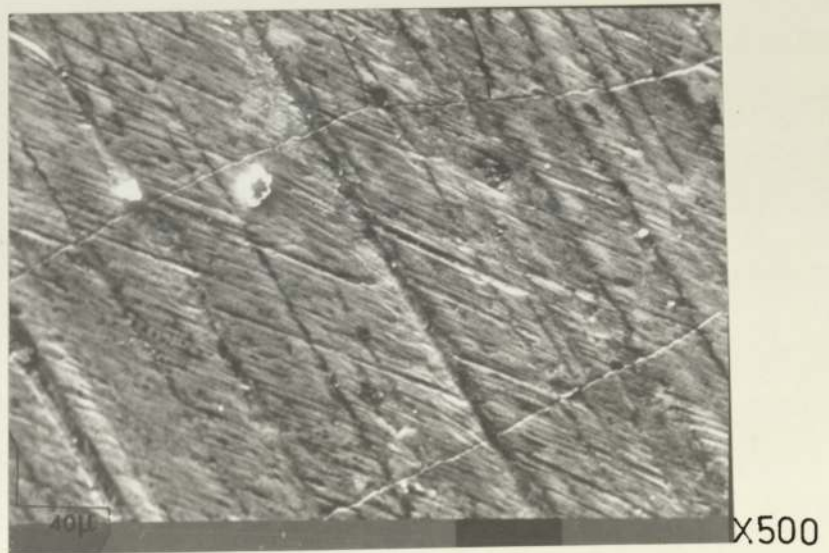
Fig. 28 Scratch marks and original micro-cracks on the as-forged surface of a Co-Mo alloy plated No.5 die after 10 cycles cold forging.

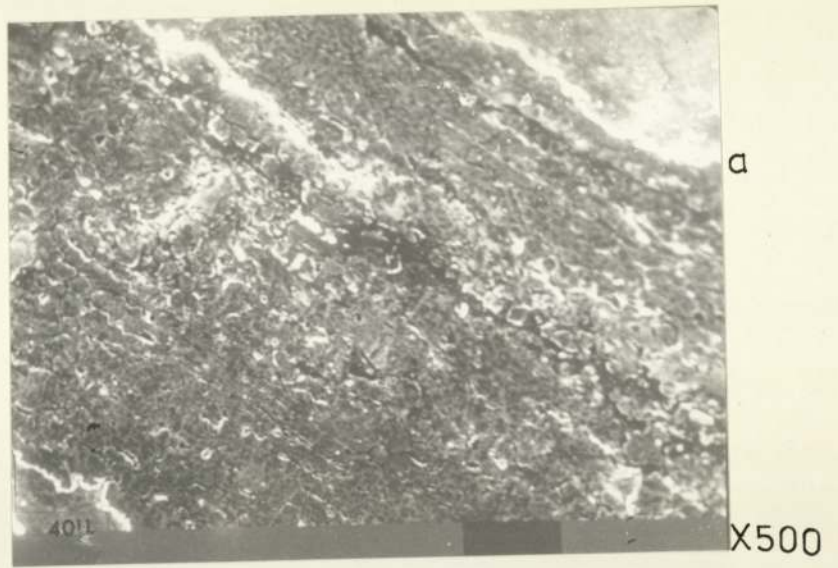
Fig. 29 Two views of the as-forged surface of a Co-Mo alloy plated No.5 die after 10 cycles hot forging showing local flattening of coating due to intermittent frictional contact between slug and die.

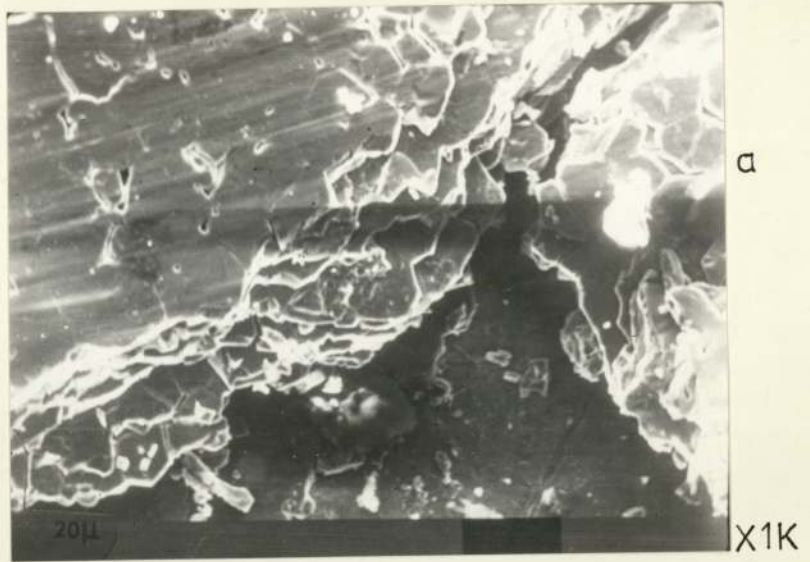
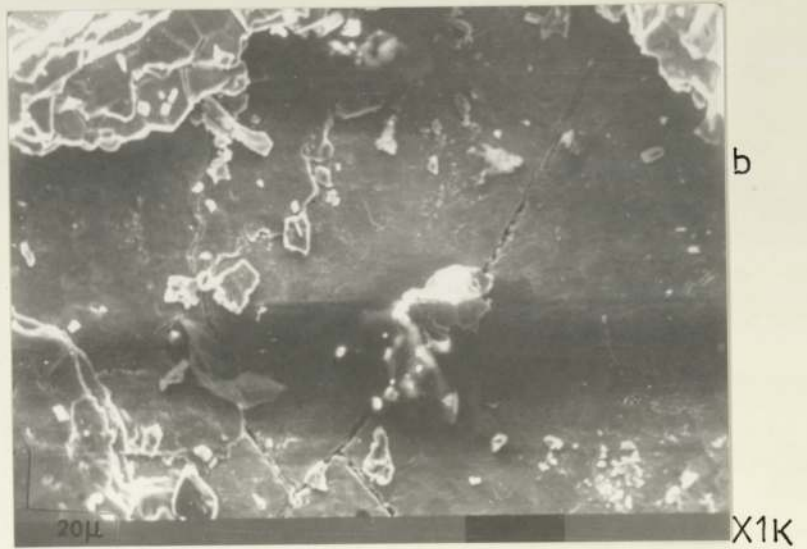
Fig. 30

Two views of the as-forged surface of a Co-Mo alloy plated No.5 die after 100 cycles hot forging showing

(a) wear edge due to delamination

(b) further polygonal cracks on the exposed underlying substrate

However it should be emphasized that after about 100 forging cycles it is highly probable that hard Cr plated inserts may become less wear resistant. This is because the hard Cr plate may become more susceptible to fragmentation due to its low ductility, thus exposing local areas of the less wear resistant underlying substrate to wear (Figs. 30 and 35).

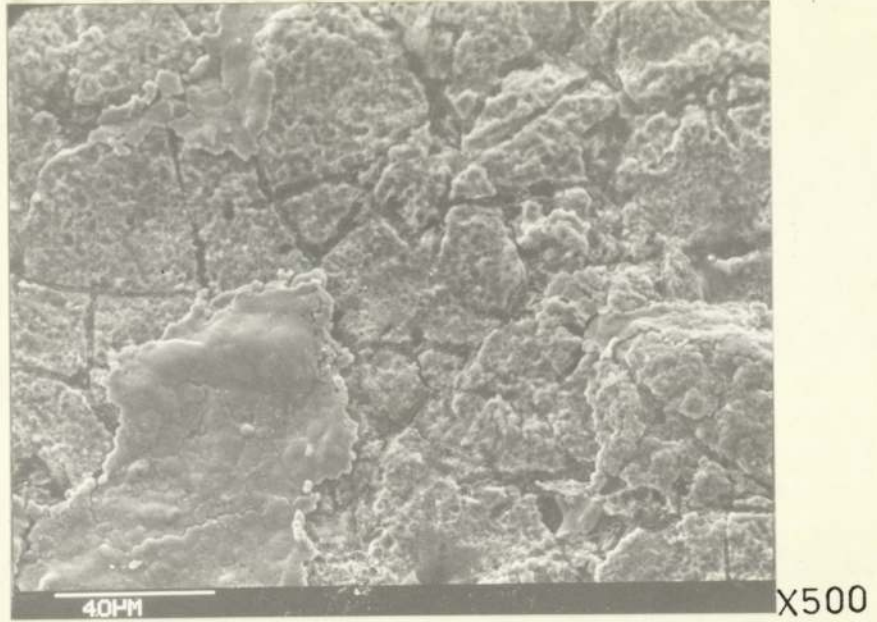
Fig. 33 A view of the surface of a hard Cr plated No.5 die after 100 cycles hot forging which was partially descaled to show how a mixture of compacted oxides and fragmented metallic particles may be formed.

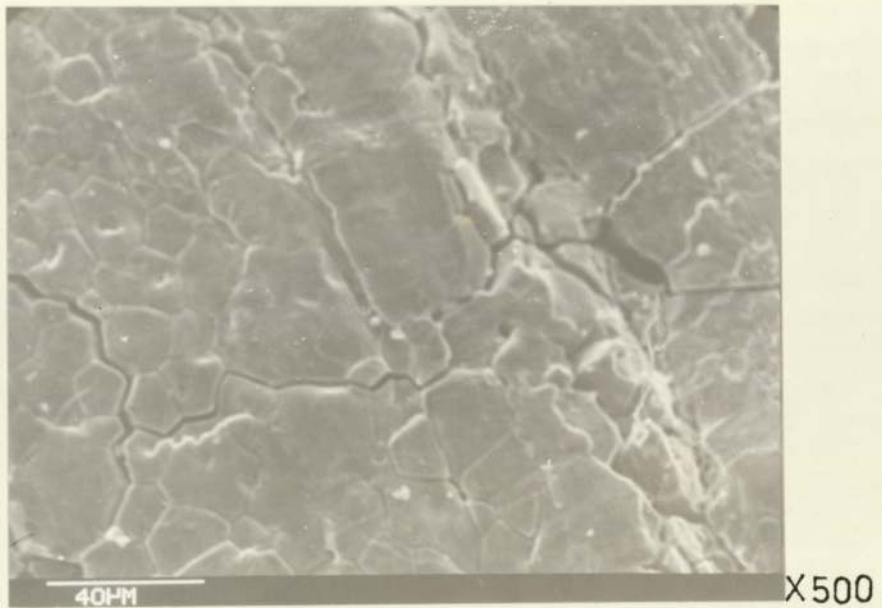
Fig. 34 A view of the surface of a hard Cr plated No.5 die after 100 cycles hot forging showing a glaze of cracked oxide layer.

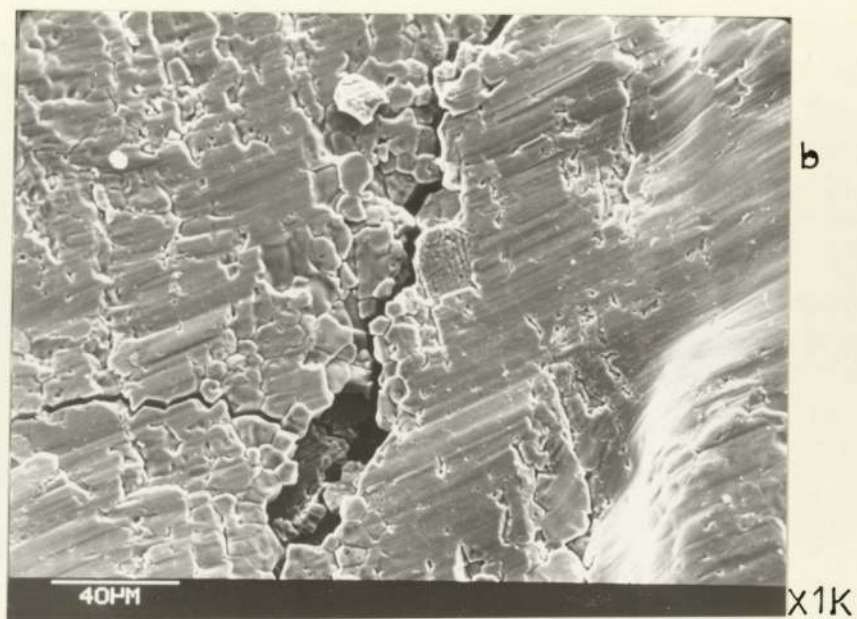
Fig. 40

Two views of the surface of a plasma nitrided BH13 die after 10 cycles hot forging showing

- (a) a thick oxide layer (b) a cracked and flattened thin oxide layer.

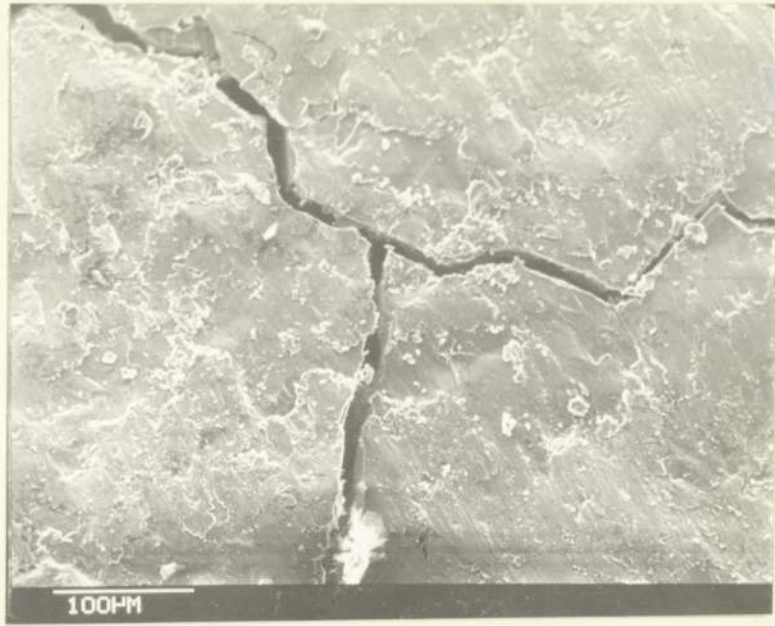
Fig. 41

A view of the as-forged surface of a plasma nitrided BH13 die after 1000 cycles hot forging showing part of the polygonal cracks.

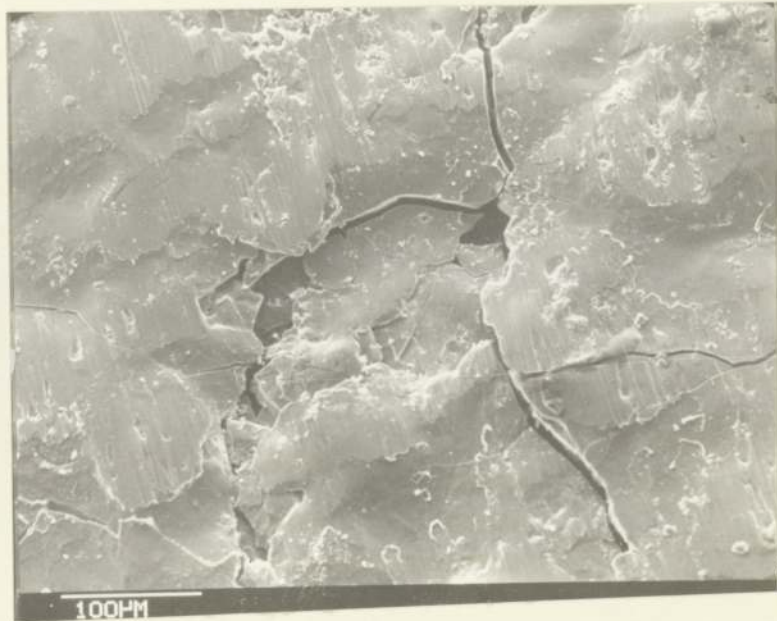
Fig. 42

A view of the as-forged surface of a plasma nitrided BH13 die after 1000 cycles hot forging showing cracks which penetrated the underlying steel.

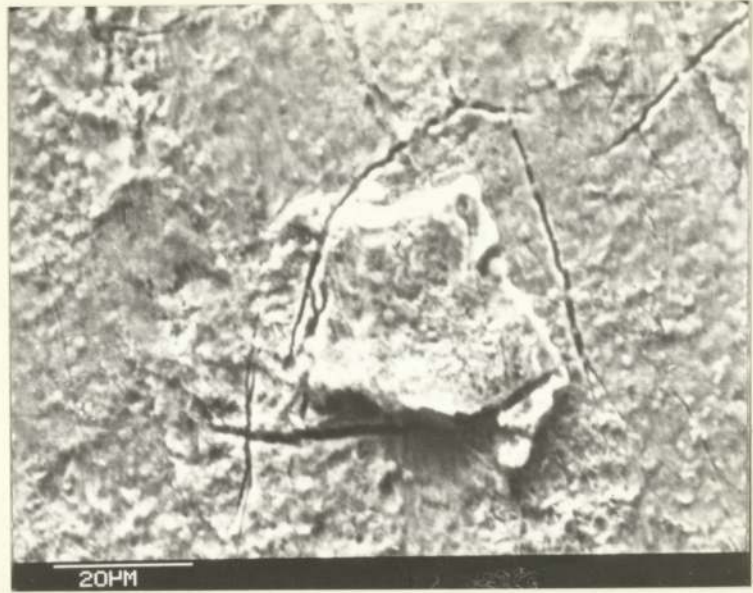
Fig. 44 A view of the surface of a plasma nitrided BH13 die after 100 cycles forging showing the effect of ploughing on a previously flattened layer, surface was descaled.

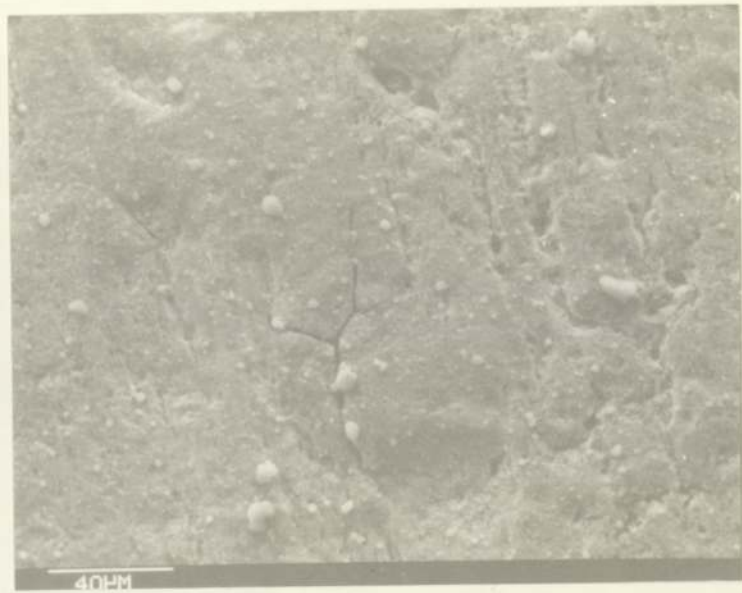
Fig. 45

A view of the surface of a plasma nitrided BH13 die after 1000 cycles hot forging showing polygonal cracks, slight erosion marks and a dislodged platelet. Surface was descaled.

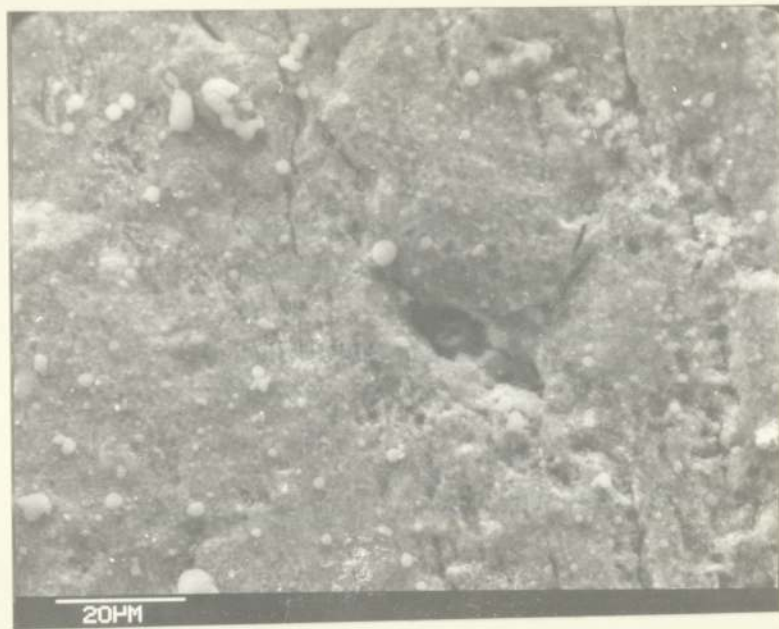
Fig. 47 An enlarged view of the top right hand corner of die area in fig. 46, showing a void and cracks.

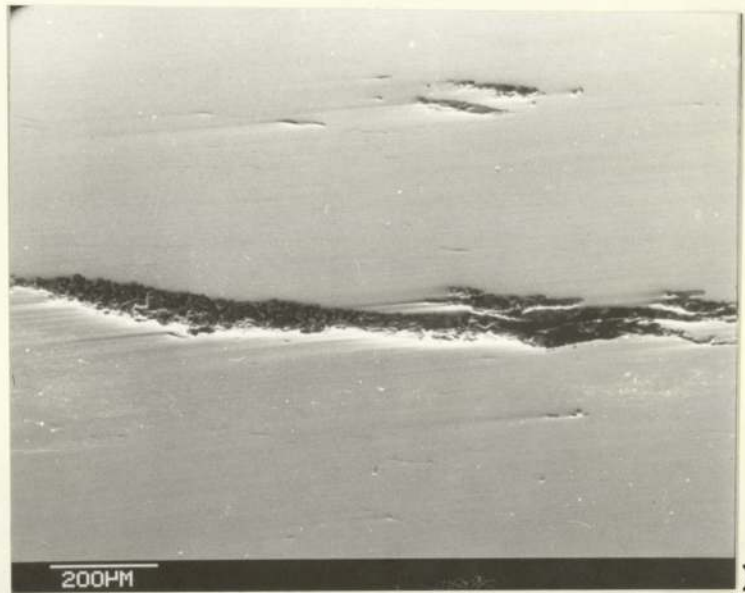
Fig. 51 S.E.M. of an elongated MnS inclusion after forging.

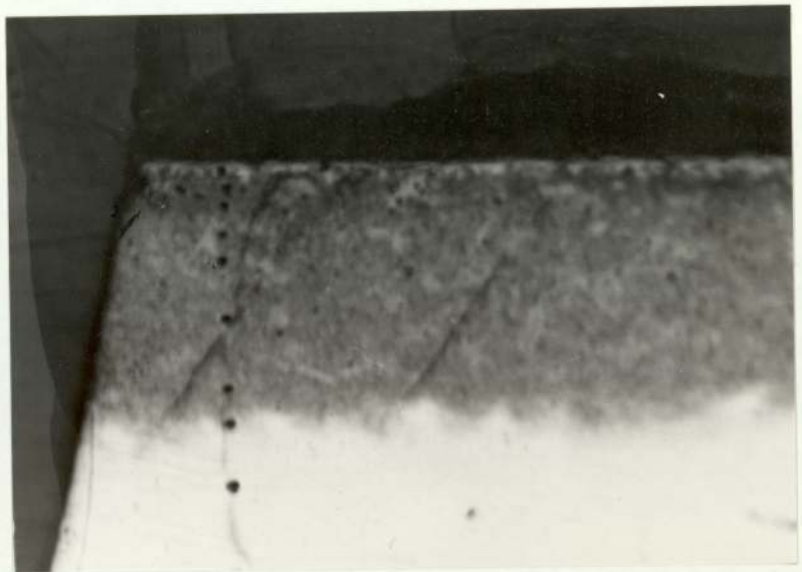
Fig. 52 Photomicrographs indicating regions of micro-hardness measurement on a BH13 die specimen. Magnifications including taper were (a) X990 (b) X510

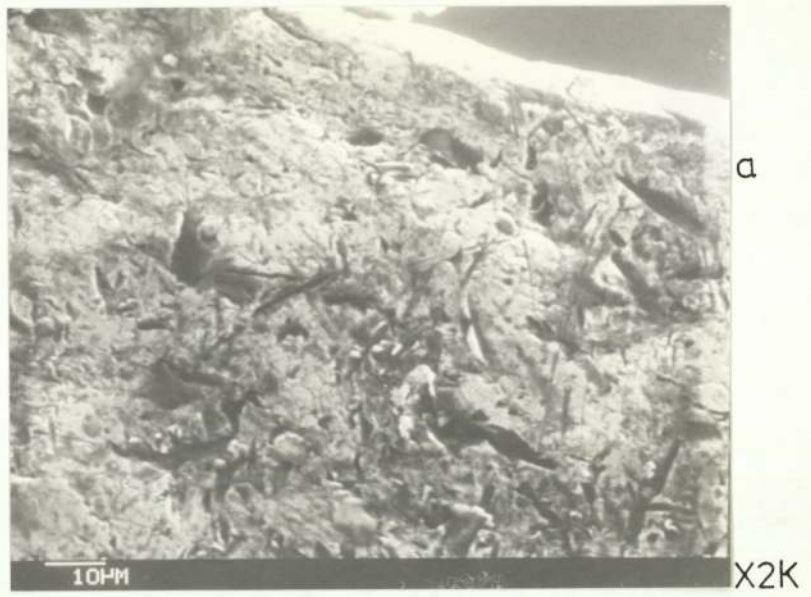
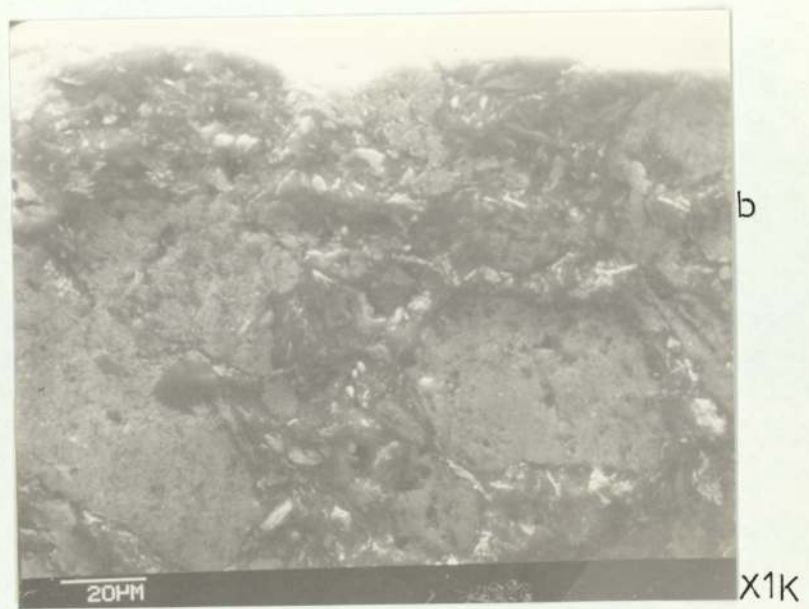
Fig. 53 Vertical sections of (a) No.5 and (b) BH13 dies showing the effects of grinding before forging.

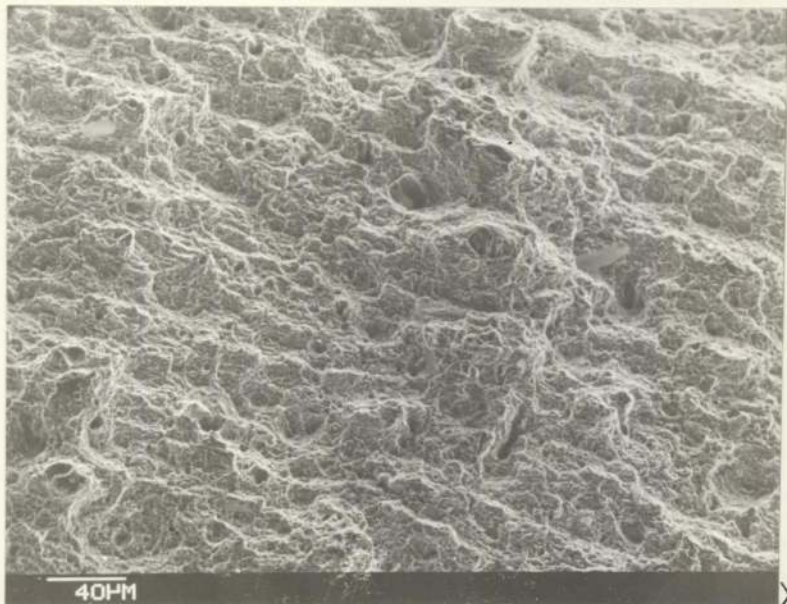
Fig. 62 S.E.M. fractograph showing large and small dimples in the core of a hard Cr plated No.5 die steel impact testpiece.

Fig. 62 shows several shallow and moderately large dimples in the steel subsurface, Fig. 63, on the other hand shows a mixture of dimples and a region of tearing. Fig. 64 (a-c) shows three views, at increasing

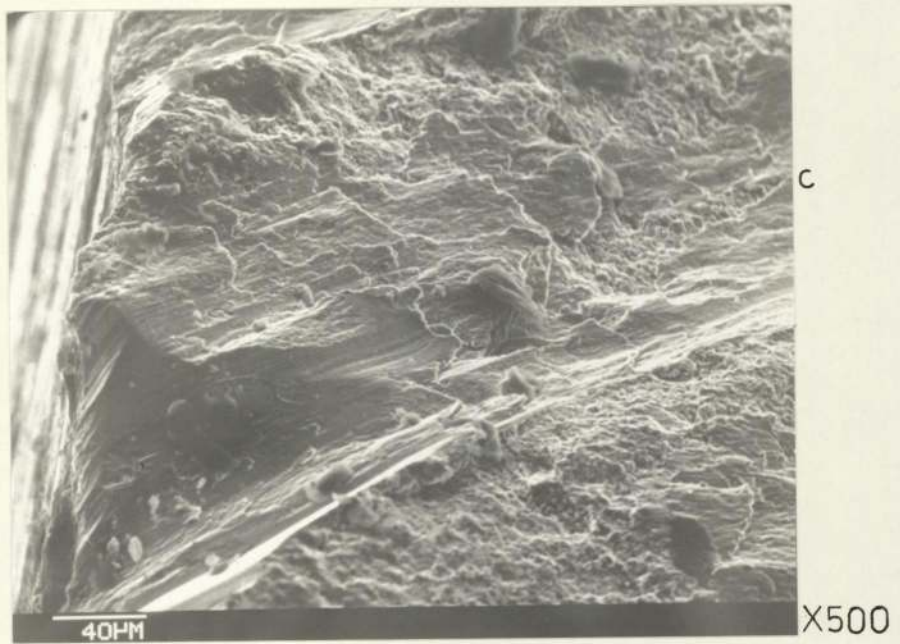
Fig. 64 Three views of the fracture surface of a hard Cr plated No.5 die steel impact testpiece showing -

- (a) the edge of the testpiece
- (b) a mixture of cleavage plus tearing
- (c) an enlargement of one of the tear ridges.

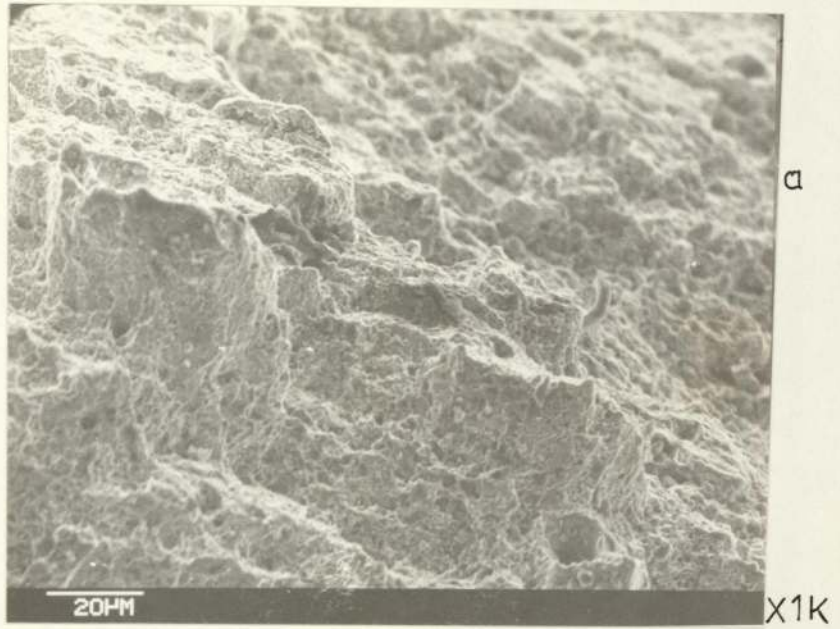
Fig. 67 Two views of the fracture surface of a Co-Mo alloy plated No.5 die steel impact testpiece showing intermingled brittle-cleavage plus dimples. (b) is an enlargement of the central region of (a) which further reveals the dimples.

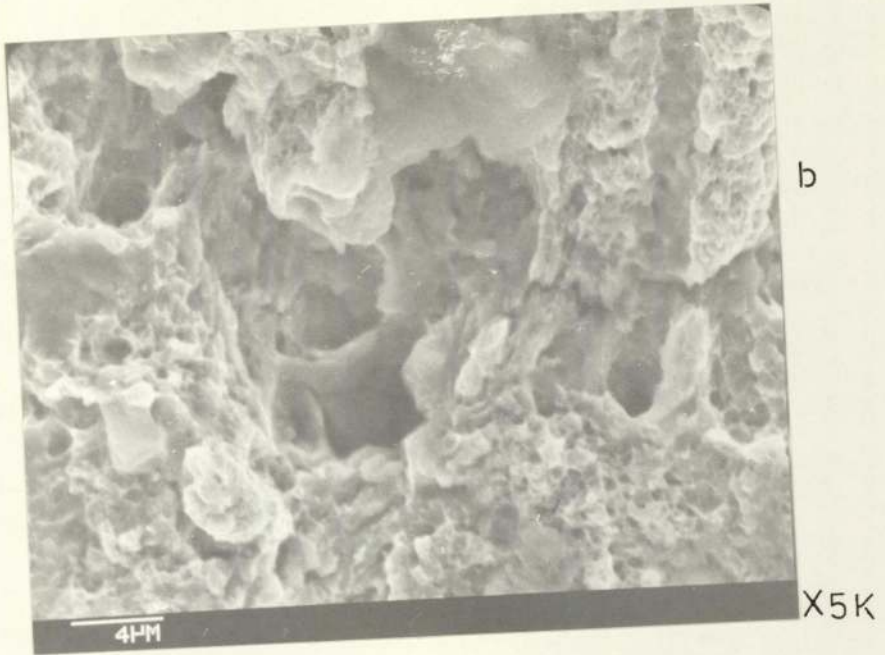
Fig. 70

S.E.M. fractographs of a Ni-P alloy plated No.5 die steel impact testpiece showing -

Scanning views of ductile fracture areas, generally further away from the notch root are shown in figs. 70 9a-c). The region shown in fig. 70. contains several shallow dimples. At higher magnification, in an adjacent area, stringer troughs were observed. Examples are shown in fig. 70(b-c) In fig. 70c an elongated sulphide inclusion (stringer) can be seen to be at the foot of its trough.

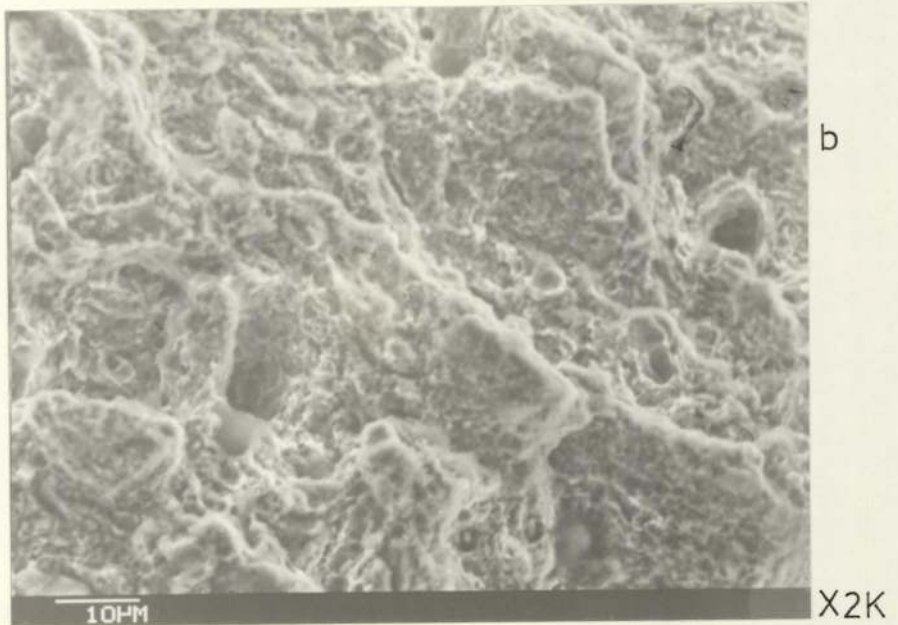
Fig. 71 S.E.M. fractographs of a hardened and tempered No.5 die steel impact testpiece showing ductile plus intermingled brittle failure areas. (b) is a higher magnification of the central region of (a)

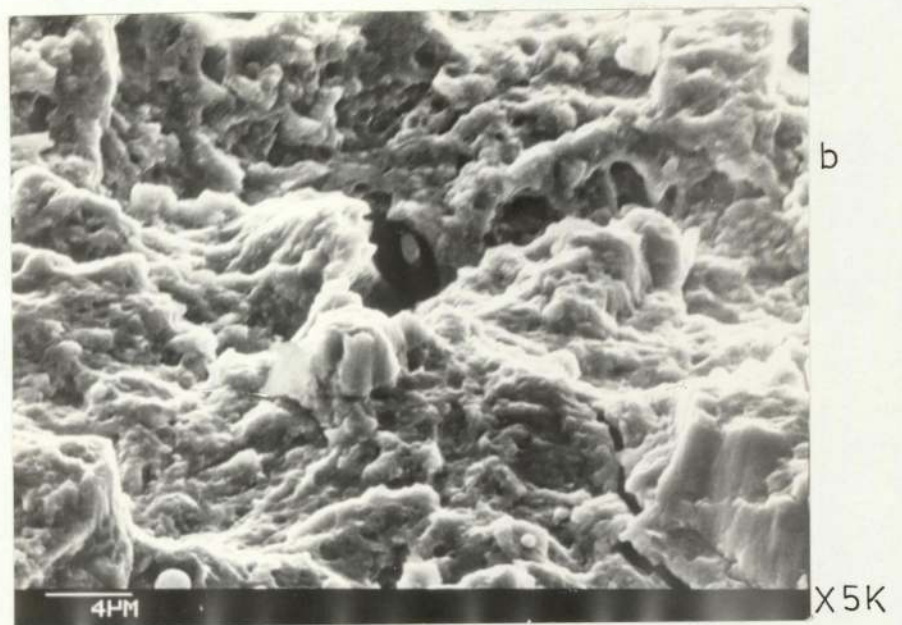
Fig. 76 S.E.M. fractographs of a Co-Mo alloy plated No.5 die steel fatigue testpiece showing void coalescence. (b) is a magnified view of (a) revealing some of the inclusions associated with the dimples.

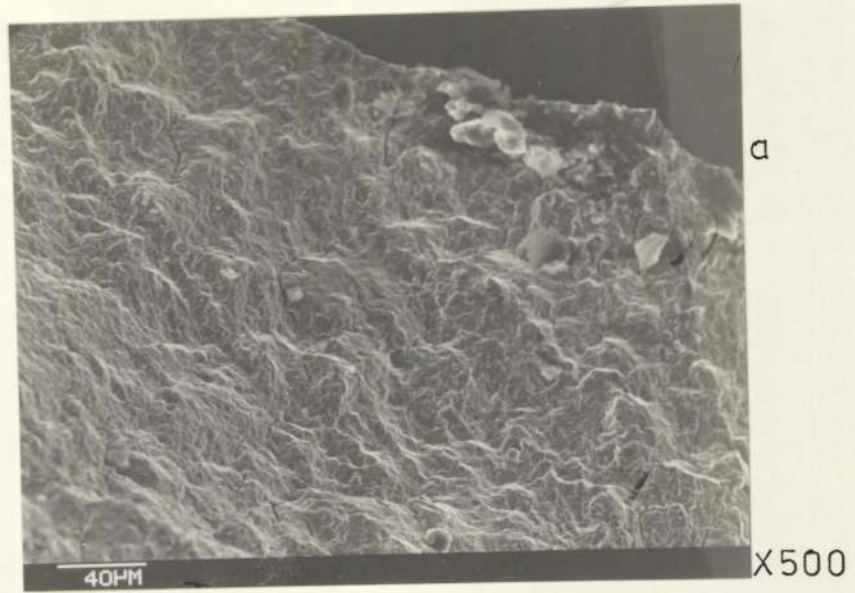
Fig. 77

S.E.M. Fractograph of a Co-Mo alloy plated No.5 die steel fatigue testpiece showing brittle failure and crack initiation at the surface (b) is a magnified view of (a)

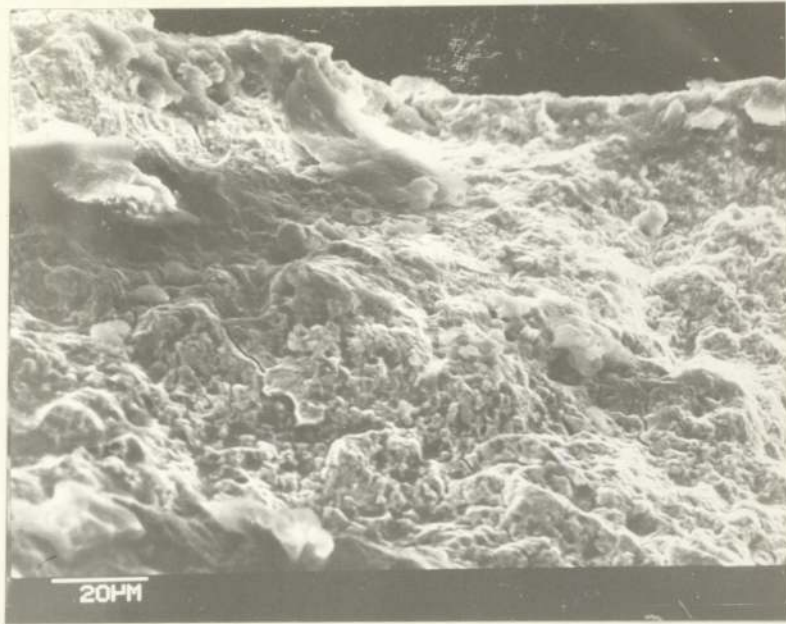
Fig. 80 S.E.M. fractograph of a hardened and tempered No.5 die steel testpiece (having a life of 9.44 kilocycles) showing brittle failure and crack initiation at the surface.

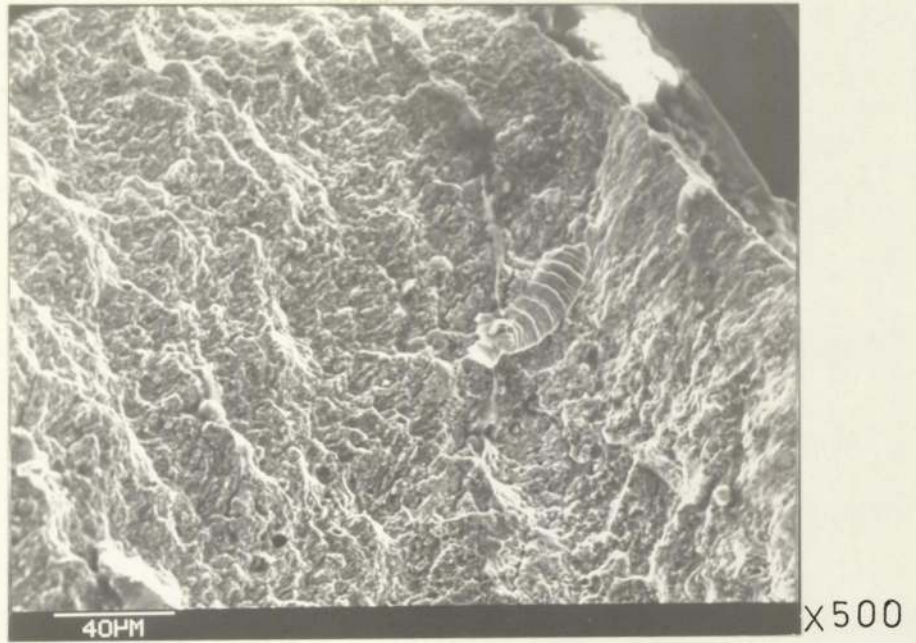
Fig. 82 S.E.M. fractograph of a hard Cr plated No.5 die steel fatigue testpiece showing a tear ridge and brittle failure at the coating-steel interface.

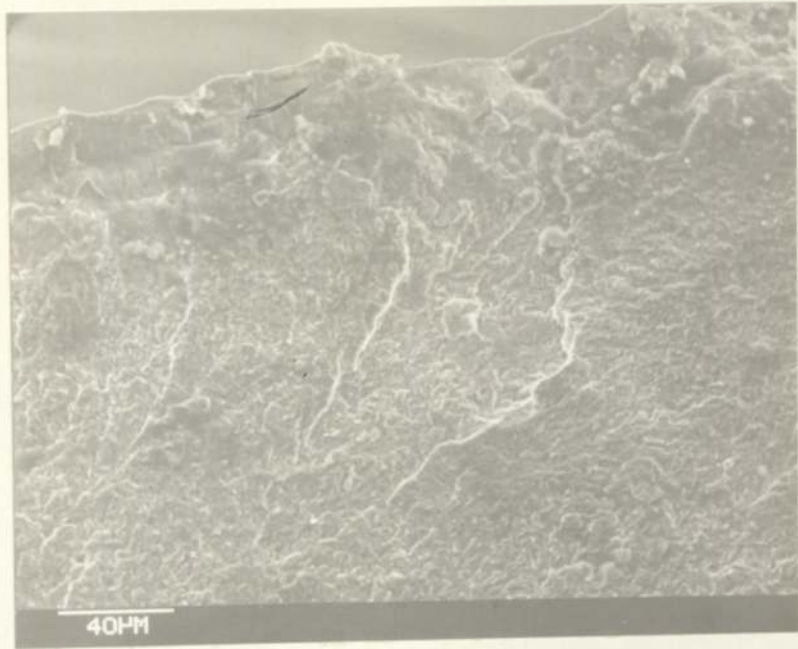
Fig. 86

S.E.M. fractograph of a micro-cracked Cr plated No.5 die steel fatigue testpiece showing cleavage steps and river patterns near the surface.

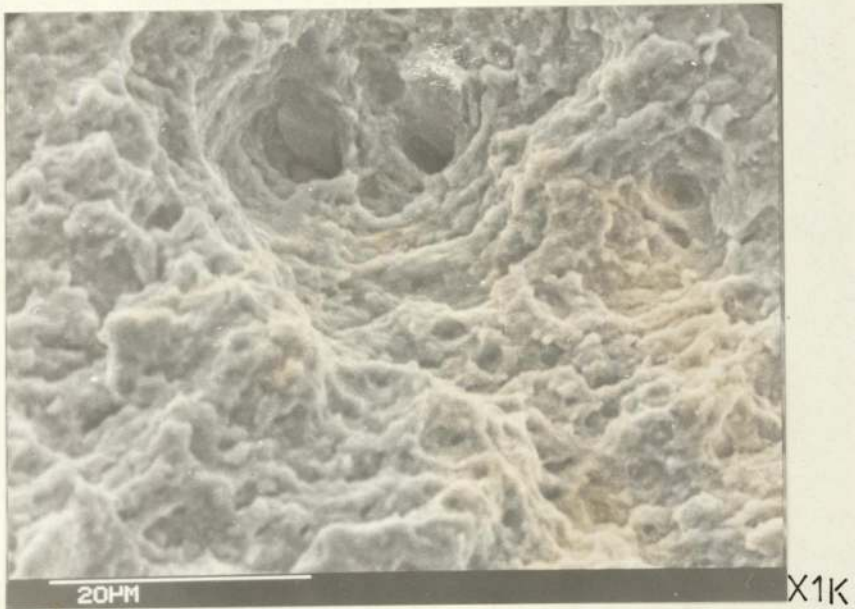
Fig. 90

S.E.M. fractograph of a Ni-P alloy plated No.5 die steel fatigue testpiece showing void coalescence in the core. Fracture is of the "Cup and Cone" type typified by the presence of equiaxed dimples. Note the tilting of cups and the cracks from them.
