1 A Cadaveric Study Validating *in vitro* Monitoring Techniques to Measure the Failure
2 Mechanism of Glenoid Implants against Clinical CT

33 **Abstract**

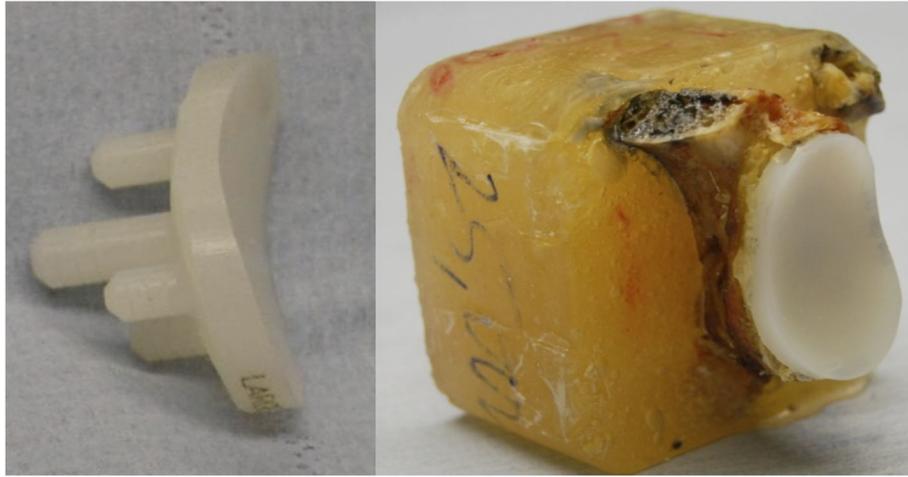
502 **Figure 1.** Curved-back cemented glenoid implant (left). Cadaveric scapula cemented and
 503 potted for testing (right).

120 The ten scapulae were implanted with a commercially available glenoid implant, an Aequalis
121 all-polyethylene, curved-back, pegged design (Tornier Inc., Grenoble, France) (Figure 1).
122 Three small, six medium and one large glenoid with radial curvatures of 27.5 mm, 30 mm
123 and 32.5 mm respectively were implanted by an experienced shoulder surgeon (T.G.). The
124 soft tissue and labrum were excised. The glenoid surface was reamed, removing the cartilage
125 layer, and care was taken to maintain the subchondral layer. The glenoid implants were
126 cemented using Simplex[®] bone cement (Stryker Europe, Montreux, Switzerland). The
127 scapulae were cut to size using an Exakt 310 CP diamond-tipped high precision saw (Exakt
128 Technologies Inc., Oklahoma City, USA) and cemented using Simplex[®] bone cement into the
129 specimen holder. Care was taken to ensure the correct seating of the glenoid component with

130 no tilt (Figure 1). Two holes were drilled into each glenoid implant to accommodate a 2 mm
131 diameter rod at the superior and inferior edge of the glenoid, 2.5 mm from the corresponding

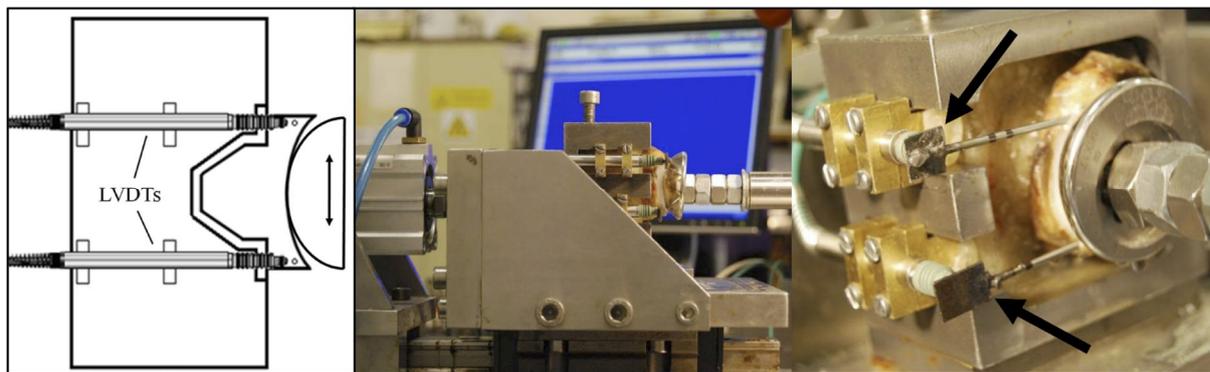
506 **Figure 2.** Mechanical glenoid fixation loosening cadaveric test (left). Reference pins (arrows)
 507 were used to monitor horizontal rim displacement using LVDTs attached directly to the
 508 specimens (right).

132 rim. The two rods were prepared as reference points to measure the corresponding rim
133 displacements via two displacement transducers (LVDTs) (Figure 2).

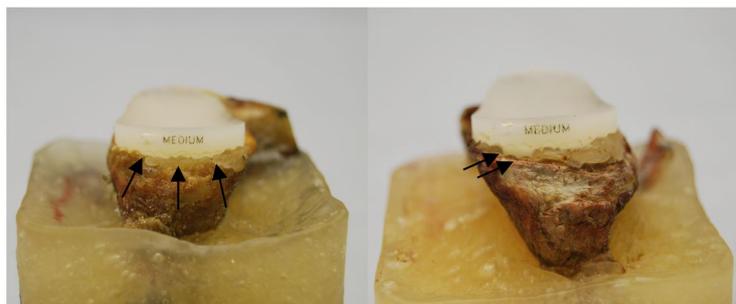
512 **Figure 3.** Failure definition: “partial failure” as inferior rim distracts away from cement (left)
 513 and “failure” as inferior pegs visible (right).

160 During testing, failure visually was defined in two stages (Figure 3), initial failure was
161 indicated by visible distraction of the inferior glenoid rim from the cement or bone substitute
162 block. Partial failure was defined as the point when the inferior pegs were visible during
163 inferior rim distraction, where the test was stopped. Partial failure is referred-to in the
164 following text as failure. Superior bone crushing was defined by visible embedding of the
165 superior implant rim or bone fracture and superior failure was defined as visible distraction of
166 the superior rim. “CT partial failure” was defined as a radiolucent line between the implant
167 rim and the cement and the bone or between the cement and bone (Figure 4). “Complete
168 failure” was defined as a radiolucent line reaching the inferior pegs in the CT images.
169 Microscopic images were compared to the final CT image.

205 All ten implants visibly failed except one, which only partially failed (Figure 3) where the
206 test stopped after 200,000 cycles. Six failed exclusively at the implant-cement interface, two
207 failed both at the implant-cement and cement-bone interface and two failed superiorly due to
208 cortical bone failure (Figure 4). Implant failure occurred between 16,300 and 122,500 cycles,
209 with a mean (\pm SD) of $80,966 \pm 53,729$ cycles. The earliest specimen to fail had previously
210 been identified as partially sclerotic. The partially failed implant was stopped at 200,000
211 cycles, although some superior and inferior implant-cement distraction was observed and CT
212 scans revealed initial good implant seating. All final CT scans confirmed failure, which were
213 observed visually (Figure 5), however, in three specimens it was difficult to identify which
214 interface loosening was apparent either visually or with CT. No significant difference was

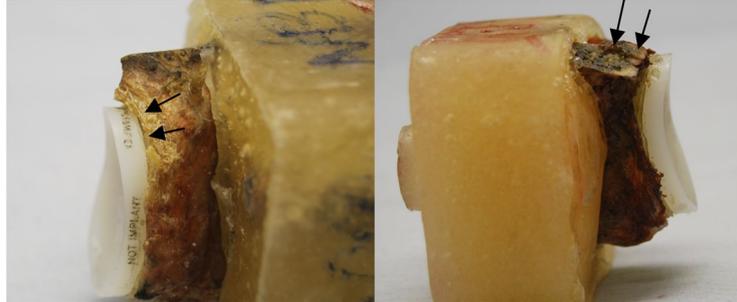
516 **Figure 4.** Superior failure-rim distracts away from cement (left) and bone crushing-bone
 517 fracture or implant embedding (right).

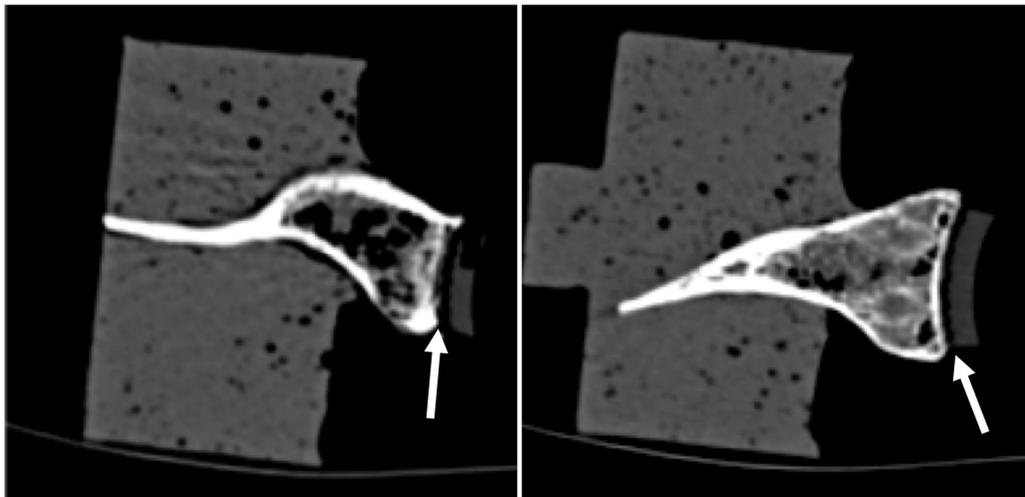
520 **Figure 5.** CT slices of the transverse plane showing an example of superior (left) and inferior
 521 (right) failure at the implant-cement interface in a specimen.

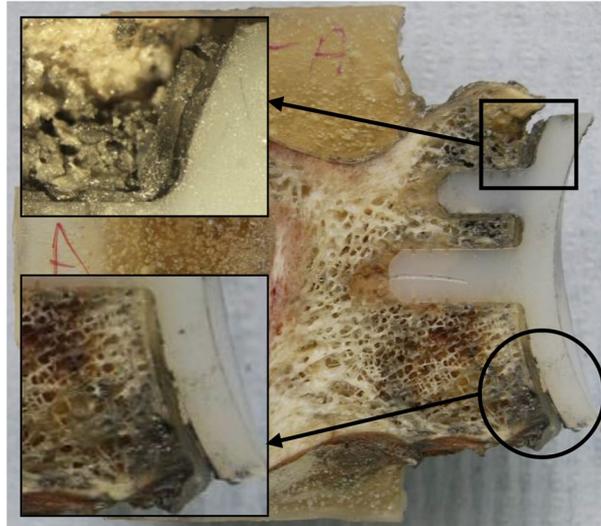
524 **Figure 6.** Cross-sectional slice of same specimen as CT after failure. Note: inferior failure of
 525 the implant-cement (circle) and superior bone crushing (square).

217 The visual examination of the sectioned specimens confirmed clear failure at the implant-
218 cement interface and superior bone crushing, as was observed from inspection of unsectioned
219 specimens (Figure 6). The microscopic study revealed the cement thickness varied from 0.5-
220 1.5 mm and was cracked in three specimens at one of the peg junctions where bending
221 stresses had been experienced. There were no other apparent cement fractures anywhere else.
222 In one case, the implant completely detached at the implant-cement interface, the cement
223 embedded in the peg grooves was still intact.

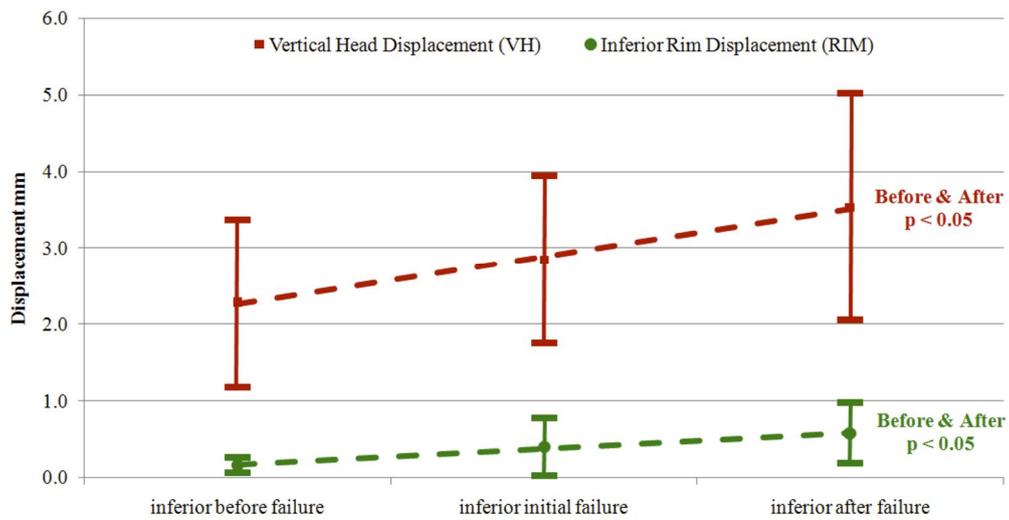
528 **Figure 7.** Positive correlation between vertical head displacement ($p < 0.05$) and inferior rim
 529 displacement ($p < 0.05$) with visual failure.

226 Inferior rim displacement and vertical head displacement both increased with observed
227 failure (Figure 7). The positive correlation between vertical head displacement before failure

228 and at failure was statistically significant ($p < 0.05$). This was also true for the inferior rim
229 displacement ($p < 0.05$). The mean vertical head displacement (\pm SD) before and after failure
230 was 2.3 ± 1.1 mm and 3.5 ± 1.5 mm respectively.

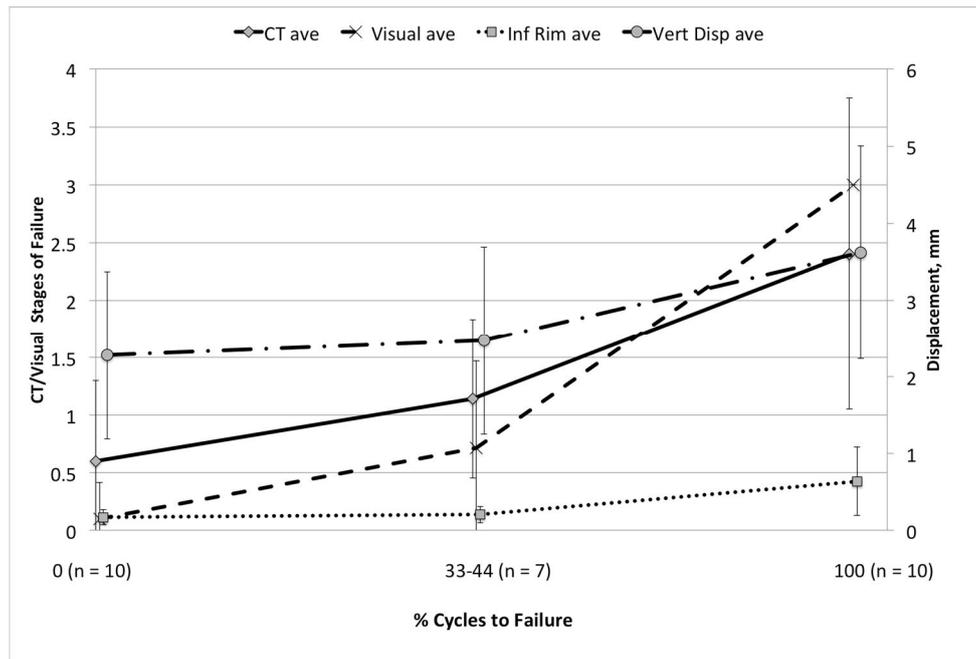
533 **Figure 8.** A plot of the mean clinical CT failure* and qualitative visual measures* with
 534 quantitative inferior rim and vertical head displacement against cycles to failure,
 535 normalised to a percentage. The plot shows correlation between displacements with
 536 CT and visual failure. * No failure = 1, partial failure = 2 and failure = 3.

233 All four failure measures: clinical CT, qualitative visual, quantitative vertical head and
234 quantitative inferior rim displacement, positively correlated with cycles to failure (Figure 8
235 and Table 1). On average, failure was identified in clinical CT images before visual failure
236 was observed (Figure 8). This observation was found in 8/10 shoulders. In the remaining two
237 shoulders, CT and visual failure were observed together in one and visual failure observed
238 first in the other.

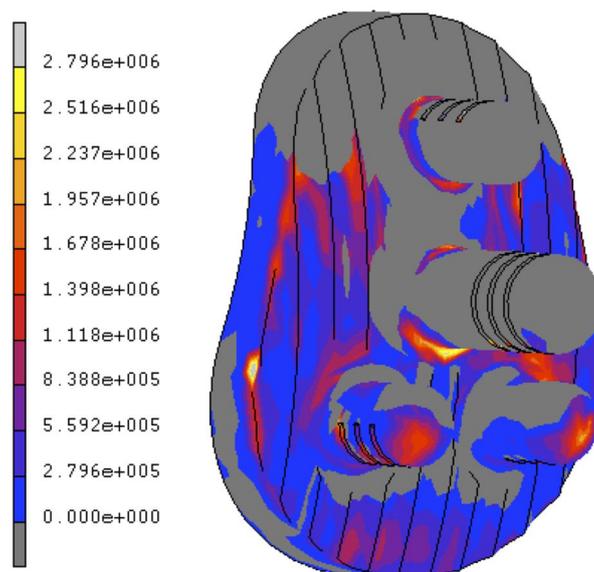
539 **Figure 9.** Tensile normal contact stresses at the implant/cement interface. Note: peak stresses
 540 at the inferior edge and pegs reaching up to 1 and 2.5 MPa respectively.

246 The implant/cement interface normal stress predicted by the FE model showed superior
247 compressive stresses and inferior tensile stresses. Tensile peak stresses were found at the base
248 of the pegs (2.5 MPa) and peaked at the inferior edge of the implant (1 MPa).

278 in seven cases and was able to detect failure before or with visual failure in nine specimens.
279 All *in vitro* measurements correlated with CT failure, with quantitative rim displacement and
280 head displacement both showing a significant increase from no failure to failure ($p < 0.05$)
281 (Figure 7). The FE model showed peak tensile loads at the inferior rim and at the base of the
282 inferior pegs. Unpublished work in our laboratory have found implant/cement interface
283 strengths at between 0 and 1 MPa for smooth implant surfaces, placing the peak tensile
284 stresses within the failure range, thus possibly corroborating the experimental findings
285 (Figure 9).

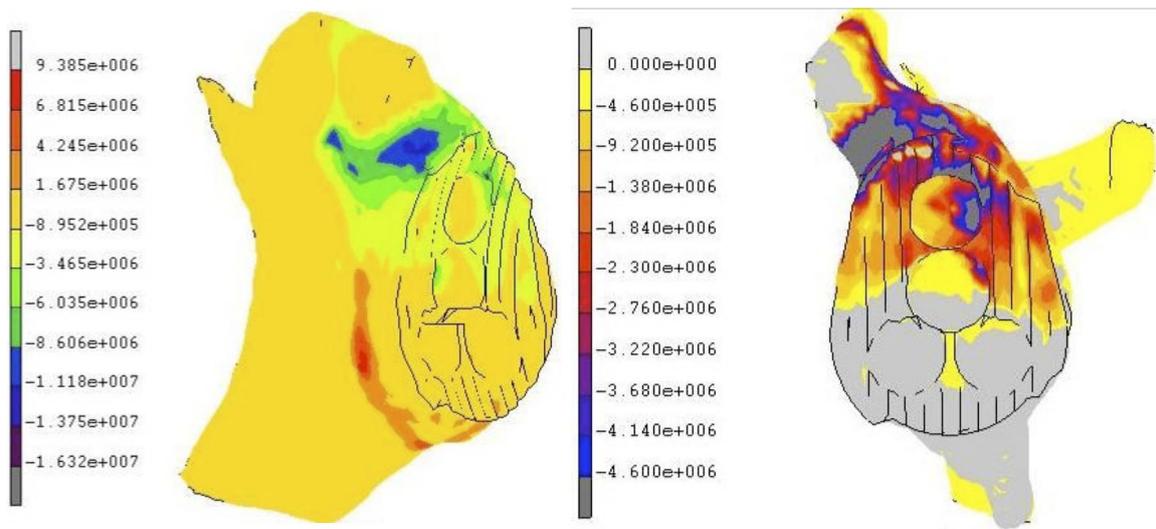
543 **Figure 10.** Color plot of the cadaveric bone showing minimum principal stress (compressive
544 stresses-blue) and maximum principal stress (tensile stresses-red) (left). Color plot of
545 minimal principal stress (compressive only) showing dark grey areas exceeding 4.6
546 MPa (predicted bone strength) (right).

251 The strength of the cancellous bone was calculated using the lowest bone density as 4.6 MPa,
252 the compressive stresses in the bone exceeded this superiorly during loading, corroborating

286 Furthermore, the 4.6 MPa predicted bone failure compressive strength was exceeded during
287 the tests. This prediction was corroborated by the superior crushing found in seven of the ten
288 experimental samples.
