THE USE OF AERIAL PHOTOGRAPHY FOR SPOILED
AND DERELICT LAND STUDIES - WITH SPECIAL
REFERENCE TO GLAMORGAN

Submitted for the degree of Doctor of Philosophy

May 1976

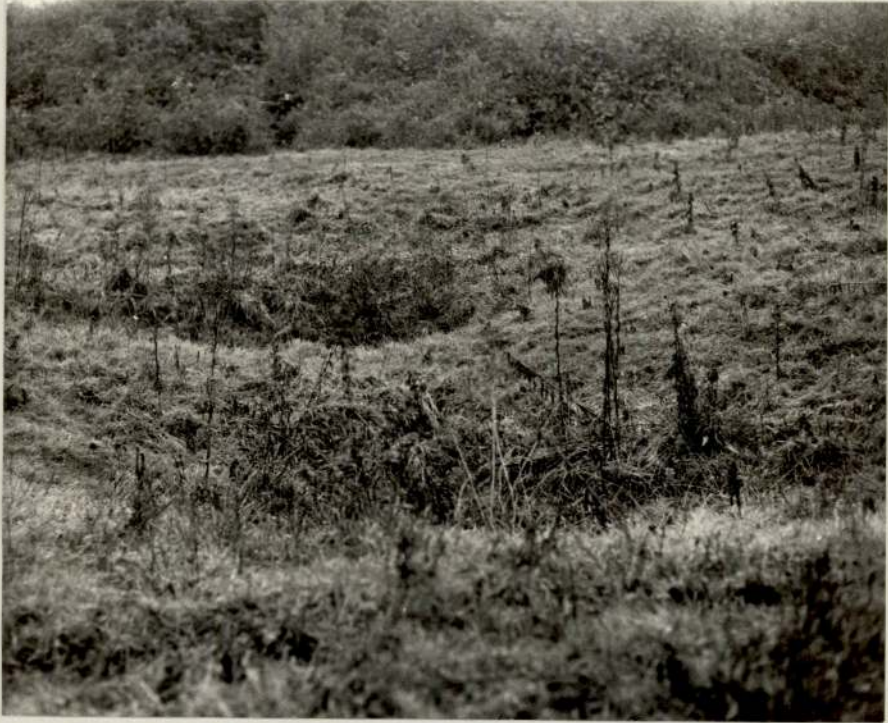
Fig. 7.1 Pit resulting from lead mining

The pits described above are found where the mineral bearing rocks outcrop at or near the surface of the land. A similar situation occurs with "cropworking" or "trenching" where coal seams and/or ironstone bands outcrop at the surface, usually on valley slopes. The form of the resulting dereliction (Figure 7.2) is clearly

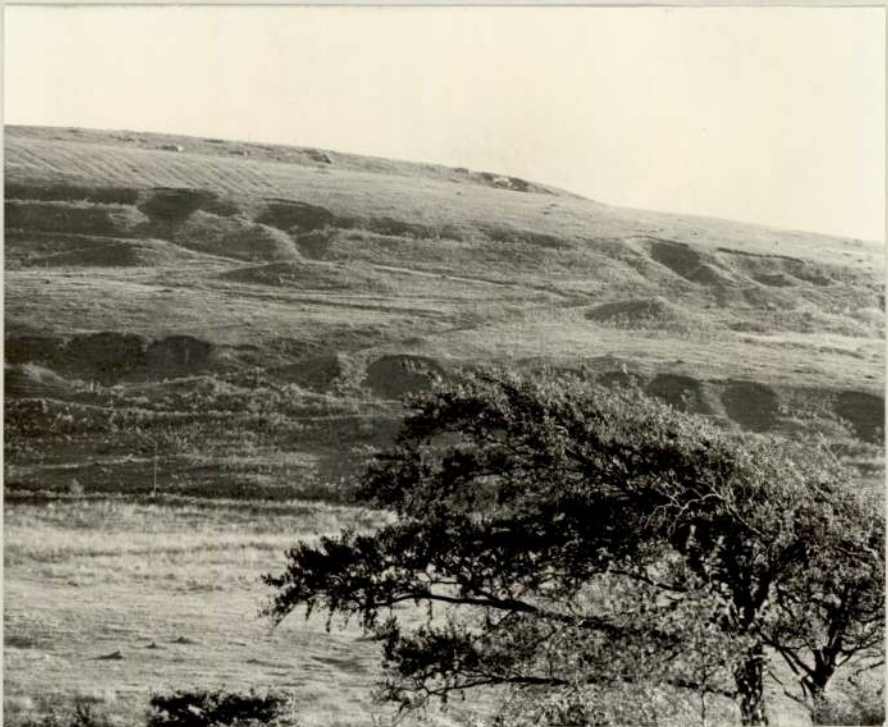
Fig. 7.2 Cropworkings

recognisable both on the ground and on the aerial photograph. A series of scooped out hollows or trench in the hillside is immediately juxtaposed with a parallel series of spoil heaps on the downslope side. Occasionally an isolated hollow and spoil heap are found where trial excavations were begun but not extended because there was no coal or ironstone present, or because the geological structure inhibited exploitation of the seam.

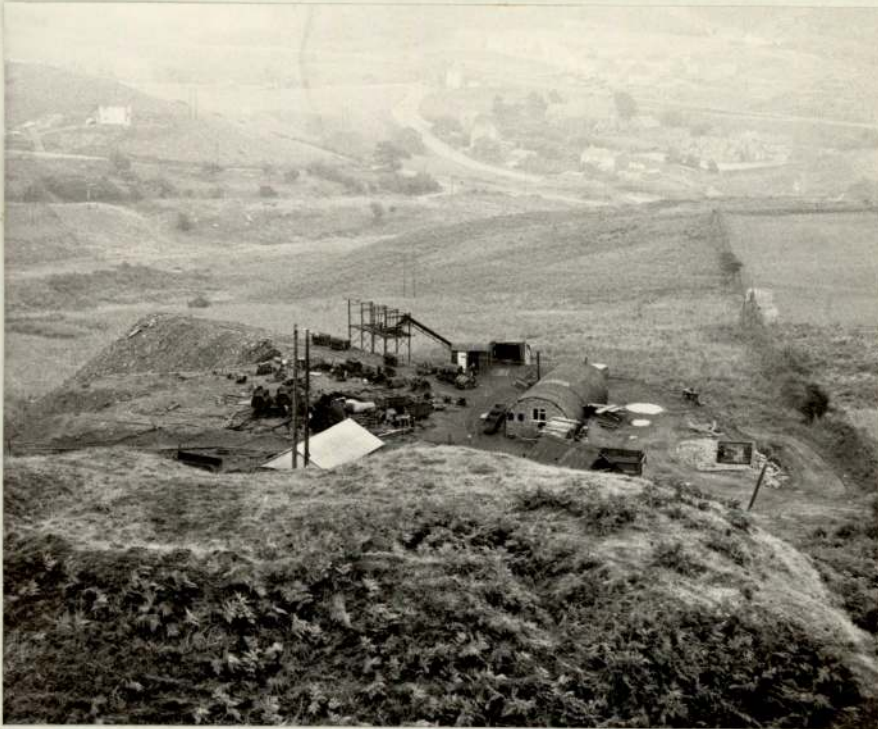
Fig. 7.5 Private mine

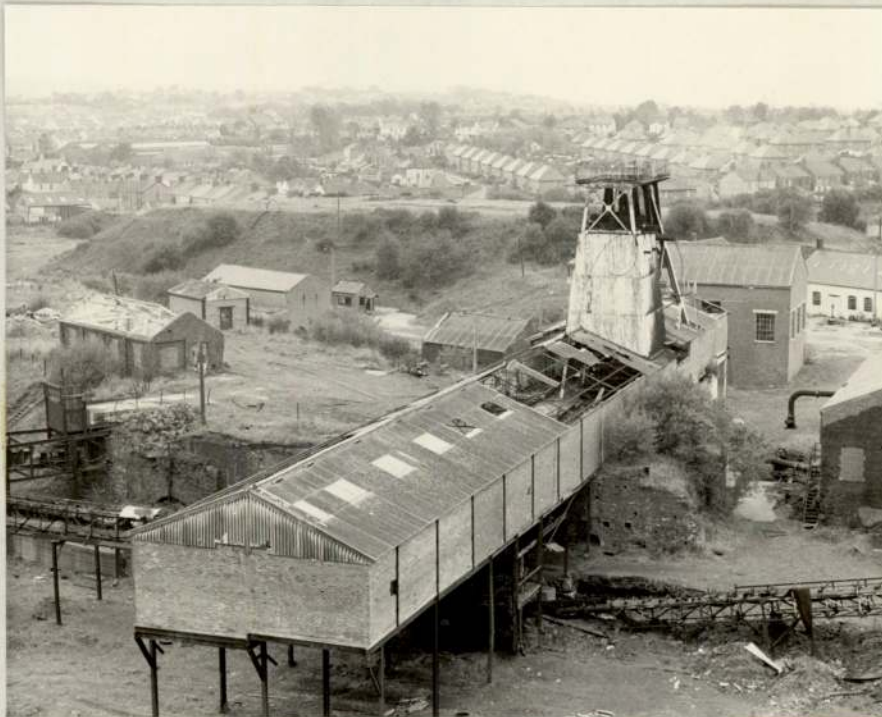
Fig. 7.8 Mountain colliery

These then are the major features and some of the variations which are found at active collieries, but there are several points to bear in mind when interpreting such sites. As an example, pithead gear may not always be visible since being dark toned (the true colour of the painted metal is usually dark green or blue, or black), it may be lost in shadows cast by nearby buildings. Here is one instance, however, where its own shadow may indicate the presence of headgear.

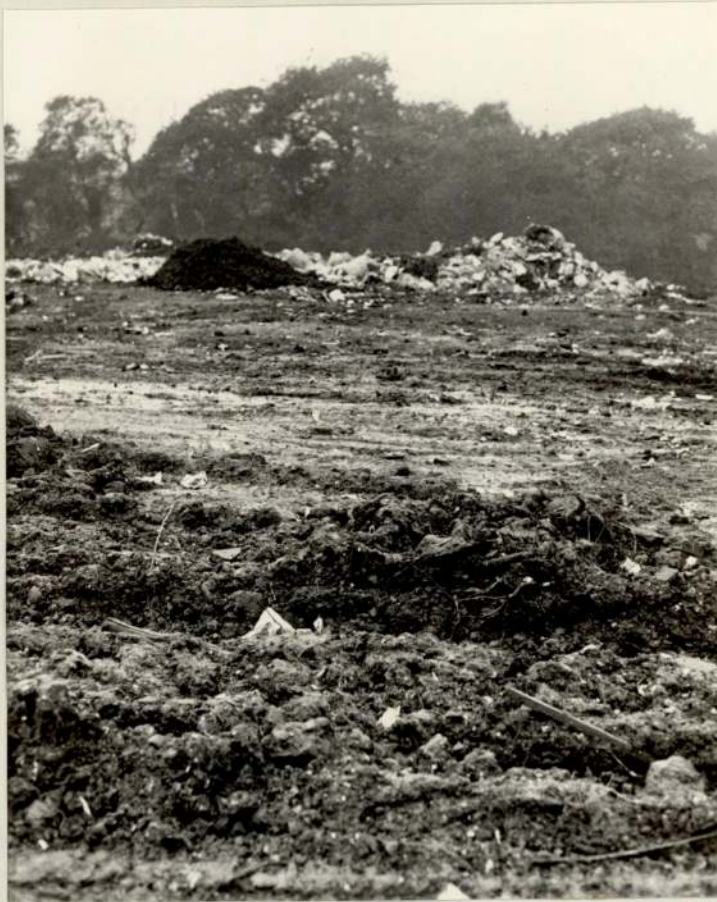
Fig. 7.13 Domestic refuse tip

In the case of sites where tipping is observed but where the nature and source of the tipped material cannot be ascertained, little more can be said. One example is shown on AP16 where material has been tipped into the disused Penarth Dock. Discounting the debris floating

on the surface of the water, the material in area 1 appears to be inorganic and resembles sub-soil or overburden. In contrast to this, area 2 exhibits more heterogeneity which is characteristic of refuse. Since the tipping is taking place in water, however, the material is unlikely to be domestic refuse since for health reasons such material is usually tipped in dry areas.

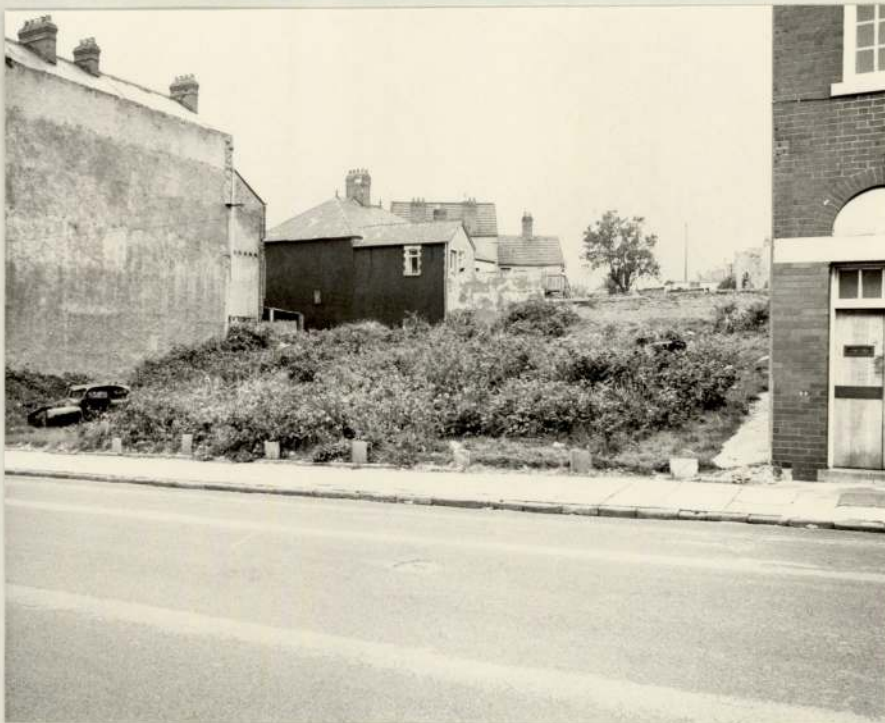
Fig. 7.14 Residual open space (waste ground)

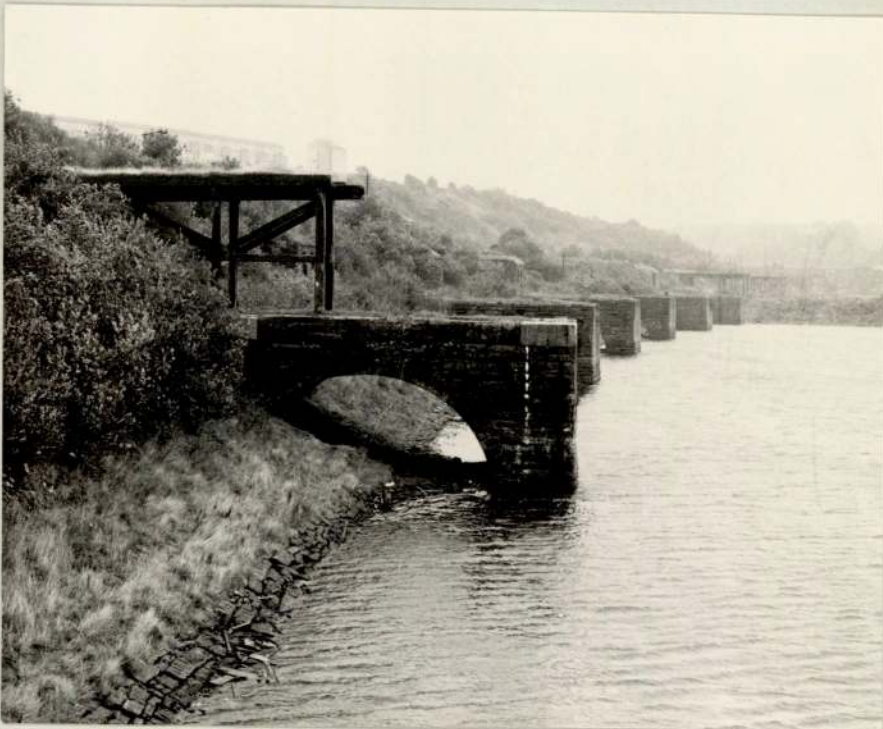
Fig. 7.17 Derelict staithe at Penarth Dock

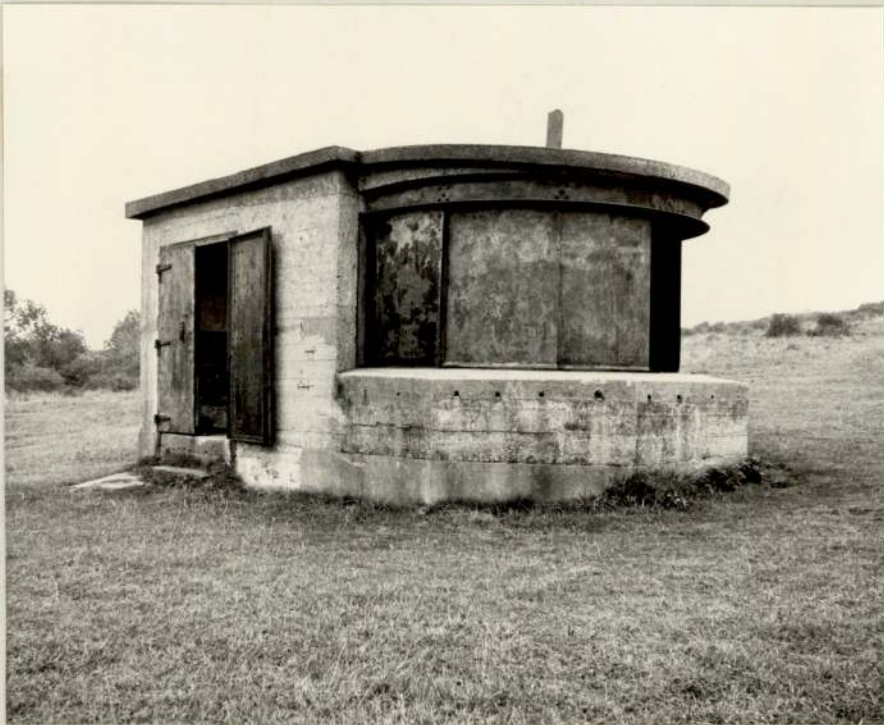
Fig. 7.18 Derelict coastal defence installations

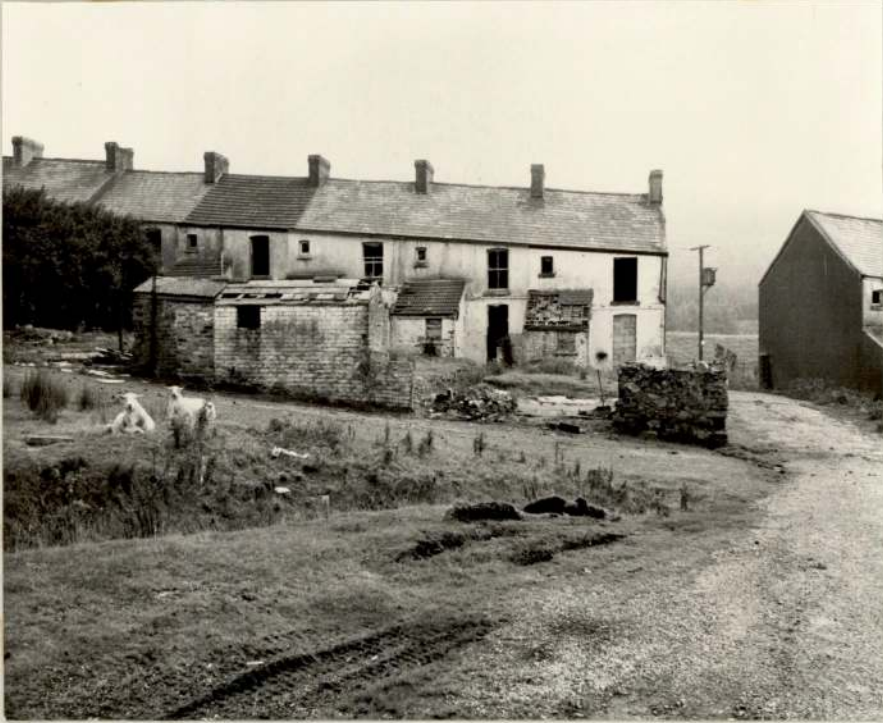
Fig. 12.1 Derelict terraced housing.
