Distributed dynamic fibre-optic strain monitoring of the behaviour of a skewed masonry arch railway bridge

Abstract

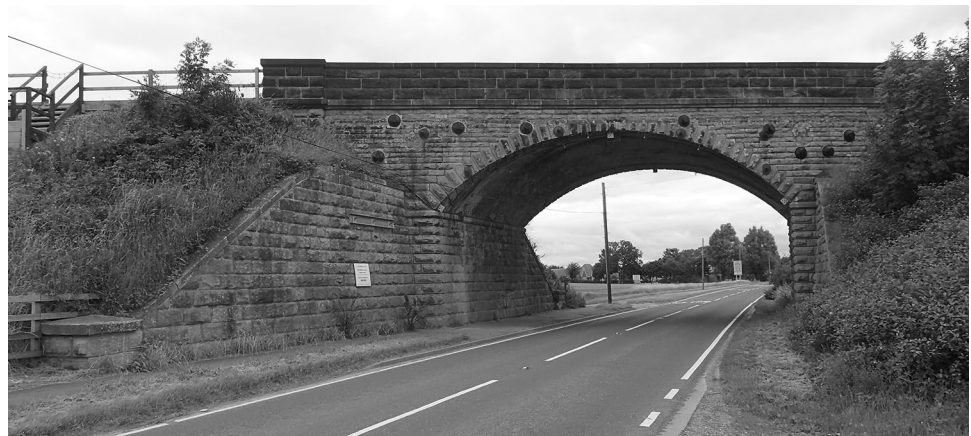
Fig. 1 Upside elevation view of the case study bridge, looking north

rods. Visible signs of this damage and intervention work are shown in Fig. 2, and the extent of the tie rods can also be seen in the elevation view of Fig. 1. The new tie rods were installed to replace previous ones, which had been found to be ineffective in preventing further expansion of the spandrel separation cracks. Pattress plates for the previous tie rods can also be seen in Fig. 2; these are smaller and a lighter colour than those for the new tie rods.

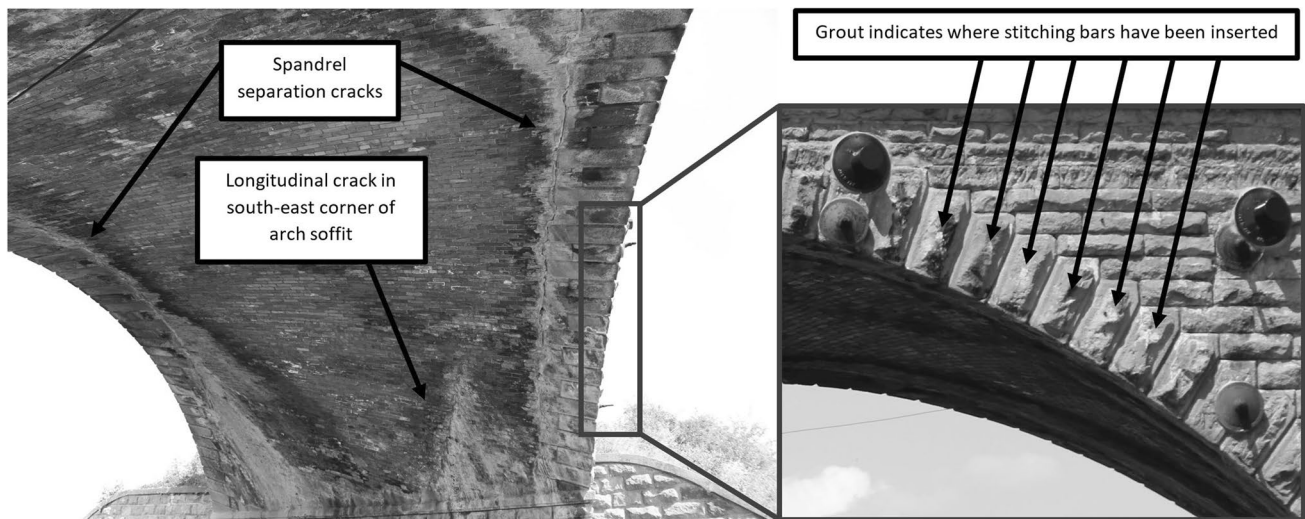
Fig. 2 Views of the arch soffit and south spandrel, with key cracks and signs of past interventions highlighted

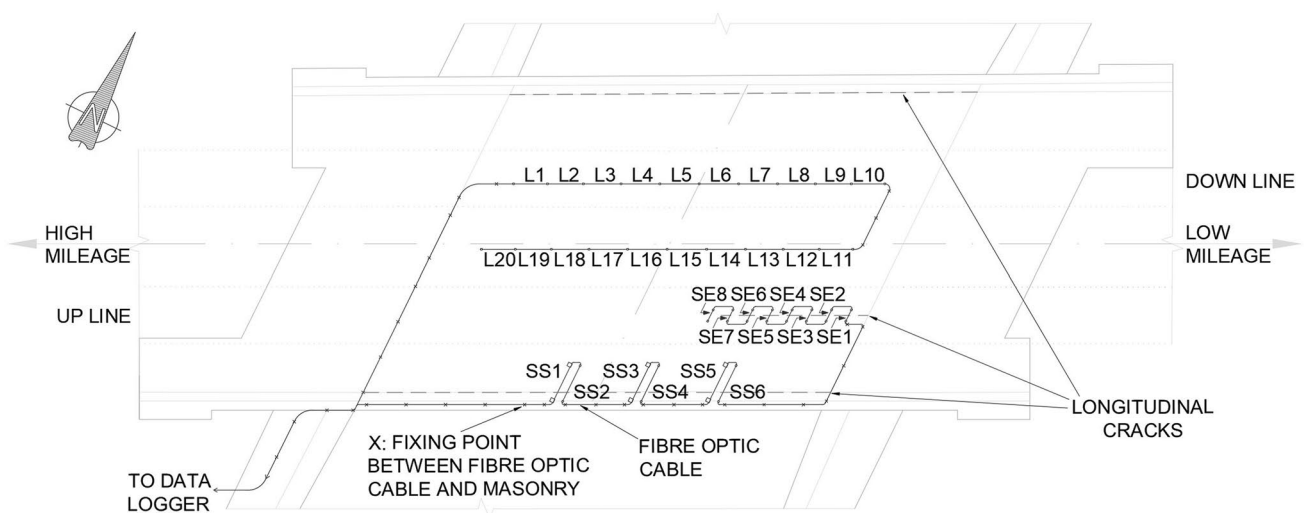
Fig. 3 Plan view schematic of the arch soffit at the case study bridge, highlighting the installed FBGs and key cracks

The FBG sensors which will be discussed in this paper were fixed to the case study bridge in accordance with the installation plan in Fig. 3. Key accompanying dimensions are given in Table 1. Values for the thickness of the arch barrel and the depth of ballast and fill material are based on inspection reports and could not be independently verified in this study. The FBGs in Fig. 3 monitor three key regions of the bridge:

1. FBGs L1 to L20 are installed in two longitudinal lines of ten FBGs each along the arch intrados, directly underneath the centreline of the north track and the overall bridge centreline. There are no clear visible signs of damage in this region of the bridge, and so these sensors are used to investigate the general structural behaviour of a skewed masonry arch railway bridge. It was previously reported by the authors in [13, 14], that the skewed span direction appears to offer a preferential load path for the arch to transmit applied train loading to its abutments. In this paper, the sensitivity of this longitudinal response to various parameters is investigated in detail. These FBGs are installed with gauge lengths of 1 m.
2. FBGs SE1 to SE8 are installed to measure the in-plane crack opening of the south-eastern longitudinal crack.

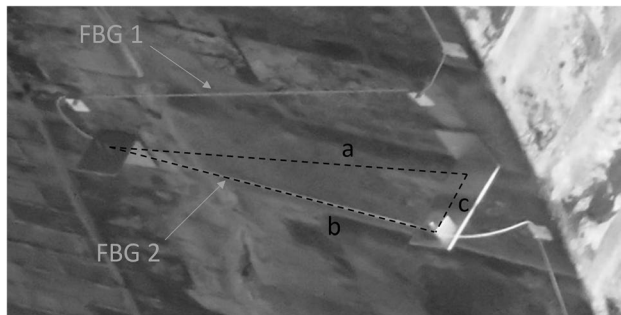
a: parallel to FBG 1
b: parallel to FBG 2
c: parallel to desired measurement

Fig. 4 A typical “FBG pair” installed at the south spandrel separation crack

from both sensors, it is possible to calculate the relative vertical movement across the crack, i.e. movements parallel to *c* in Fig. 4. These readings were validated against other measurement technologies which recorded the relative vertical displacements directly [7].

Using the notation in Fig. 4, the fibre measuring pure crack opening has a gauge length of $a = 1$ m. This fibre is parallel to the transverse direction of the arch barrel, while one end of the second fibre in this pair is displaced by $c = 150$ mm. As a result, the gauge length of this second fibre is $b = \sqrt{a^2 + c^2} = 1.011$ m. Relative movements across this spandrel separation crack are known to be small in magnitude, such that there is a negligible change to the interior angles of this triangle. Therefore, as movements across the crack occur, the new side lengths of this triangle are given by Eq. (2).

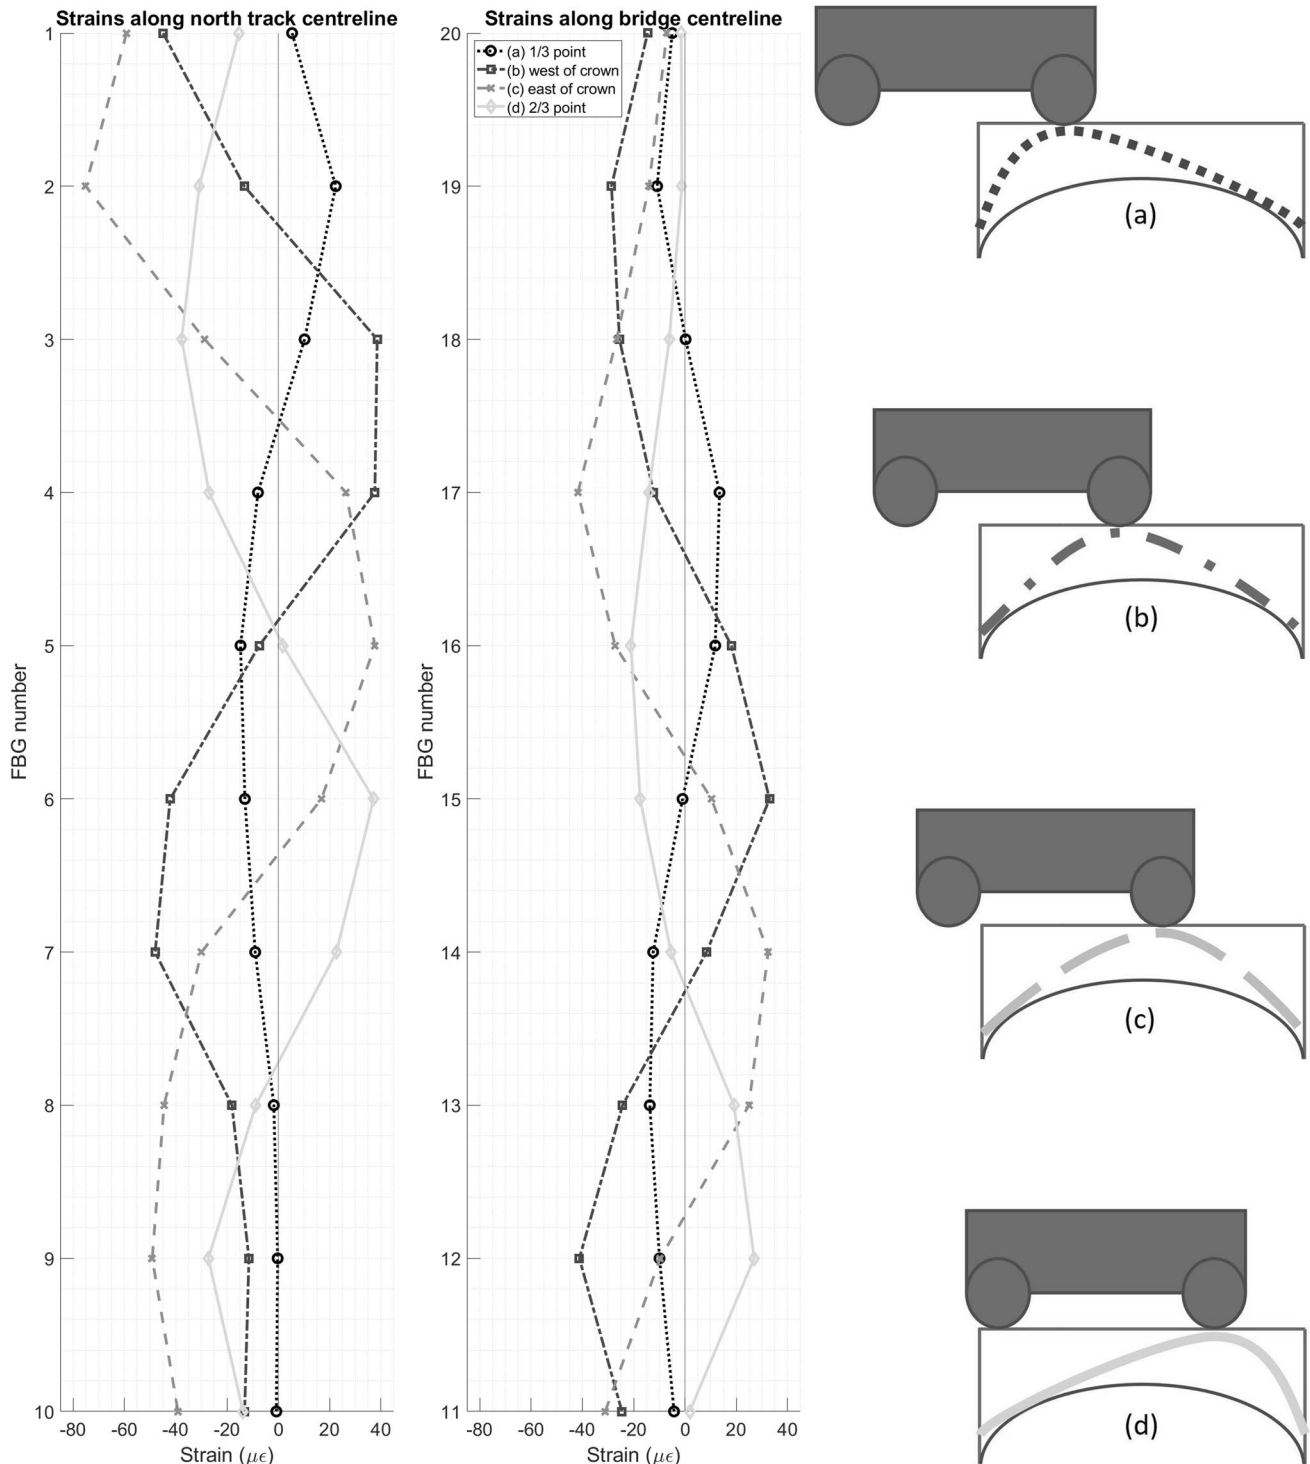
Fig. 6 The instantaneous longitudinal strain responses observed at the arch intrados when the leading axle of a typical Class 185 train passes above key locations along the arch span, and schematics of the anti-

crack thrust lines in the arch bridge for point loads applied in these locations, namely **a** the western third point, **b** west of the arch crown, **c** east of the arch crown, and **d** the eastern third point

In each case, a bulb of positive, tensile strains is observed in the vicinity of the applied load, with compressive strains either side of this bulb. This observation supports the notion that a potential load path for these applied forces is through arching action in this longitudinal direction. Furthermore, the instantaneous intrados strain distributions in Fig. 6 are consistent with the anticipated thrust lines for concentrated loads applied at locations (a–d) along the span, which are also shown schematically in Fig. 6. Close to the applied load the thrust line will pass nearer to the arch extrados so that strains at the intrados are tensile. Outside of this region, the thrust line will be nearer to the intrados, and intrados strains will, therefore, tend to become compressive.

The distributions in Fig. 6 also demonstrate that the largest tensile strains occur close to the arch crown when loads

are applied directly overhead: the symmetric loading case. This is to be expected because close to the crown there is the least backfill material between the arch and the track and therefore the least opportunity for load distribution to occur before the load path enters the arch. The largest compressive strains, meanwhile, are observed on either side of the arch at times when loads are applied on the opposite side: the asymmetric loading case. Again, this is to be expected, as the asymmetric loading case will cause the thrust line to pass closer to the intrados in the locations where peak compressive strains are observed (see schematic thrust lines (a) and (d) in Fig. 6).

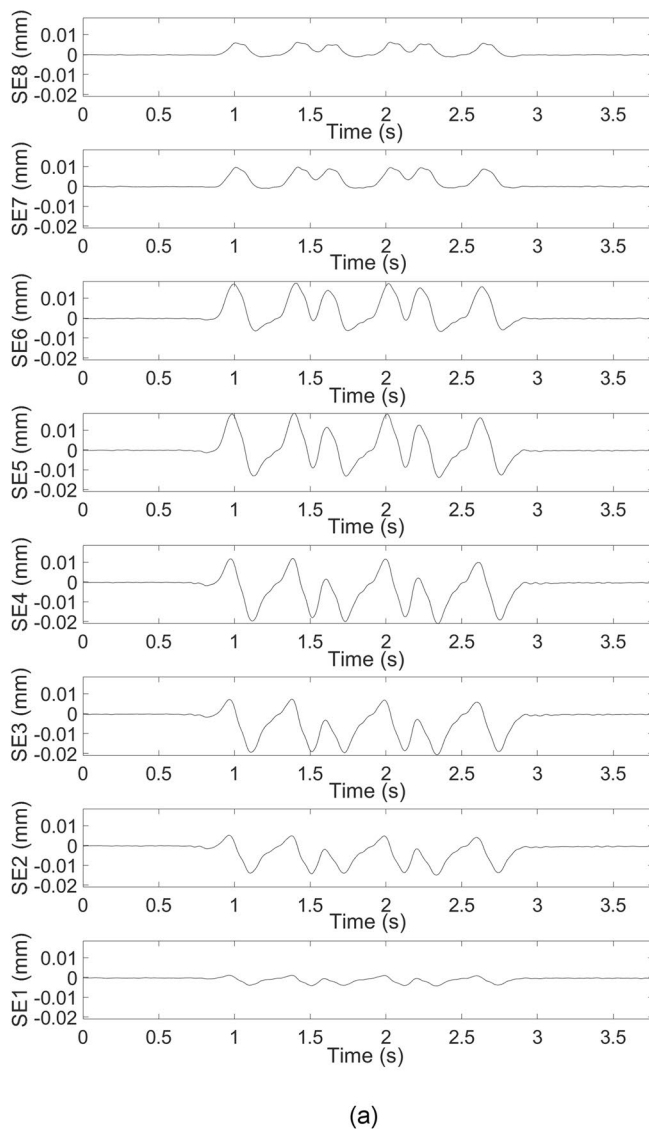
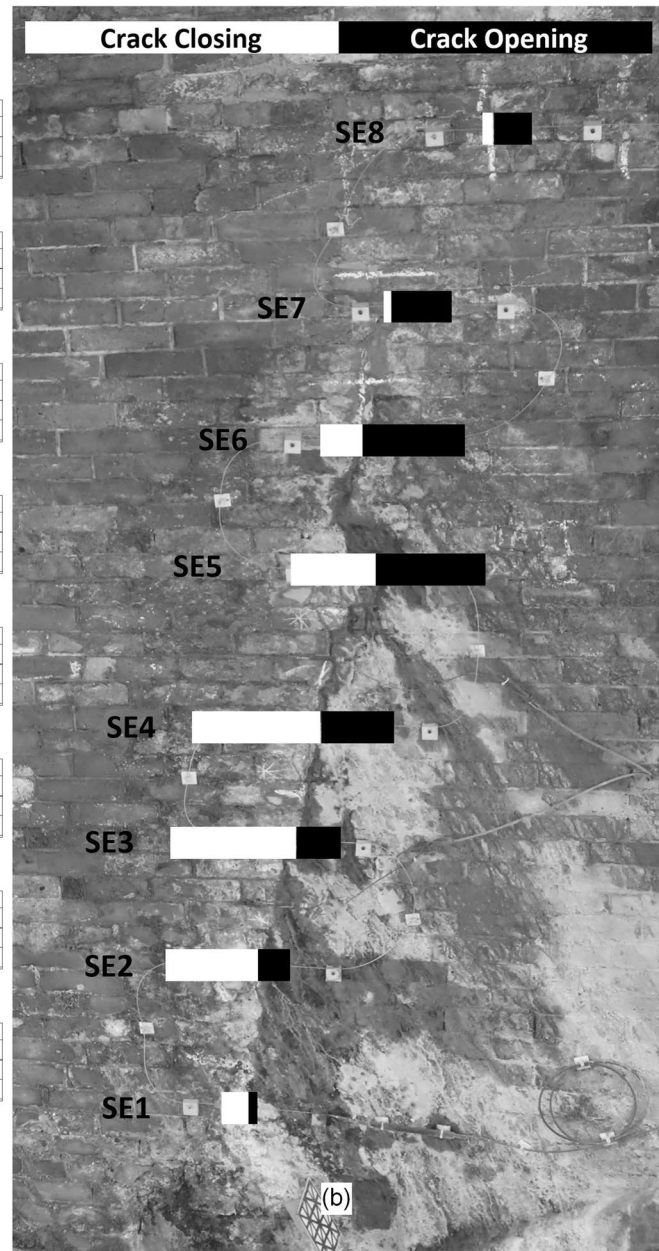
Fig. 7 **a** Typical time histories of the crack opening displacements at the south-eastern longitudinal crack, for a Class 185 train passing on the southern track, and **b** schematic showing the “football-shaped” distribution of these peak-to-peak crack opening displacements

Figures 7a and 8a show typical time histories of crack opening displacements at the south-eastern longitudinal crack, as a Class 185 train passes on the south and north track respectively. Figures 7b and 8b show schematics of these crack opening distributions overlaid on photographs of the crack. The schematics show the relative shapes of these distributions while the magnitudes of movements have been exaggerated, although the schematics in Figs. 7b and 8b are plotted at the same scale.

In Figs. 7a and 8a, crack opening is positive and crack closing is negative. In both of these figures, a “football-shaped” distribution is observed along the crack length, with the response being largest over the central portion of the crack. FBGs SE1 and SE7 are located at the root and tip of the crack respectively, while FBG SE8 is located ahead of the crack tip. Magnitudes of peak-to-peak movements are similar at FBGs SE1 and SE8, and only slightly larger at FBG SE7, although the ratio of tension to compression is higher at the crack tip than it is at the crack root.

Comparing each FBG between Figs. 7 and 8, the magnitudes of peak-to-peak crack opening remain similar regardless of the track on which trains are travelling. However, in Fig. 7, for a train travelling on the south track directly above the crack, movements over the upper half of the crack are primarily tensile and the crack is opening, while movements over the lower half of the crack are primarily compressive and the crack is closing. When trains pass on the northern track, as in Fig. 8, movements at the crack are almost entirely compressive, at all points along its length.

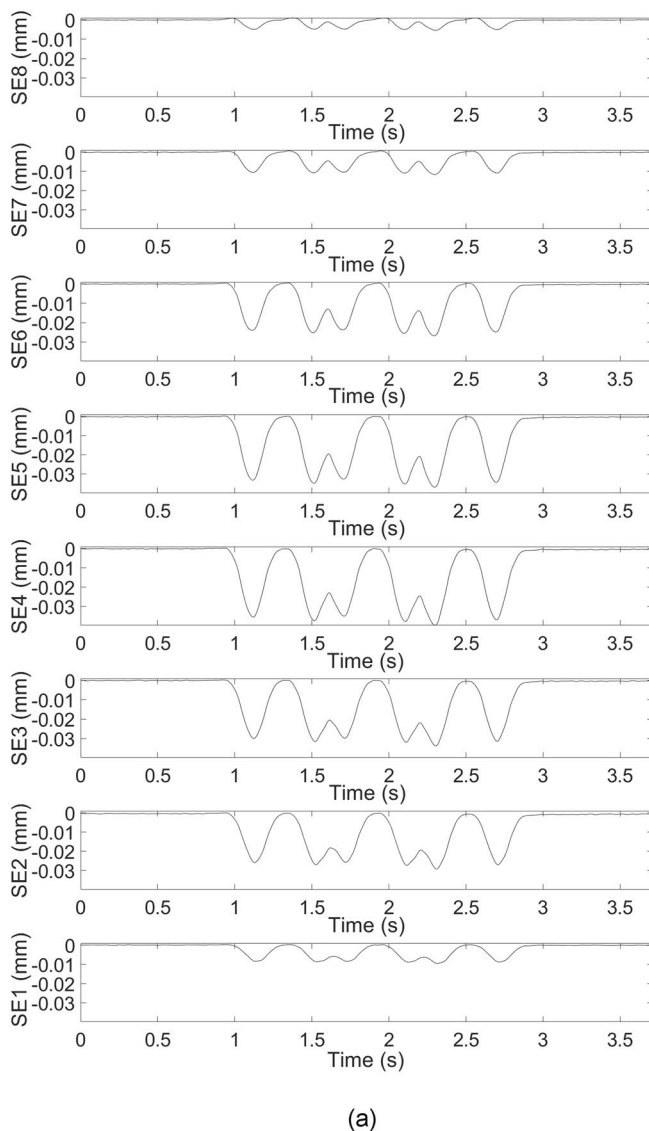
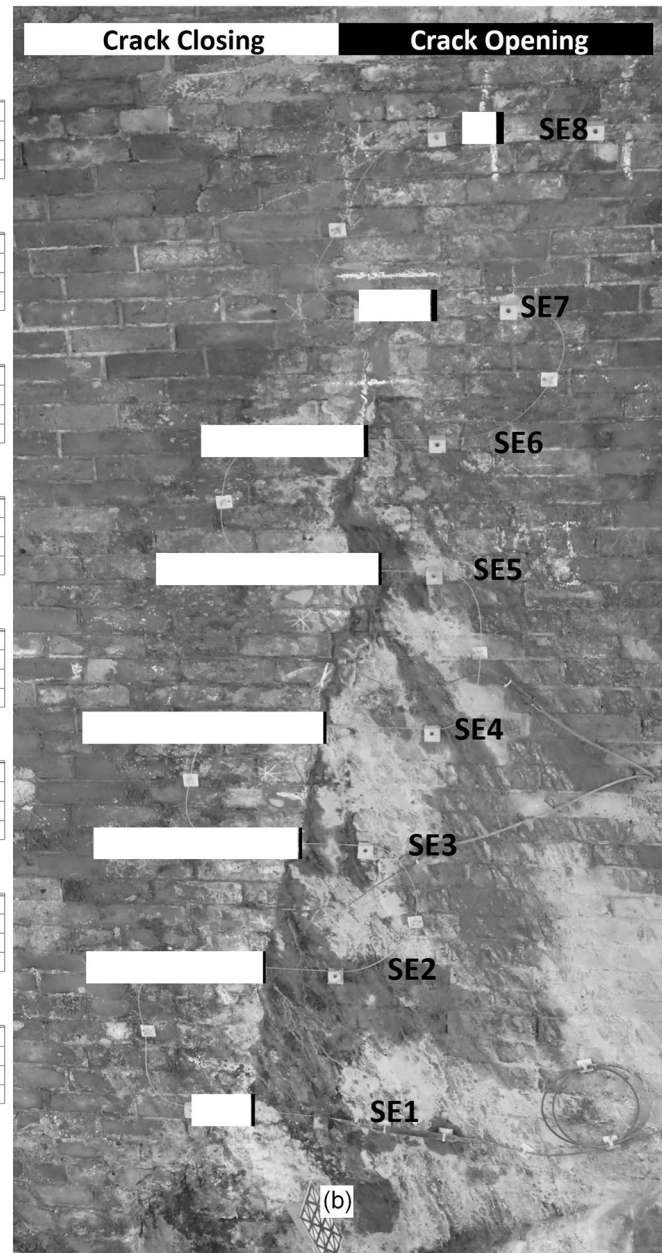
Fig. 8 **a** Typical time histories of the crack opening displacements at the south-eastern longitudinal crack, for a Class 185 train passing on the northern track, and **b** schematic showing the “football-shaped” distribution of these peak-to-peak crack opening displacements

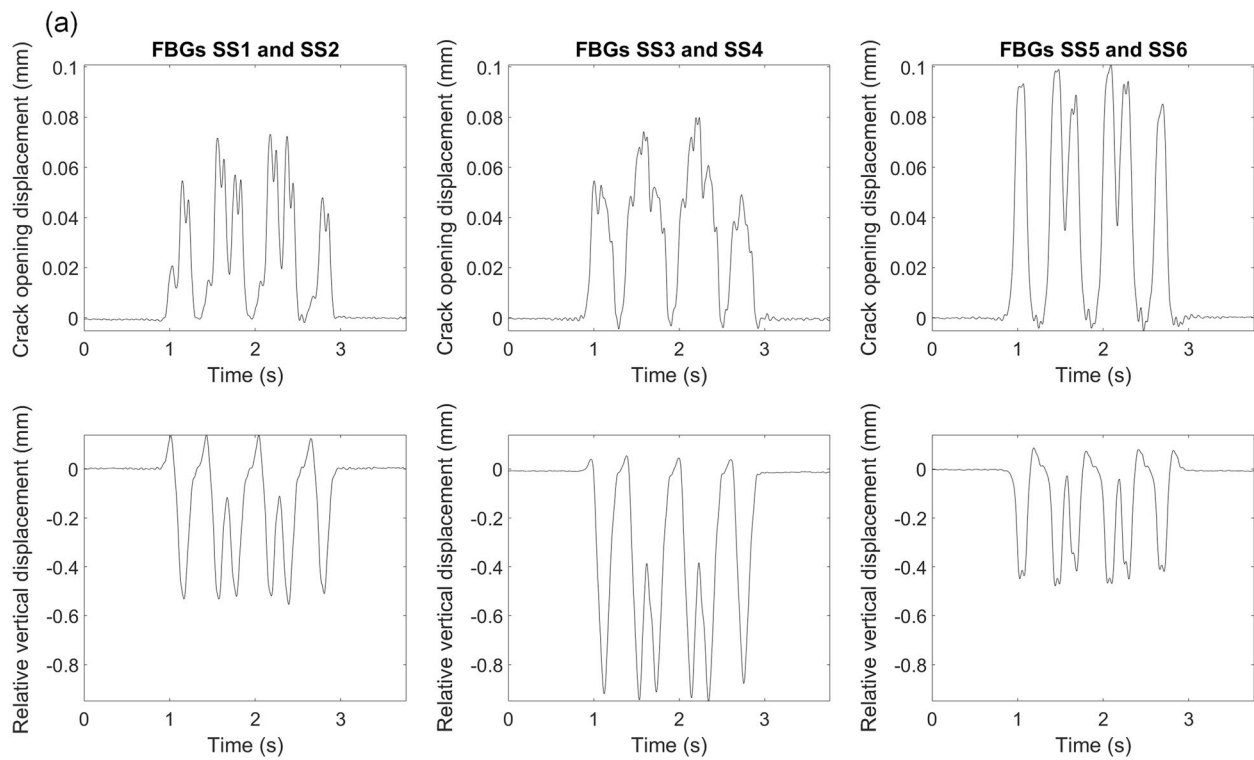
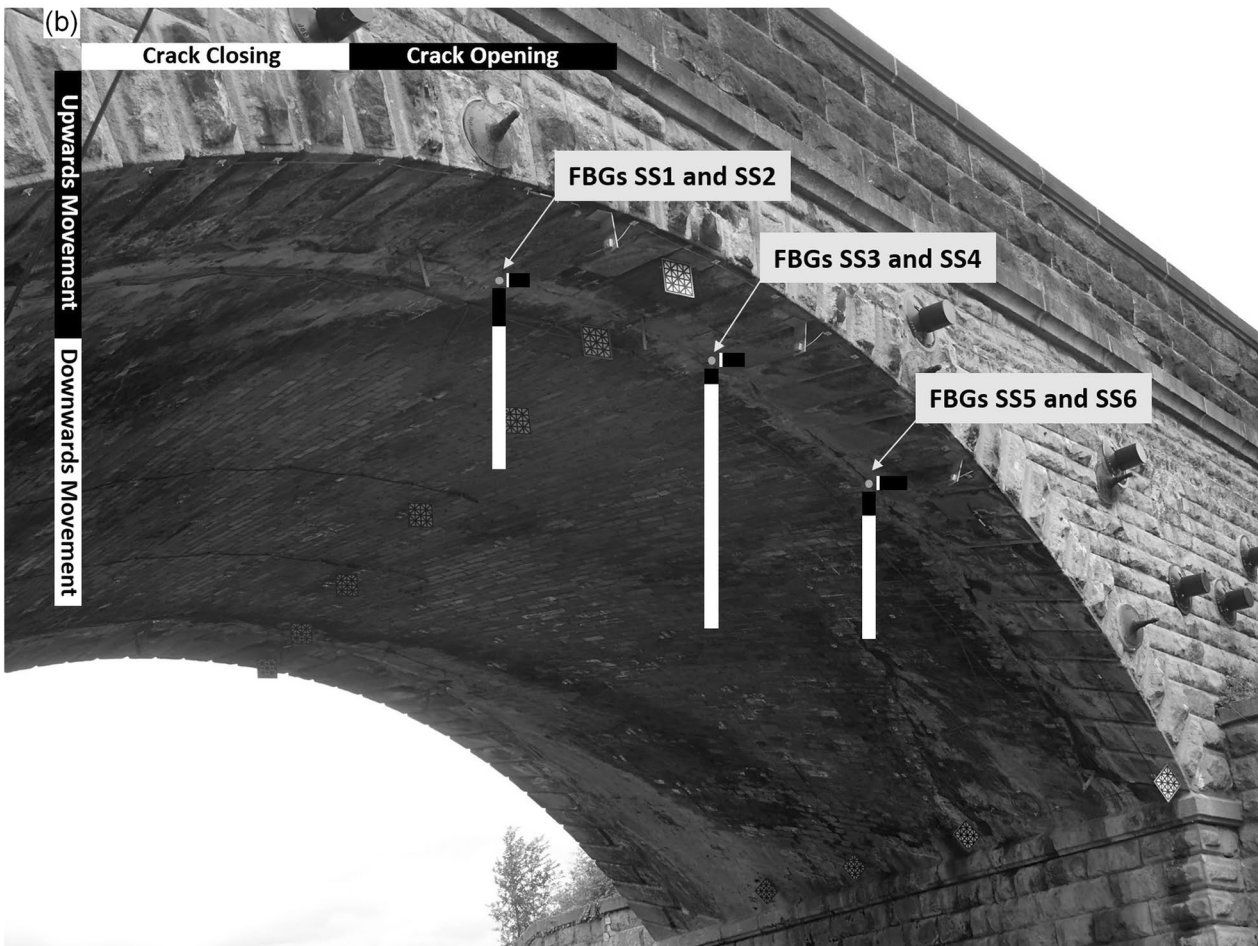
Fig. 9 **a** Typical time histories of the crack opening and pumping displacements at the southern spandrel separation crack, for a Class 185 train passing on the southern track, and **b** schematic showing the distribution of these peak-to-peak displacements

Figures 9 and 10 show typical crack opening and relative vertical displacements at the three monitoring locations, for Class 185 trains passing on the southern and northern tracks respectively. The top rows of these Figs. 9a and 10a show that the separation crack always opens, in the transverse direction, when trains pass on the southern track and closes when trains

For trains passing on the southern track, as in Fig. 9, the vertical component of the response at the separation crack is dominated by downwards movement of the arch barrel relative to the spandrel wall. However, small upwards movements are seen in the responses at all three monitored points on the crack, corresponding to instances in time when axle loads are applied to the opposite side of the arch span. Magnitudes of movement are largest in the central region of the crack, peaking for FBG SS4 to the east of the arch midspan, although interestingly the response is not symmetric on the two sides of the crown (at FBGs SS2 and SS4).

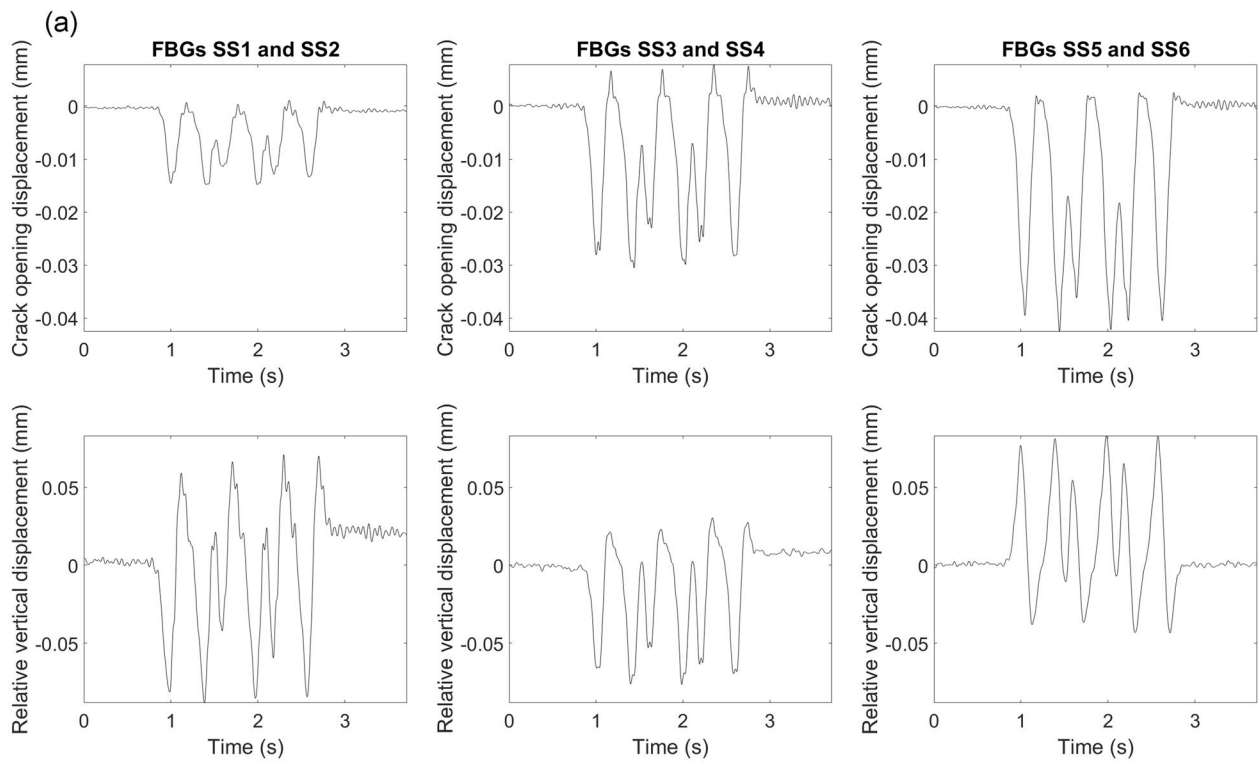
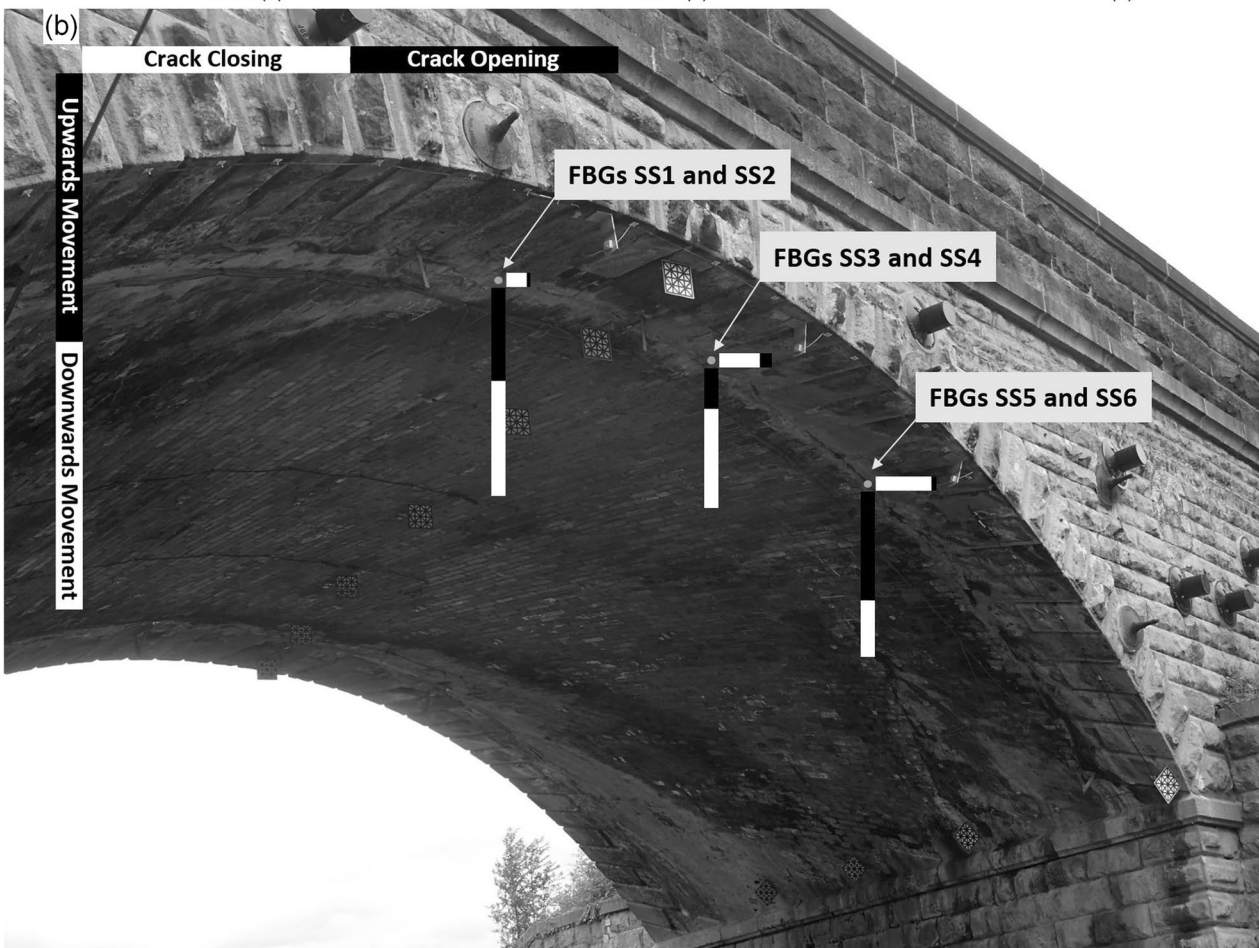
Fig. 10 **a** Typical time histories of the crack opening and pumping displacements at the southern spandrel separation crack, for a Class 185 train passing on the northern track, and **b** schematic showing the distribution of these peak-to-peak displacements

A different pattern is observed when trains pass on the northern track. In this case, shown in Fig. 10, movements at FBG SS4, just to the east of the arch crown, are notably smaller than those observed on either side, at SS2 and SS6, and there are appreciable upwards movements of the southern edge of the arch barrel relative to the spandrel wall. The response to the west of the arch crown (at FBG SS2, shown in the bottom-left subplot of Fig. 10a) demonstrates that application of axle loads at a corresponding point along the arch span still leads to downwards movement of the arch relative to the spandrel wall, but upwards movements occur in the “troughs” between these peaks. The response at the eastern quarter point (at FBG SS6) is more notably dominated by upwards movements, at the same times as the peak downwards movements are observed at the arch crown (particularly at FBG SS2).

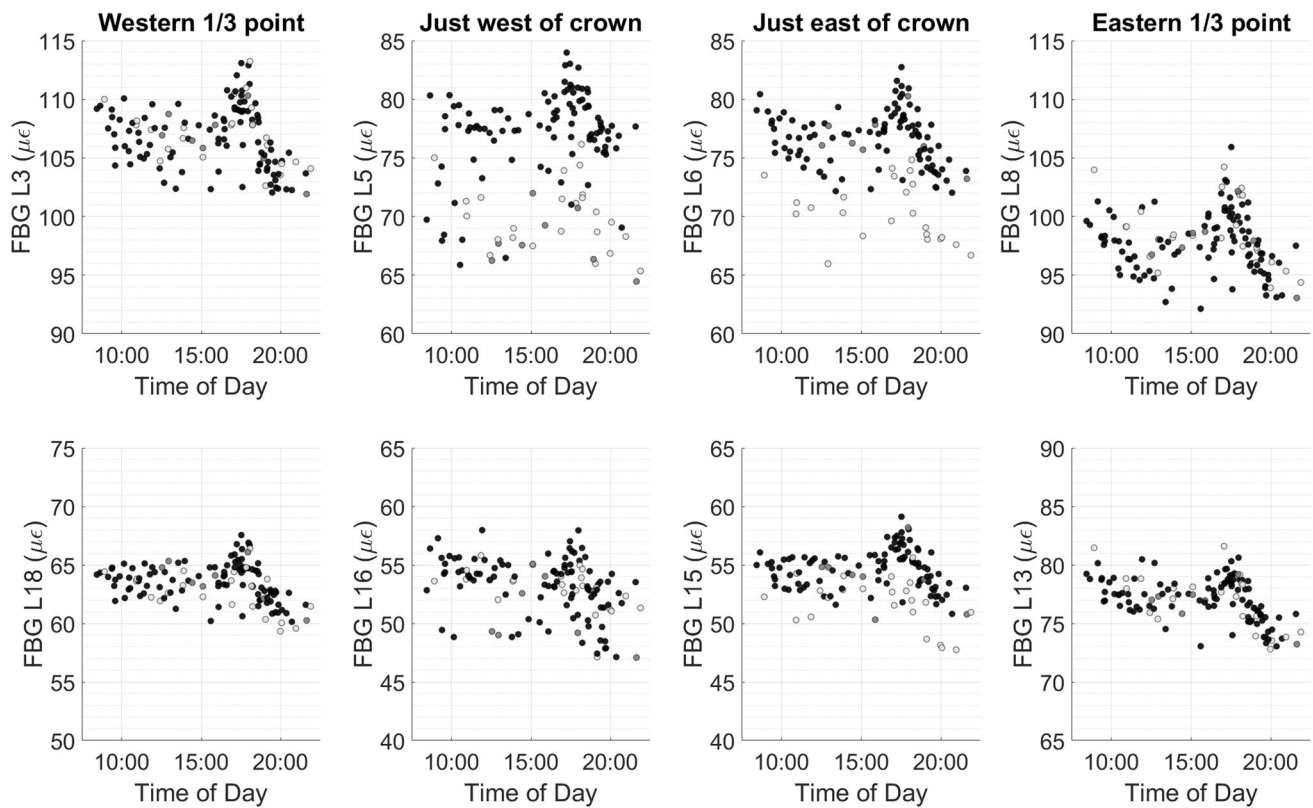
Fig. 13 Variation of peak-to-peak longitudinal strains with time of day, for all Class 185 trains passing on the northern track (data coloured by train speed)

In Fig. 13, time of day is used as a proxy for passenger loading. The actual axle loads applied to the bridge are not known a priori; although the train weights are known, the overall axle loads can vary significantly depending on passenger levels. Information obtained from Network Rail, the asset managers, suggests that the axle loads applied by a Class 185 train may increase by as much as 10–16% between typical and maximum, termed “crush,” passenger loading scenarios. Furthermore, “crush” loadings can be 27% higher than those applied by an empty train. These increases are not uniform across all axles.

Despite the spread in the data, a clear increase in the peak strain responses of the longitudinal FBGs can be seen in Fig. 13 around the evening commute, between 5 and 7 pm, before decreasing later in the evening to a lower level than is observed during the day. Qualitatively, this trend matches

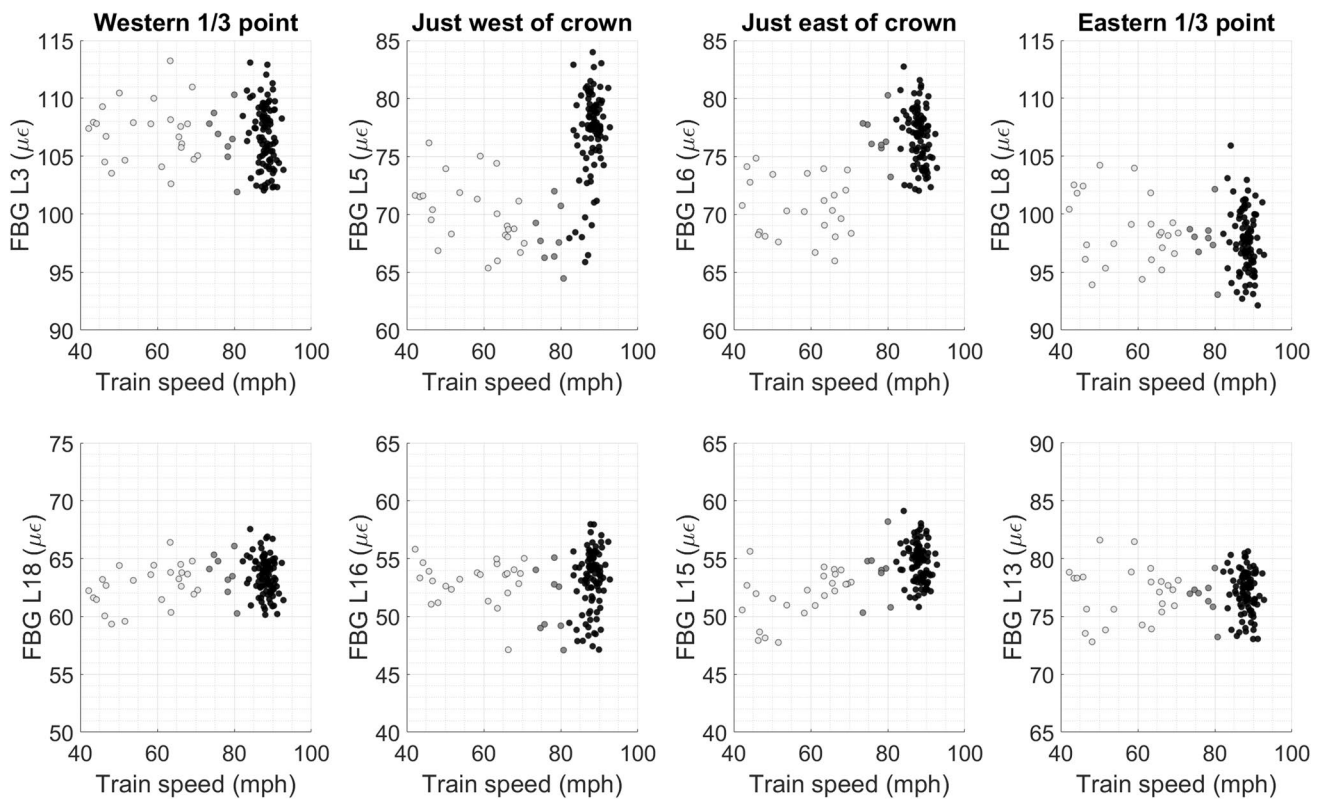
Fig. 14 Variation of peak-to-peak longitudinal strains with train speed, for all Class 185 trains passing on the northern track (data coloured by train speed)
