# Unzipping flood vulnerability and functionality loss: tale of struggle for existence of riparian buildings

Floods pose significant risk to riparian buildings as evidenced during many historical events. Although structural resilience to tsunami flooding is well studied in the literature, high-velocity and debris-laden floods in steep terrains are not considered adequately so far. Historical floods in steep terrains necessitate the need for flood vulnerability analysis of buildings. To this end, we report vulnerability of riparian-reinforced concrete buildings using forensic damage interpretations and empirical/analytical vulnerability analyses. Furthermore, we propose the concept and implications of functionality loss due to flooding in residential reinforced concrete (RC) buildings using empirical data. Fragility functions using inundation depth and momentum flux are presented for RC buildings considering a recent flooding event in Nepal. The results show that flow velocity and sediment load, rather than hydrostatic load, govern the damages in riparian RC buildings. However, at larger inundation depth, hydrostatic force alone may collapse some of the RC buildings.

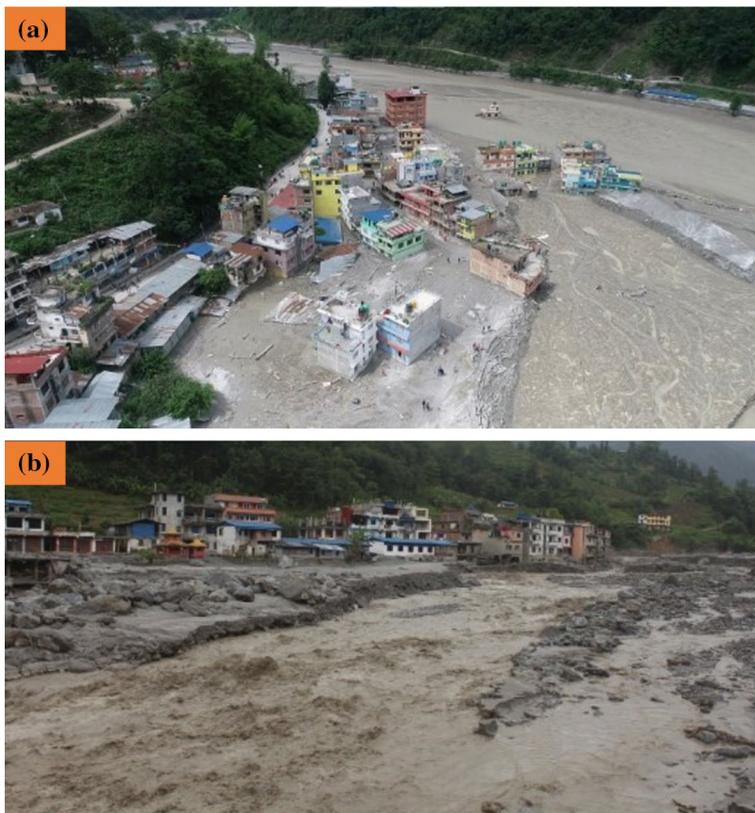
**Fig. 1** a Damage scenario after the Melamchi River flood in: a Melamchi neighborhood, b Chanaute neighborhood

the riverbank were affected by the flood. It is interesting to note that RC building resisted flood entry significantly, so the impact had deterred in the areas that did not face the riverbank directly. Due to the gentle riverbed slope, we did not observe any boulder impact on buildings in Melamchi neighborhood. On the contrary, Chanaute neighborhood observed the scenario in which large boulders directly impacted the buildings, leading to significant damage to collapse as shown in Fig. 3b. Notably, the riverbed slope in Chanaute neighborhood was considerably steep, so the flood event transported heavy boulders.

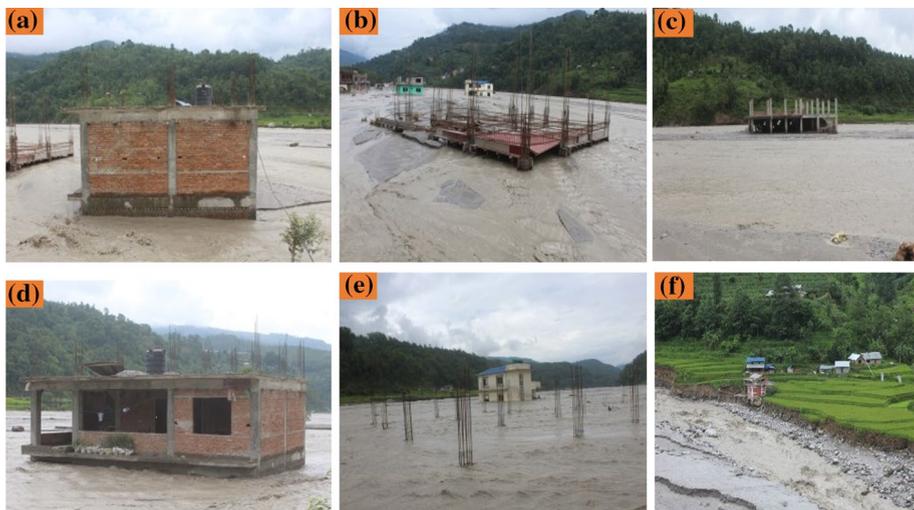
**Fig. 2** Manifestations of debris-laden flooding in Melamchi (27.830680 N, 85.575513E): **a** debris (fine sand) deposition up to the first story in an engineered RC building, **b** debris (fine sand) deposition in an under construction RC building, **c** RC building filled with debris due channel shifting due to the flood, **d** partly submerged under construction RC building, **e** completely submerged single storied RC building with exposed reinforcements left for story extension, **f** about to collapse RC building due to foundation erosion

(boulders), structural and nonstructural components of RC buildings are barely damaged. Figure 2f shows a near collapse code non-compliant RC building due to foundation erosion. Due to channel shifting, the Melamchi flood caused substantial damage to many buildings that were assumed to be above the flood level. Debris-laden flooding and subsequent debris deposition in the main river channel were responsible for damage to buildings and structures above the flood level.

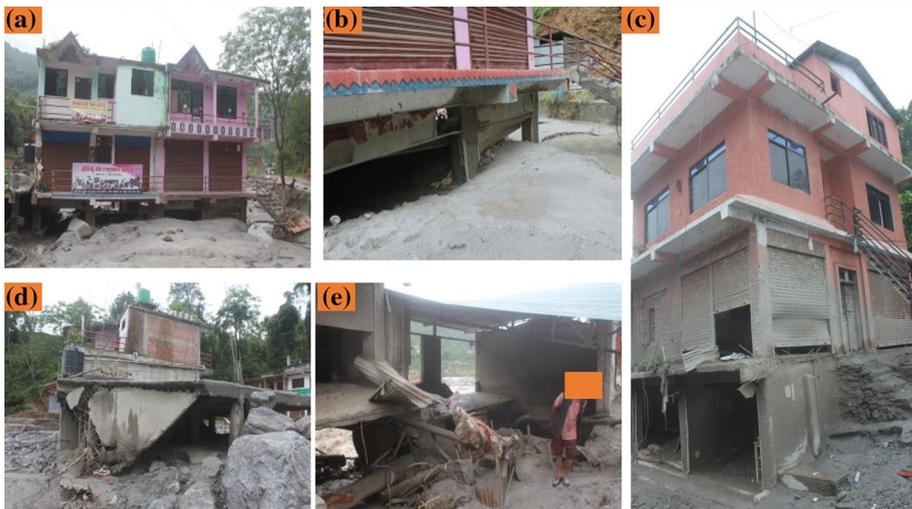
**Fig. 3** Manifestations of debris-laden flooding in Chanaute (27.902162 N, 85.543736E): **a** damage to shutters used for partitioning, **b** close-up view of flood damage to the ground story that shows debris deposition, **c** collapsed and heavily damaged shutters, **d** collapsed columns and slab due to boulder impact, **e** damage to structural and nonstructural components due to debris impact

Figure 3 shows flood damage to RC buildings in Chanaute neighborhood, approximately 25 km upstream of the Melamchi neighborhood. Large boulders were also observed along the riverbank that struck many riparian RC buildings which suffered greater devastation than that those in Melamchi. In this neighborhood, several buildings suffered collapse of structural members such as columns, beams, and floor slabs. Many such collapses were due to boulder impact. Meanwhile, damage to nonstructural components such as infill walls was mainly due to debris-laden flooding which generates lateral pressure against the walls. Even examples of damage due to impact of tree trunks and cobbles carried by the flood were observed (see Fig. 3). Nonstructural components such as shutters used for partitioning were affected even when not exposed to cobbles or tree trunks.

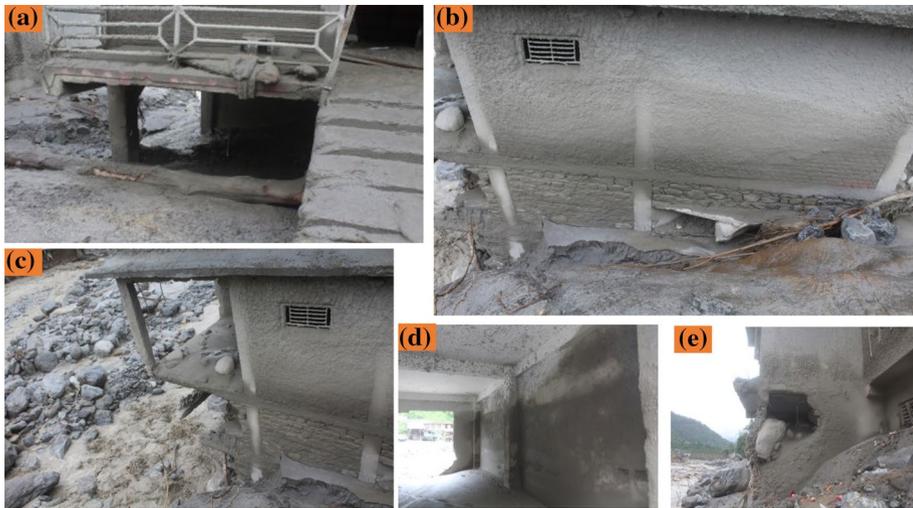
**Fig. 4** Damage to RC buildings due to flood: **a** collapsed brick infill walls, **b** heavily damaged walls and column damage, **c** partially collapsed faces of ground and first stories and heavily damaged corner column of the second story, **d** collapsed brick infill walls, **e** column damage due to debris impact

Some spectacular observations were made during the field reconnaissance regarding flood performance of RC buildings as shown in Fig. 4. When exposed to storm surge or inundation with clear water, ground or the first story of a building are often most damaged. When the flood carries massive debris, impact loads can damage building components at higher levels as shown by the damaged column in the second story of a building shown in Fig. 4. Unlike seismic loading, debris impact load is not proportionally distributed with building mass but is rather concentrated near impact points. Local stress concentrations generated by such impacts can have devastating effects on building components. RC buildings, by virtue of their resistance to flow-induced loads, divert flood current. The diverted current imposes high intensity loads near the corners of the buildings. These phenomena of local impact and flow diversion result in damage

concentrations and localized failures, which can subsequently lead to global failure of the buildings. Apart from this, waterways formed by debris impact leads to erosion of building components as well as severe damage to areas around the waterways where the flow velocity is high.

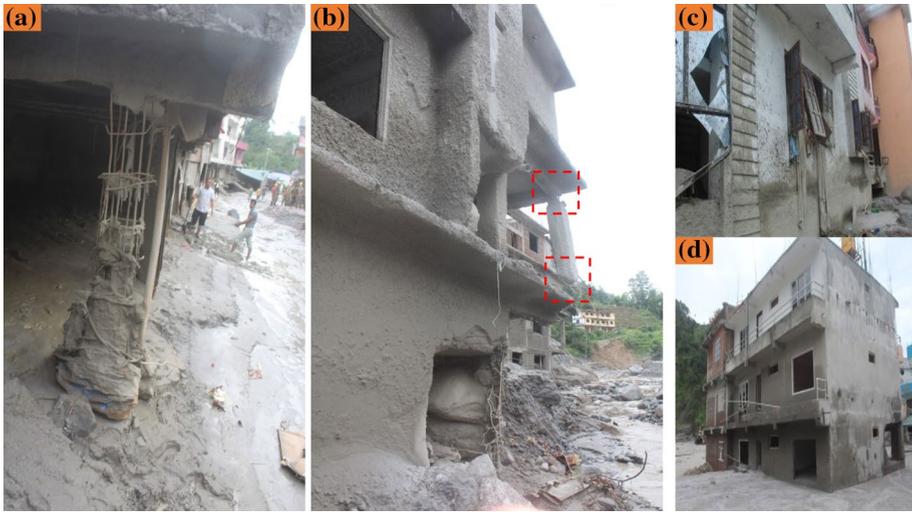
**Fig. 5** Damage to RC buildings due to flooding: **a** eroded column depicts remains of reinforcements of a substandard RC building, **b** progressive damage to an RC building due to debris-laden flood, **c** damage to window frames due to flood entry inside an RC building, **d** damaged infill walls and sediment deposition in two stories of an RC building

In substandard RC construction, debris-laden floods can easily erode concrete and leave just the reinforcements behind as shown in Fig. 5. This can lead to local failure, and in the lack of structural redundancy, continued flooding can aggravate damage leading to potential collapse. Structures exposed to prolonged debris-laden floods are thus prone to progressive collapse. Flood water intrusion can also dislocate window frames and damage windows because window frames are generally not adequately anchored to structural components or infill walls.

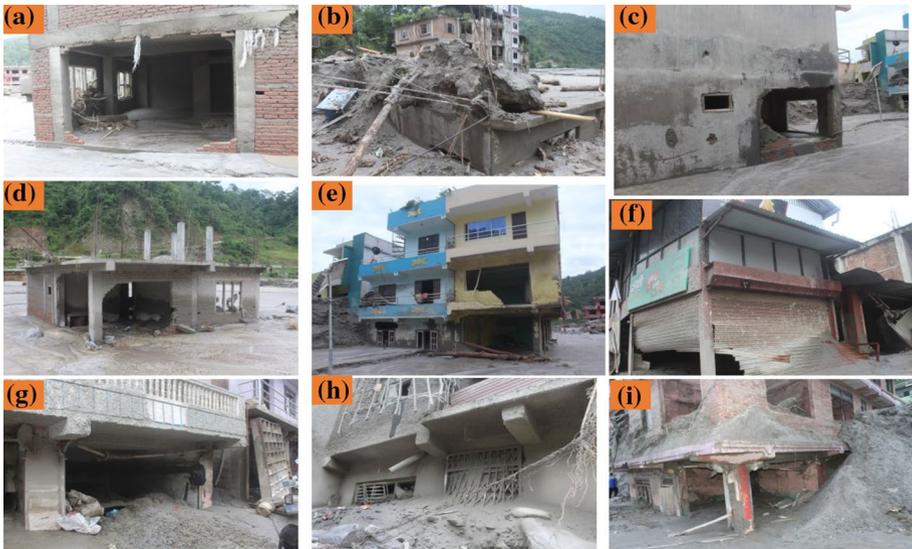
**Fig. 6** Damage to RC buildings due to flooding: **a** out of plane collapse of infill wall of an engineered RC building, **b** damage to RC column and distortion of longitudinal reinforcements, **c, d, e** infill damage at the corner locations, **f** damage to shutter used for shop outlets, **g** damage to shutter frame, **h** damage to steel grills provided in openings, **i** infill walls collapse in first and second stories due to debris attack

In Melamchi, flood caused substantial damage even to engineered RC buildings. As shown in Fig. 6a, an RC building with seismic bands intended to protect against out-of-plane collapse, failed. Lack of anchorage of the band and the wall to the main structural system leads to such vulnerabilities. Moreover, infill walls, which have the maximum thickness of 230 mm in the buildings studied here, do not seem to have adequate resistance to debris-laden flooding. Figure 6 shows examples of damage to RC buildings and components when fine sediments are more prominent than large boulders. Metal shutter gates in the lower floors were often found to be damaged, leading to aggravation in overall damage of the buildings.

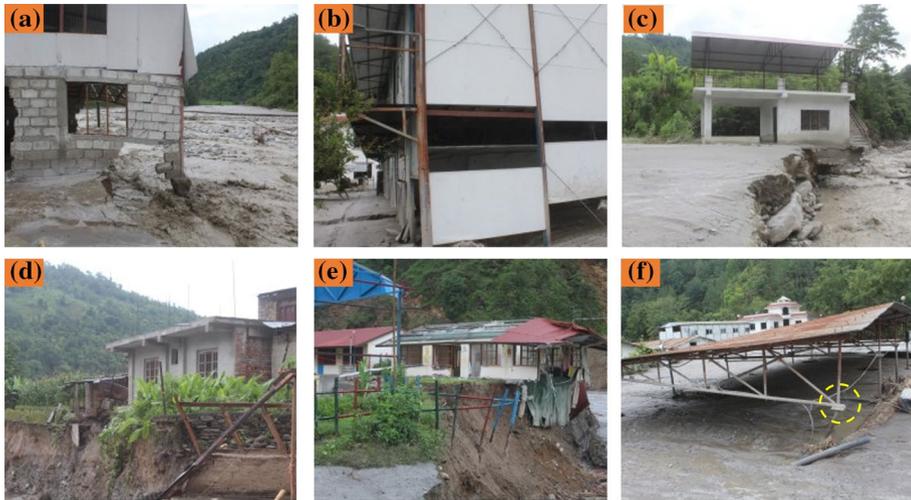
**Fig. 7** Flood damage to buildings: **a** foundation damage and damage to block infill masonry, **b** damage to infill panels, **c** damage to RC foundation, **d** foundation erosion in an RC building due to toe cutting, **e** foundation damage in a steel building due to toe cutting, **f** distortion in tubular steel post due to debris impact

Foundation erosion and subsequent damages were observed in non-RC residential buildings as shown in Fig. 7. Plinth beams in RC buildings seemed to hold the columns effectively together. In masonry buildings, the lack of integral connection between orthogonal walls led to severe damages. Steel structures without proper anchorage to the foundation were also severely damaged. Toe cutting was responsible for damaging many stone masonry and substandard RC buildings. Debris impact destroyed many tubular steel-frame buildings as shown in Fig. 7.

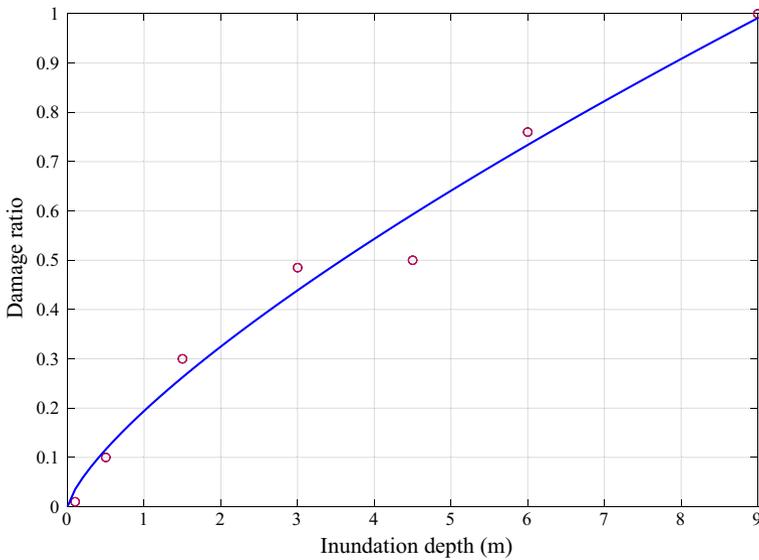
**Fig. 8** Empirical flood vulnerability curve for RC buildings

For multiple buildings with the same IM value, we averaged the damage ratio and fitted the vulnerability function. For up to 3 m inundation, the damage ratio is less than 50% and it reaches 75% if 6 m inundation (roughly correspond to two stories) takes place.

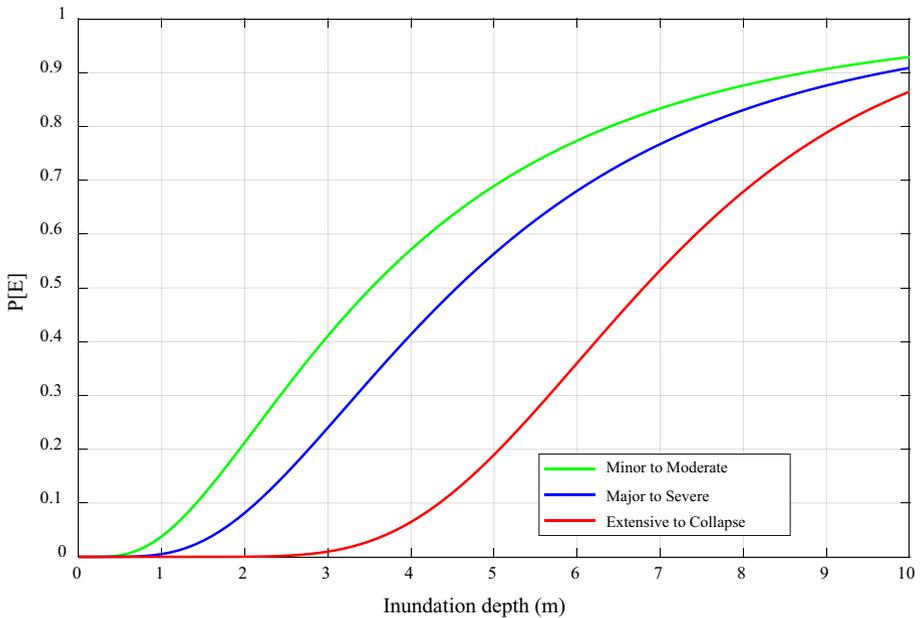
Using the parameters of Table 1, flood fragility functions for RC buildings are constructed as shown in Fig. 9. Figure 9 shows that due to limited data for minor to moderate damage state, their fragility functions tend to converge to the major to severe damage state after 10 m inundation depth. The fragility function for extensive to collapse damage state highlights a 50% exceedance probability at ~7 m inundation depth. Extreme events such as the 2021 Melamchi River floods are expected to result in inundation depth even greater than 7 m, and thus the likelihood of observing extensive to collapse damage state in most of the RC buildings is very high. Meanwhile, most of the shallow inundation (<1.5 m) is found to be insignificant for RC buildings, unlike the wattle and daub constructions as reported by Thapa et al. (2020).

**Fig. 9** Empirical flood fragility functions for RC buildings

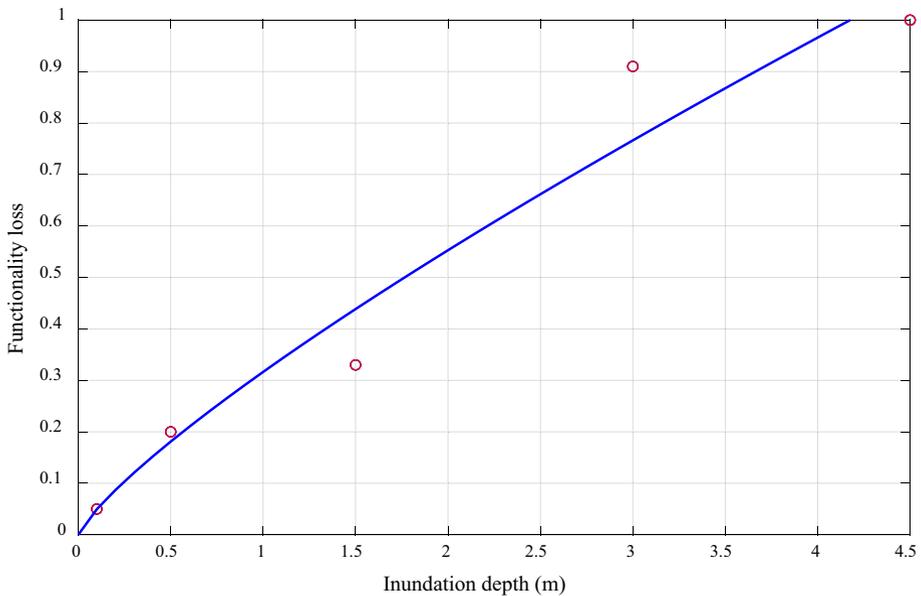
expected that functionality loss decreases with time as repair and retrofitting is carried out. As a quantitative measure of loss, we use the ratio of out-of-use to total plinth area as a measure of functionality loss. Functionality loss is best modeled as an evolving process (see e. g., Rupakhety and Sigbjörnsson 2014) which requires a series of functionality evaluation after a damaging event. Since we only have one survey, which was a week after the flood, our functionality loss model is only a snapshot in time of an evolving process. Functionality loss percentage for each of the 72 buildings surveyed during the field assessment was assigned based on the status of building use as per plinth area. For example, if the ground story has debris deposition and is not cleared until the designated period, then the ground story cannot be used for any purpose, be it storage, a shop outlet, or even residential space. While assigning the functionality loss ratio, we also noted the inundation depth. Functionality losses in buildings with similar inundation depths were averaged. The averaged losses are then fitted to a logistic model as shown in Fig. 10. It should be noted that 100% functionality loss occurs if the inundation depth is more than 4 m, which corresponds to one and a half stories inundation. This is expected because of several reasons. First, access to higher stories is disrupted when the lower stories are filled with debris. In addition, psychological concerns about impending damage leads to disrupted use of the unaffected floors. Functionality loss functions such as these can be used for planning temporary shelters in the case of similar flood events. It is expected that functionality losses in less resilient constructions such as unreinforced masonry is higher.

**Fig. 10** Functionality loss function for RC buildings

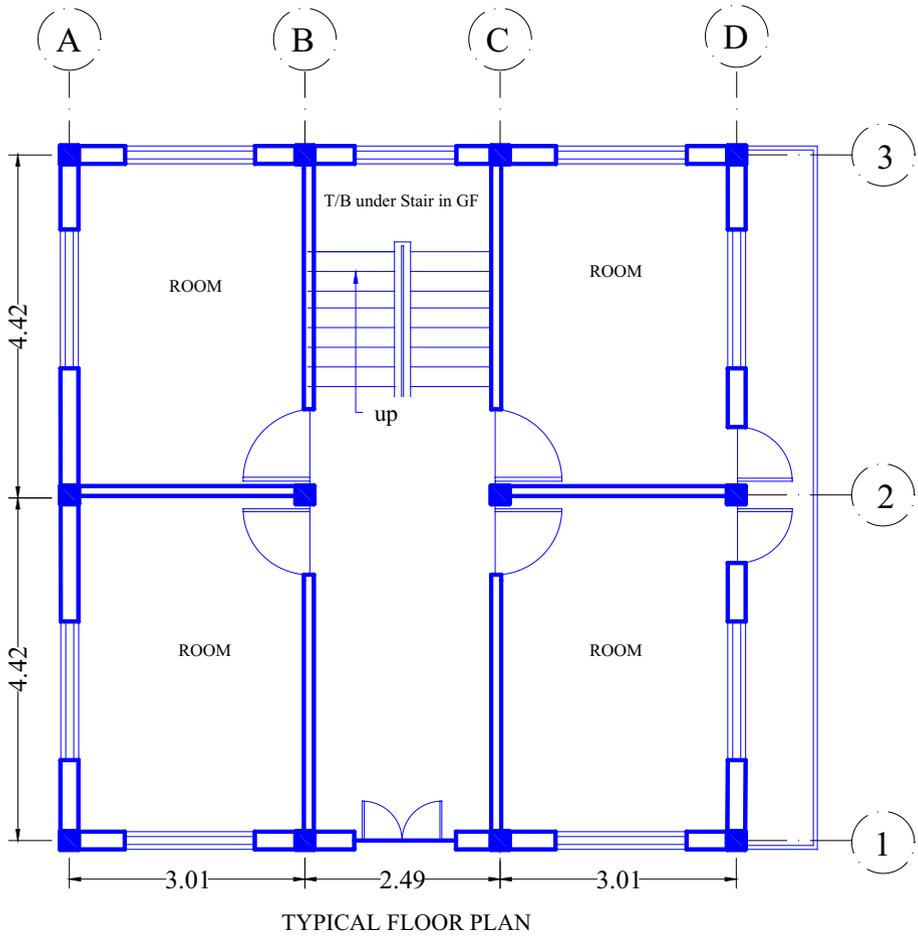
Fig. 11 Typical plan of a residential RC building in Nepal used as a case study

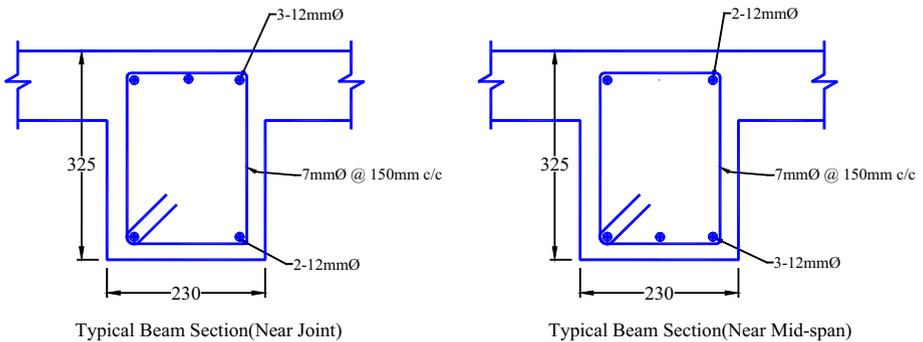
Fig. 12 Typical sectional details of beam at joint and mid-span

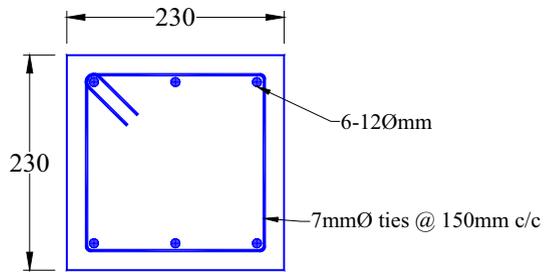
**Fig. 13** Typical column details of the case study building

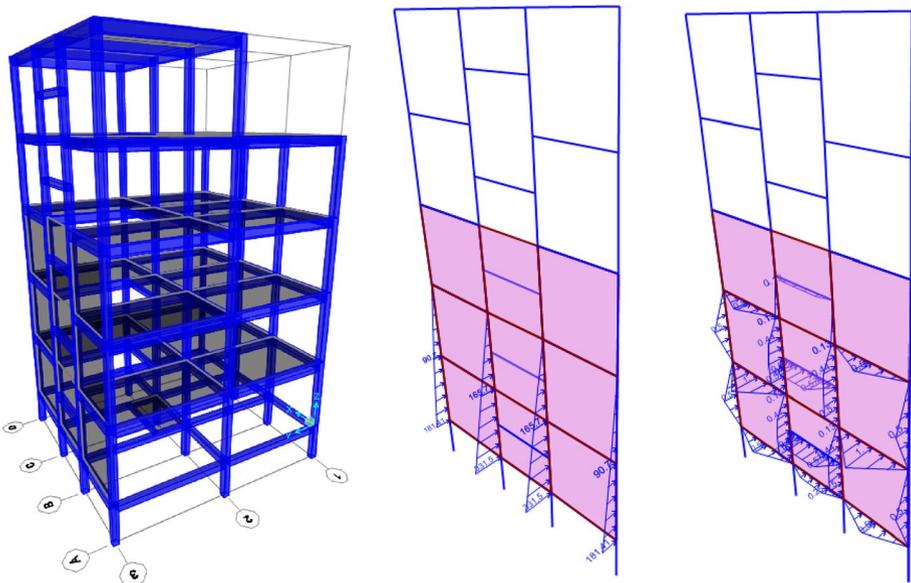
The beams and columns are modeled using 1D (line) elements with appropriate sections including reinforcements. The stiffness of the slab is neglected in the analysis, and loads from slabs are distributed to beams using the ‘none’ slab section. The building is modeled up to the foundation top level, which is 1.5 m below the plinth level and includes a plinth beam as well. Nonlinear hinges were assigned at each end of beam and column elements at a 10% distance of member length from the joint. Nonlinearity of frame is captured only at frame-hinge locations. The change in stiffness in the building due to infill walls is not considered in this model. As the loading in the structure is due to floods acting on some parts of the building only, the capacity curve for the building was obtained by performing pushover analysis in which static nonlinear analysis was carried out under displacement-controlled incremental loading, matching the flood load including the P- $\Delta$  effects. The deformation is significant within the inundation height only, the central joint in the story nearest to the flood level was considered to obtain the capacity curve which was done for incremental flood-velocity by preloading with the dead load, 30% of the live load, and total hydrostatic load. From the pushover analysis, we obtained yield and ultimate forces. Based

**Fig. 14** Finite element model of the case study building

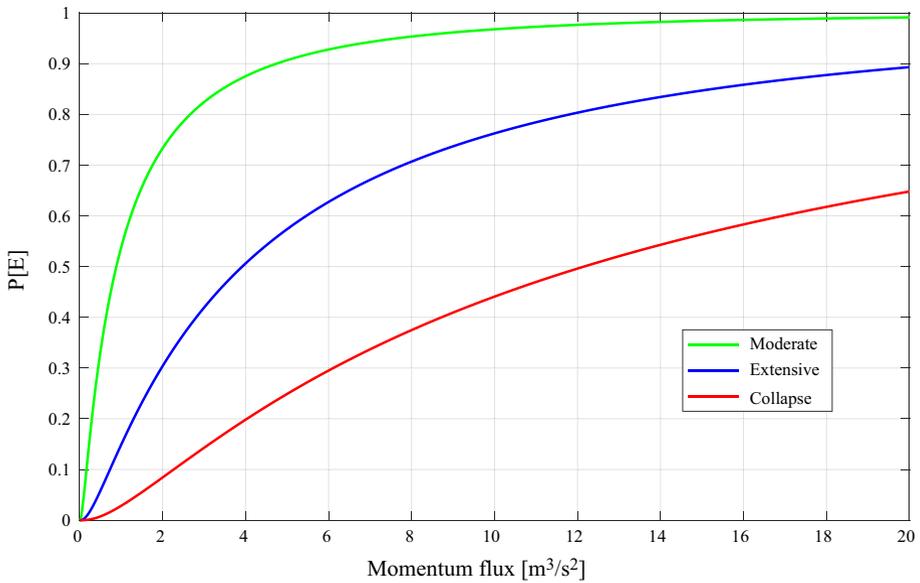
**Fig. 15** Analytical flood fragility functions for RC buildings

small momentum fluxes. For example, at  $2 \text{ m}^3/\text{s}^2$ , exceedance probabilities of moderate, extensive, and collapse limit states are, respectively, 74%, 30%, and 18%.

Fragility functions are better explained by momentum flux when considered as IM rather than inundation depth, which is well reflected in terms of exceedance probabilities of all three damage states for various momentum flux scenarios. The fragility models constructed using momentum flux as IM adhere more toward the realistic scenario since velocity undoubtedly plays an instrumental role in structural damage. On the other hand, the analytical fragility models developed using inundation depth solely could suffer from uncertainties arising from fluid–structure interaction, spatial variation of velocity, impulsive actions, and hydrodynamic fluctuations. To this end, analytical fragility models are better explained by momentum flux as IM. However, the fragility functions presented in this research are yet preliminary in nature as we do not consider structural uncertainties and we have not modeled fluid–structure interaction, fluctuation in flow velocity, fluctuation in sediment concentration, impulsive actions due to sediments of various sizes, among others. The aim of presenting the analytical fragility is also to start discussions regarding flood vulnerability of riparian buildings, especially in debris-laden flood regimes, and to identify areas for improvement in the future. Further advancements are fundamentally needed to address the uncertainties and also to define the complexities arising due to localized actions, changes in flow velocity dynamics after impact, and exposure and flood time history.
