**INTERACTIONS AT THE HEAD-TAPE INTERFACE OF A LINEAR
TAPE SYSTEM**

MARK ANDREW WILD

Doctor of Philosophy

THE UNIVERSITY OF ASTON IN BIRMINGHAM

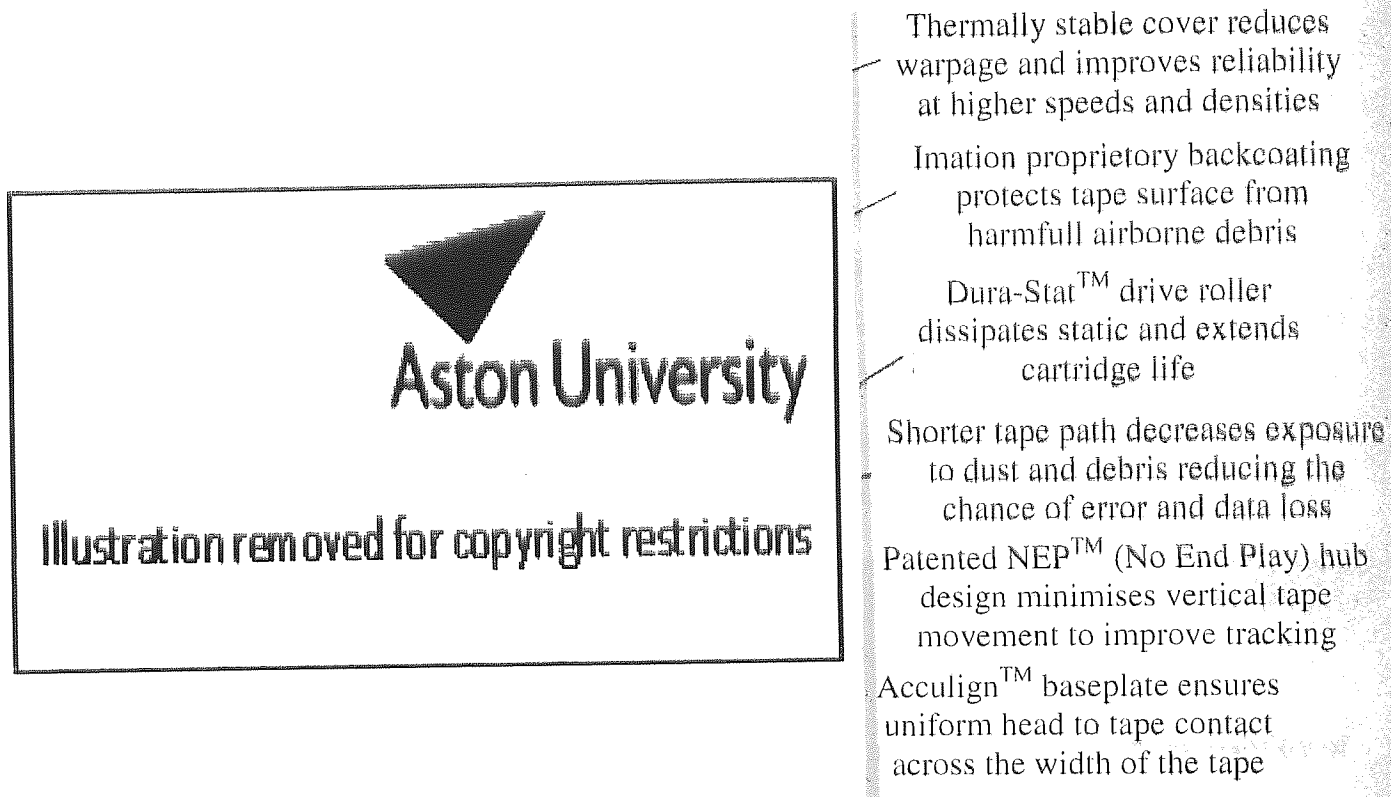
Figure 1.20 Components of a Travan NS20 QIC

The Travan QIC is of a belt driven design (Figure 1.20). A polymeric belt in contact with the magnetic surface of the tape is used to control tension in the tape by driving the supply and take-up reels. To eliminate the problem of trapped air, the polymeric drive belt has a micro texture imparted to the surface in contact with the magnetic coating of the tape⁶⁸. The effects of the belt on the tape surface have been reported in earlier works^{69,70}.

During running, the tape encounters a number of tape path components. The front side of the tape is in immediate contact with the drive belt and read/write head, while the backside of the tape contacts the cartridge guide pins. The frontside and backside of the tape are in contact with each other when they are wound onto the supply or take up reel in the cartridge. Tape and indeed cartridge wear is likely to occur as a result of such contacts, which could affect the system performance.

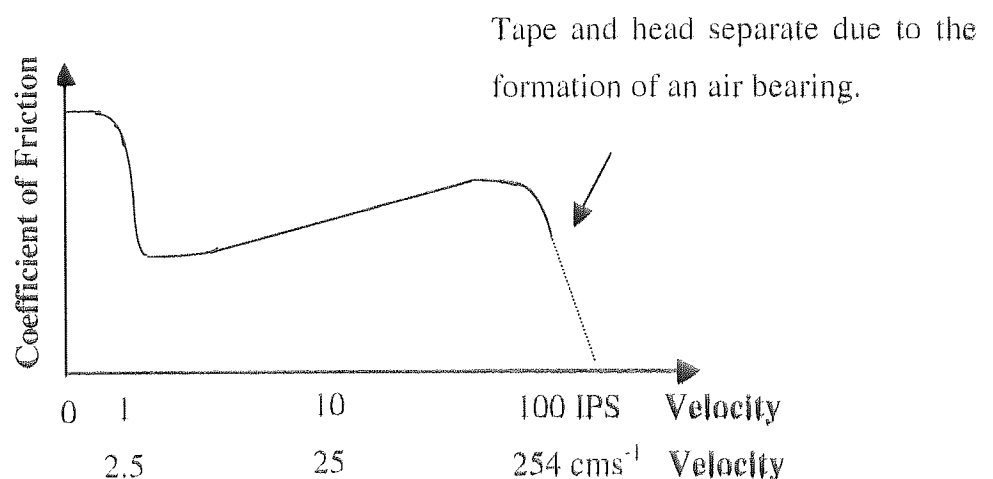
Figure 1.21 Coefficient of Friction Versus Velocity for a Typical Tape Drive

Once a lubricant is applied, this rule no longer holds. The frictional force now becomes proportional to the normal load and the relative velocity (V). When the velocity is low, there may be isolated contact points where the lubricant is missing. This leads to high friction (Figure 1.21). At higher velocities, air drawn along with the tape initiates an air bearing⁷⁶ which reduces the friction force.

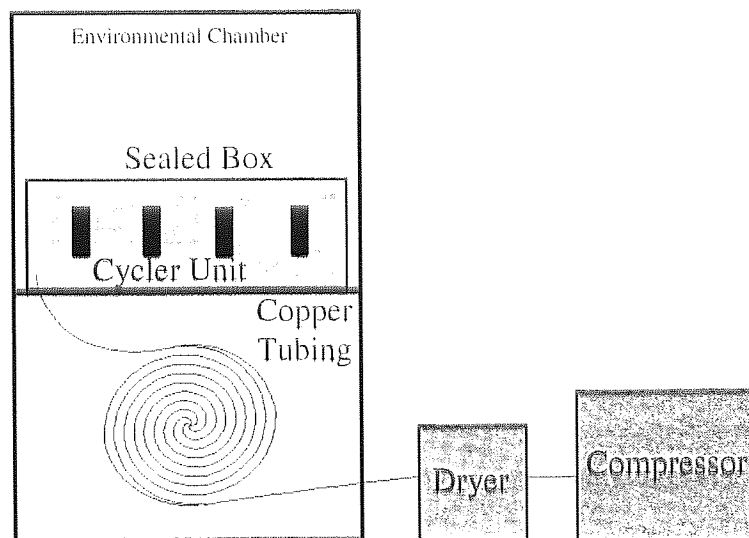
Figure 2.5 Schematic of Humidity Chamber Modifications

The cyclor was enclosed in a Perspex box before being placed into the chamber (Figure 2.5). A 20m length of copper tubing was also placed into the chamber with one end inserted into the Perspex box. A dryer unit (Zander Adsorption Dryer KE 12) was then used in conjunction with a compressor (Jun Air 2K-40 B) to blow dry air into the remaining end of the copper tubing. This had the effect of cooling the dry air before it arrived at the enclosed cyclor.

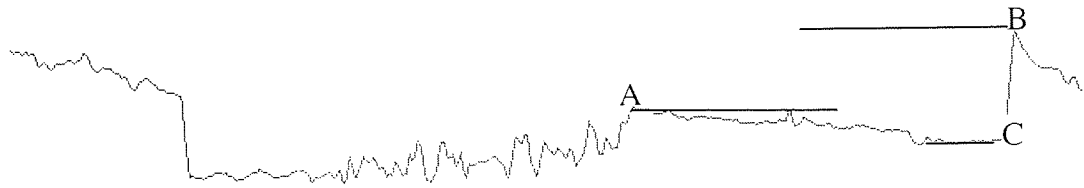
Figure 2.9 First Order Levelling

A comparison of first, second and third order levelling (Figure 2.9-Figure 2.11) as applied to data processing of an AFM image was made. The following images are to the same scale in both the X and Y directions and are of the exact same position on a virgin TR-4 head. It can

be seen from Figure 2.10 and Figure 2.11 that the curved contour of the head was retained during second and third order levelling respectively. Which radius of curvature is representative of the actual curvature was unknown.

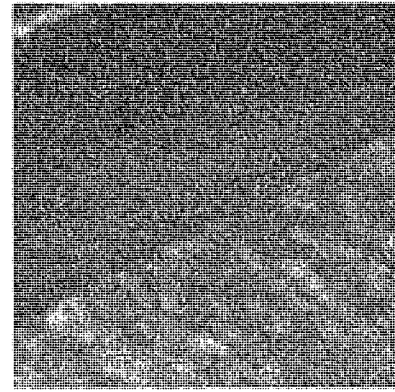
(d) AES – Ti (105 μ m)

Figure 3.78 shows SEM and AES maps (O, Fe and Ti) of the right read/write structure after 10K passes of tape MP3 at 32°C, 80% RH. Fe was seen to be dominant on the poles and ceramic regions.

Figure 3.78 (a) SEM and AES maps ((b) O, (c) Fe and (d) Ti) of the right read/write structure after 10K passes of tape MP3 at 32°C, 80% RH.
