DESIGN AND CONSTRUCTION FOR TRADITIONAL HOUSE BUILDING

Andrew Mark Jones Doctor of Philosophy 1990

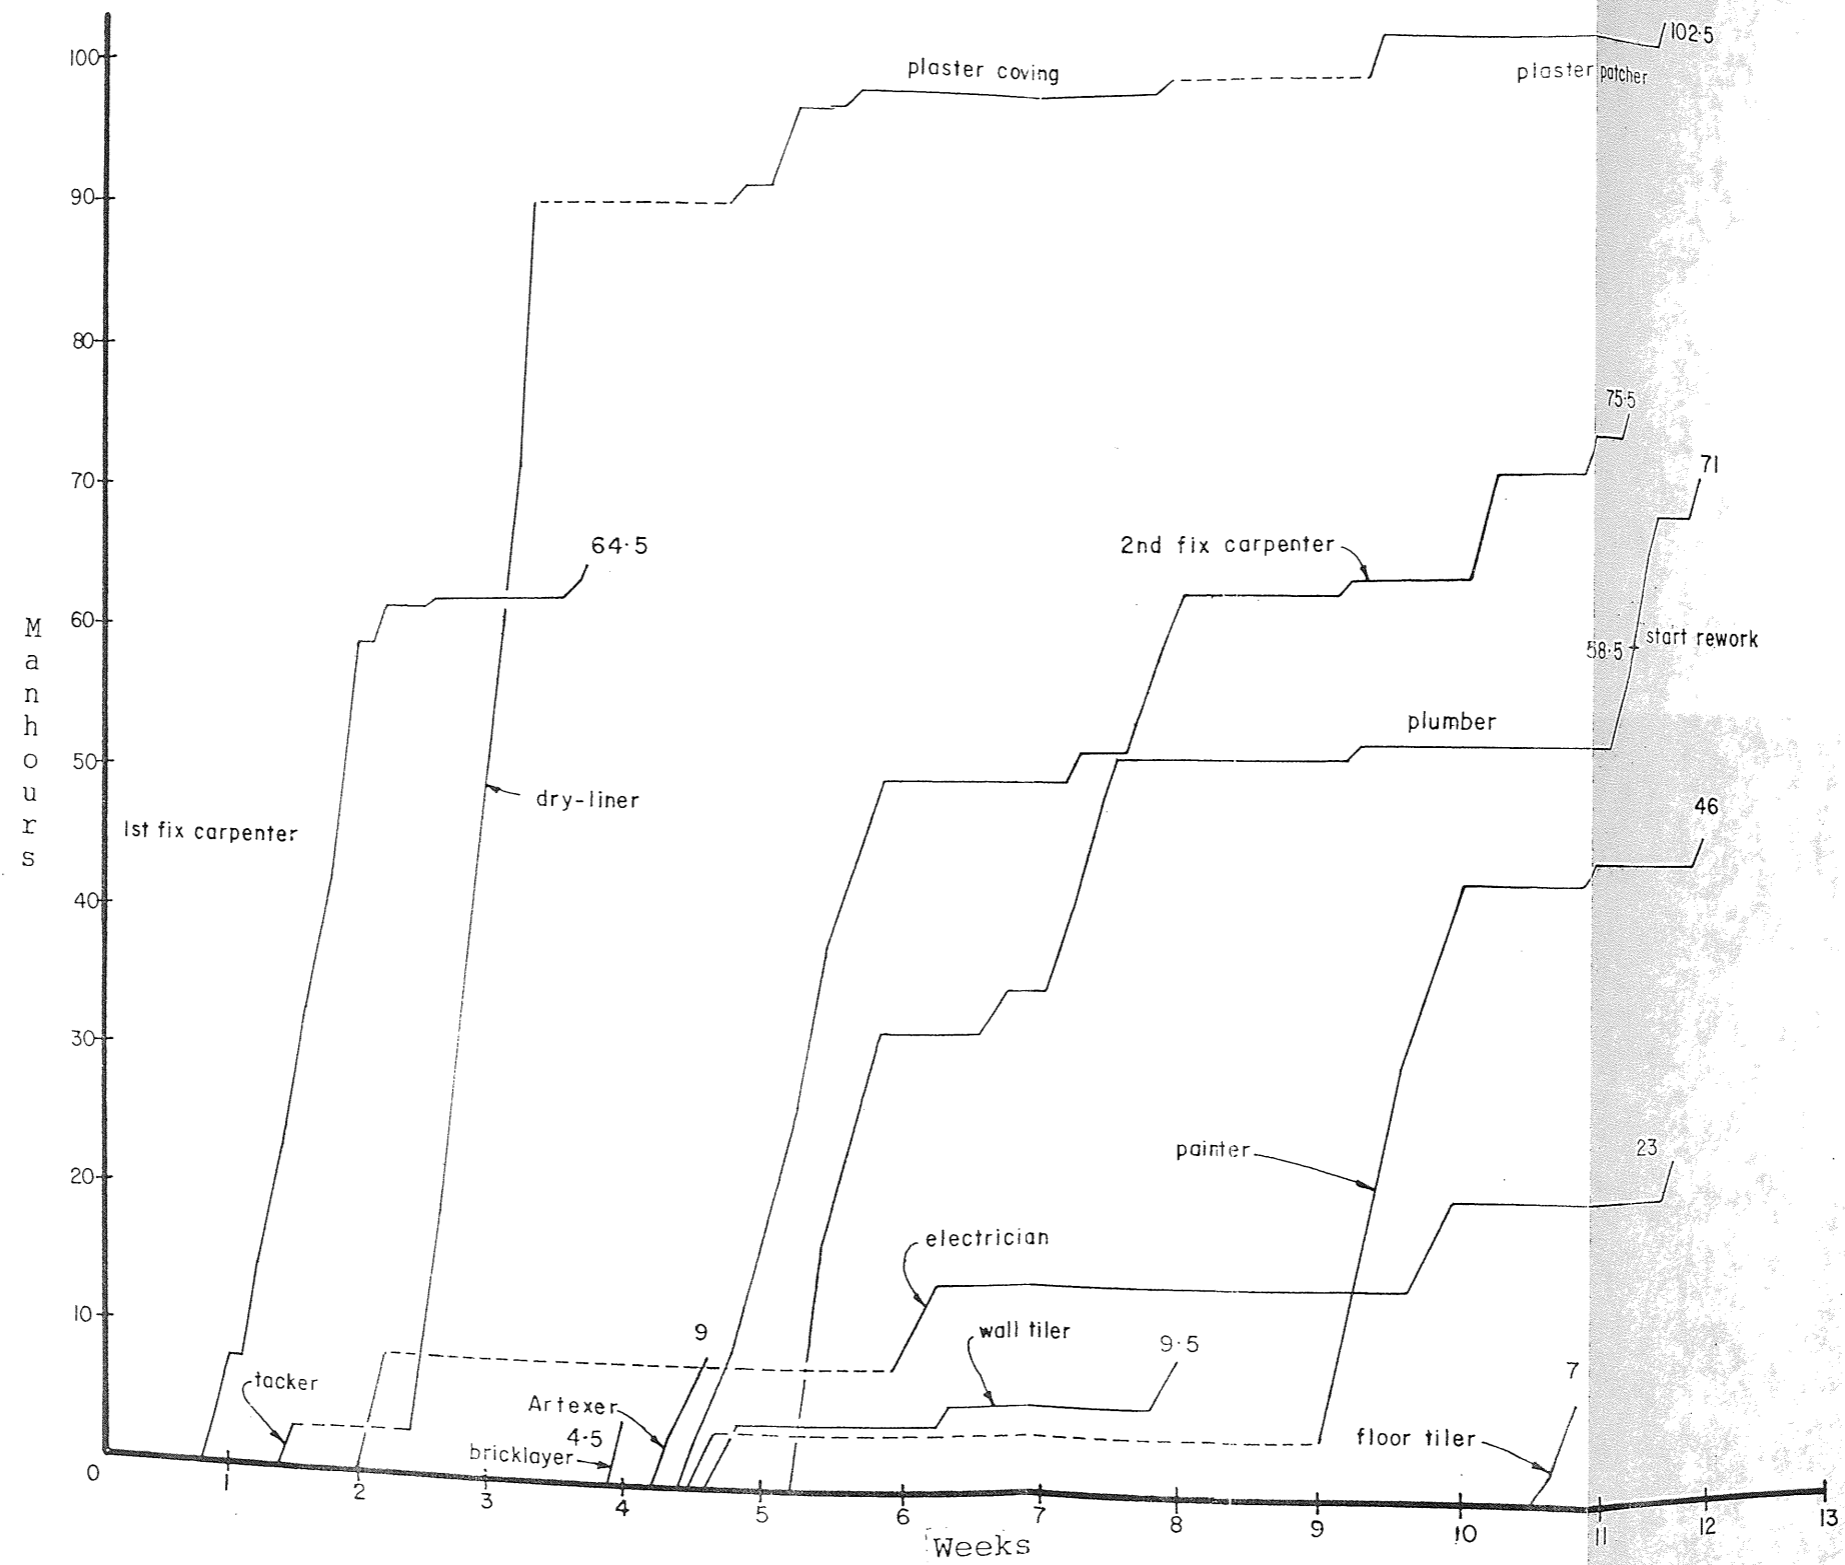
Fig.13: Graph of Progress (Plot 17)

The following text should be read in conjunction with Figures 13-22. These graphs show representations of the progress of work over time for the plots where all services and finishings operations were completed. Sloping lines represent work in progress and horizontal lines represent delays, or time spent waiting for another operation to commence. A sloping line following on from a horizontal line shows the recommencement of work (a new visit). Of additional interest, the graphs show when more than one trade was observed to be working in a house at any given time. This is indicated by the intersection of two or more sloping lines on an imaginary vertical axis.

Although the qualitative records indicate the cause of each delay shown, it would prove repetitive and futile to explain the cause and effect of each observation. The graphs show the actual sequence of operations which took place. They show confused work patterns for all but two of the experimental plots (31 and 43). For the most part this was caused by poor organisation, control and coordination at site level.
